BIENNIAL BRIDGE INSPECTIONS

FINAL INSPECTION REPORT Municipality of Dysart et al

December 2018

File No. 18-4011

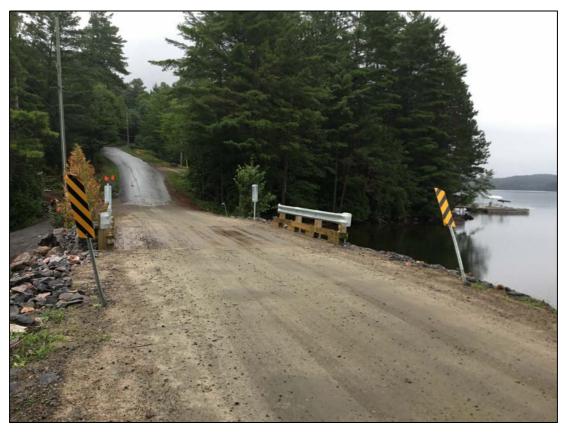
Description: Both west hazard sign posts are bent.

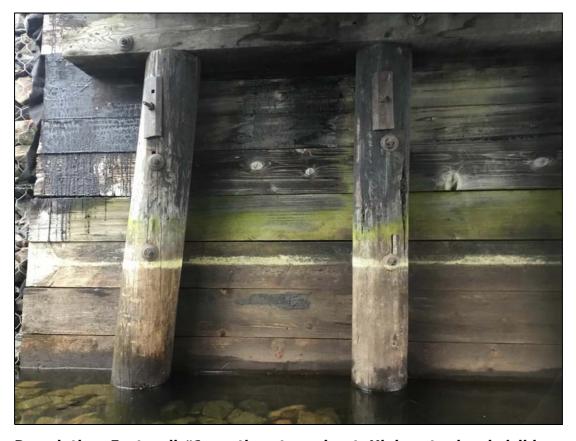
Description: East wall #1, northeast quadrant. High water level visible.

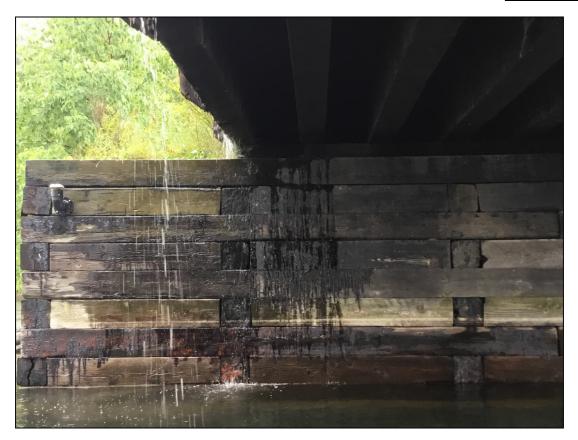
Description: Drainage from deck ponding behind abutment wall (pictured).

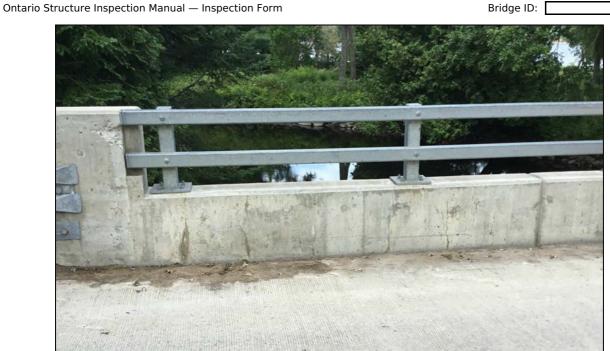
Description: West parapet wall, map cracking with stains throughout both walls. **Barriers / Barrier/Parapet Walls**

Patch spalls and cracks in barrier parapet wall.

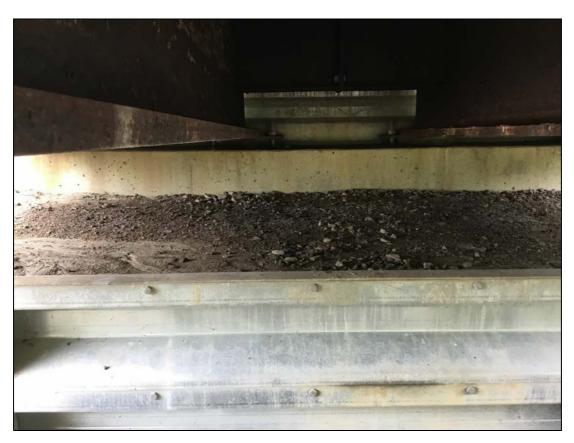
Description: South abutment, bugholes throughout

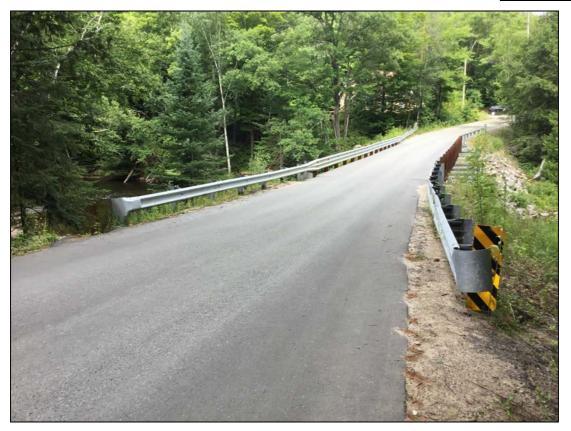
Description: Missing SW sign. Raise SE sign

Raise hazard signs and install narrow bridge sign at southwest quadrant.

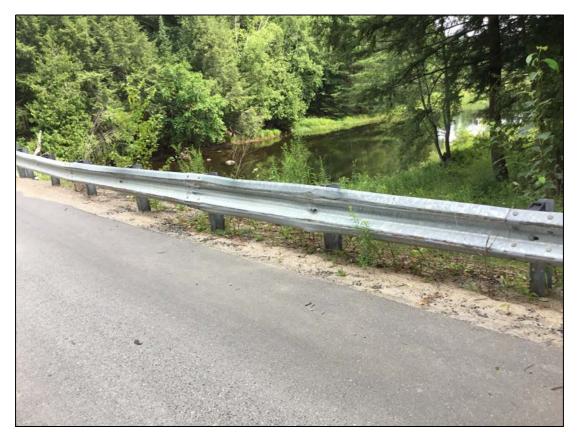
Description: SW rails have impact damage Barriers / Railing Systems (E/W)

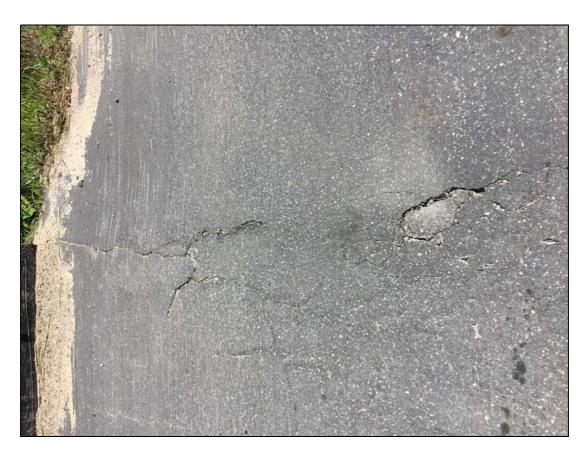
Description: Northeast transition bump from deck to approach.

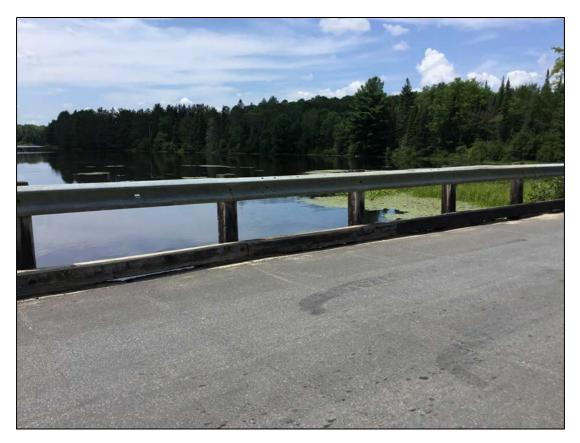
Description: Original curb, typical condition.
Sidewalks/Curb / Curb (N /S)

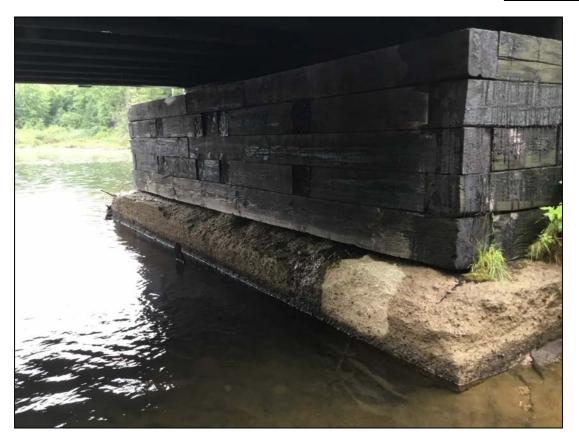
Description: Scoured east foundation

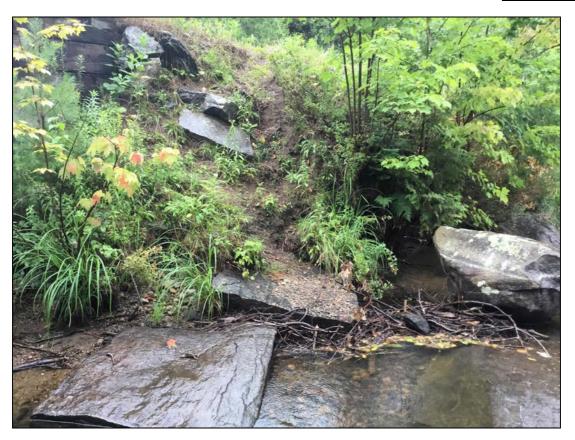
Description: Erosion at the southeast embankment.

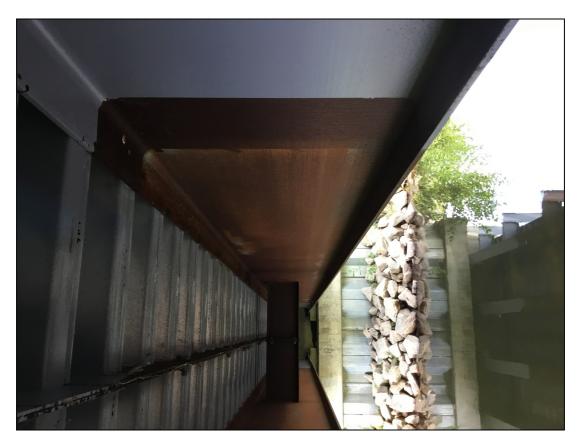
Description: Typical level of corrosion where coating is absent.

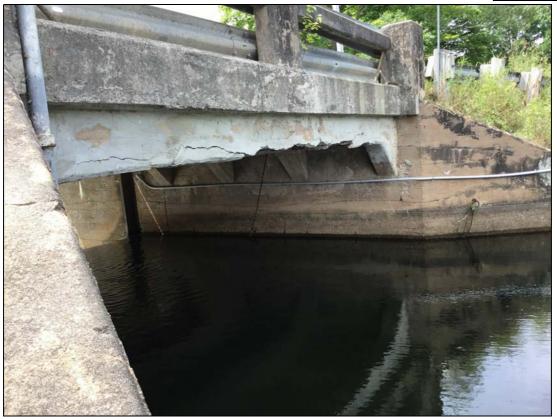
Description: West abutment, general conditions. Scaling on both abutment walls to high waterline.

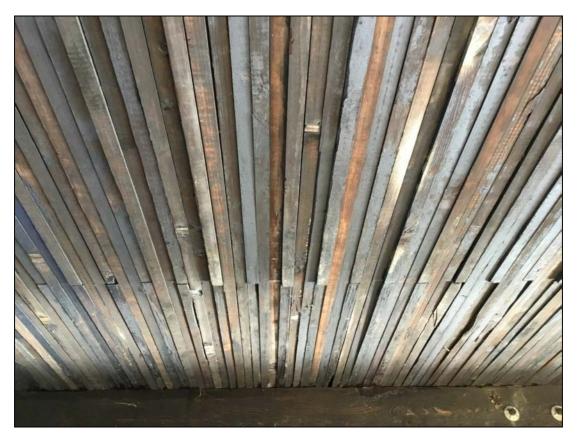
Description: General condition, north side. Note longitudinal offset due to warping at center.

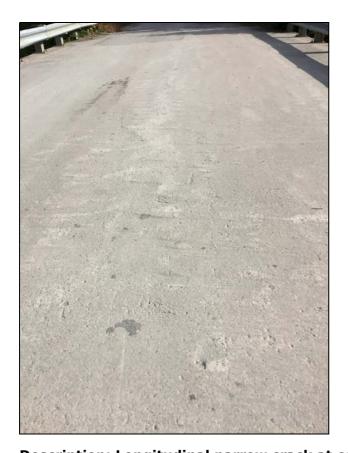
Description: Longitudinal narrow crack at center between girders.

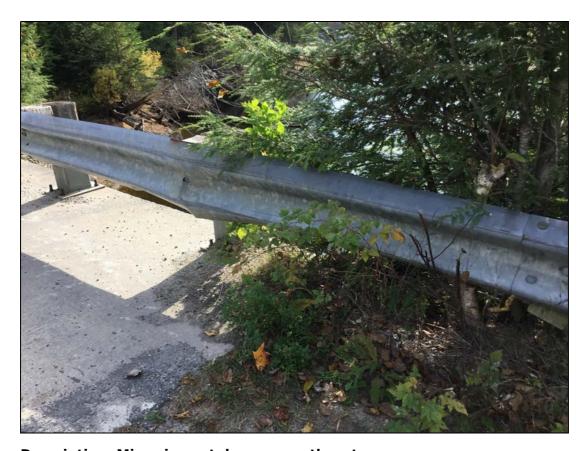
Description: Minor impact damage northeast.

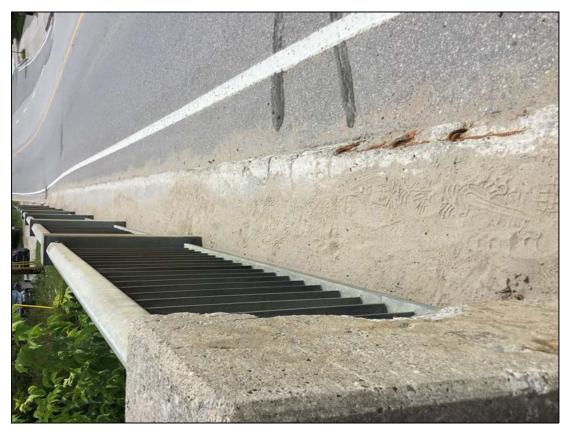
Description: East curb, typical condition. Note abrasion and spalling at edge.

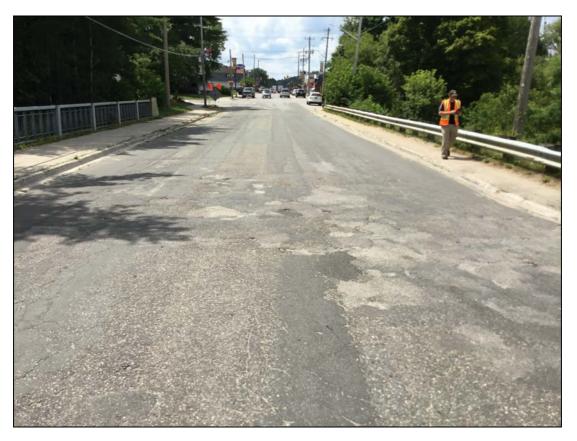
Description: East approach looking west, potholes and ravelling throughout.

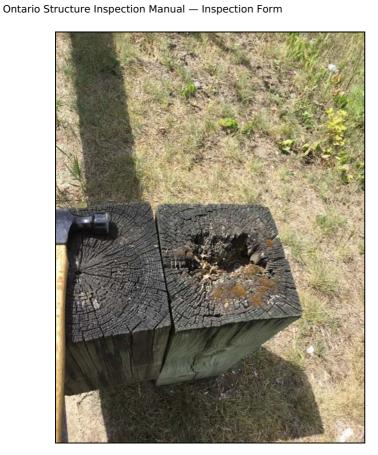
Description: Light rot, post top. **Barriers / Posts (North side only.)**

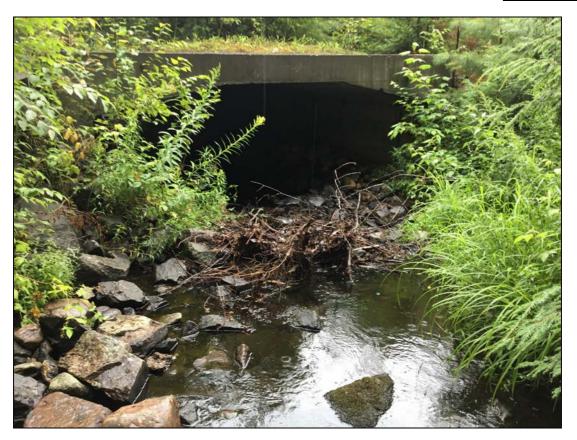
Description: Debris accumulating at inlet.

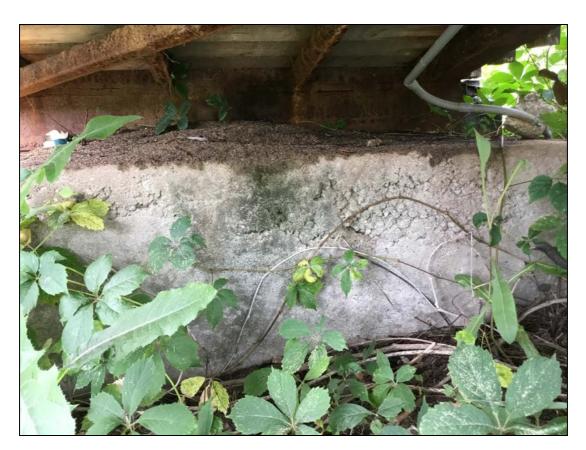
Description: South abutment wall showing honeycombing.

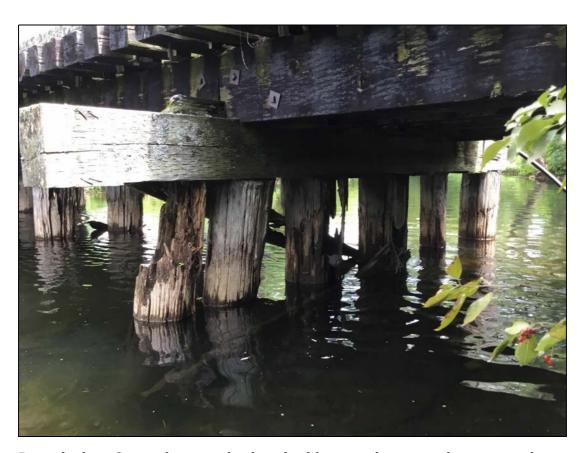
Description: Second to south piers looking northeast, at least two piers no longer providing structural support.

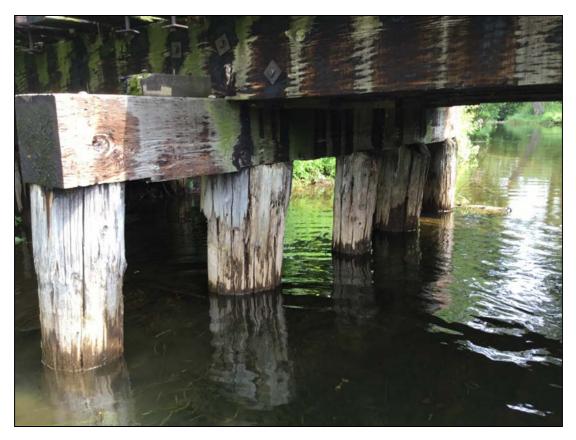
Description: Second to north piers looking northeast, note cracked pier second from left.

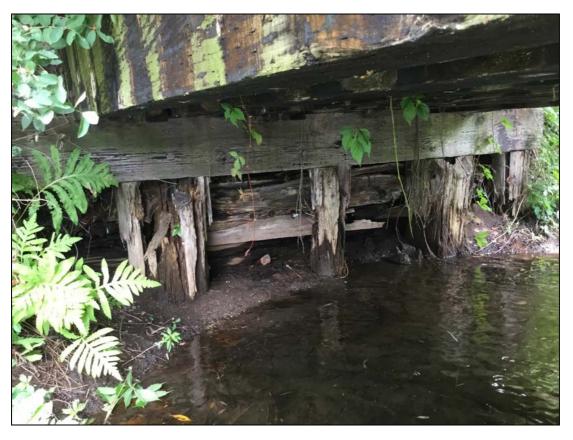
Description: North abutment piers, note severely disintegrated piers at waterline and broken in foreground.
