## BIENNIAL BRIDGE INSPECTIONS

FINAL INSPECTION REPORT  
Municipality of Dysart et al

October 2016

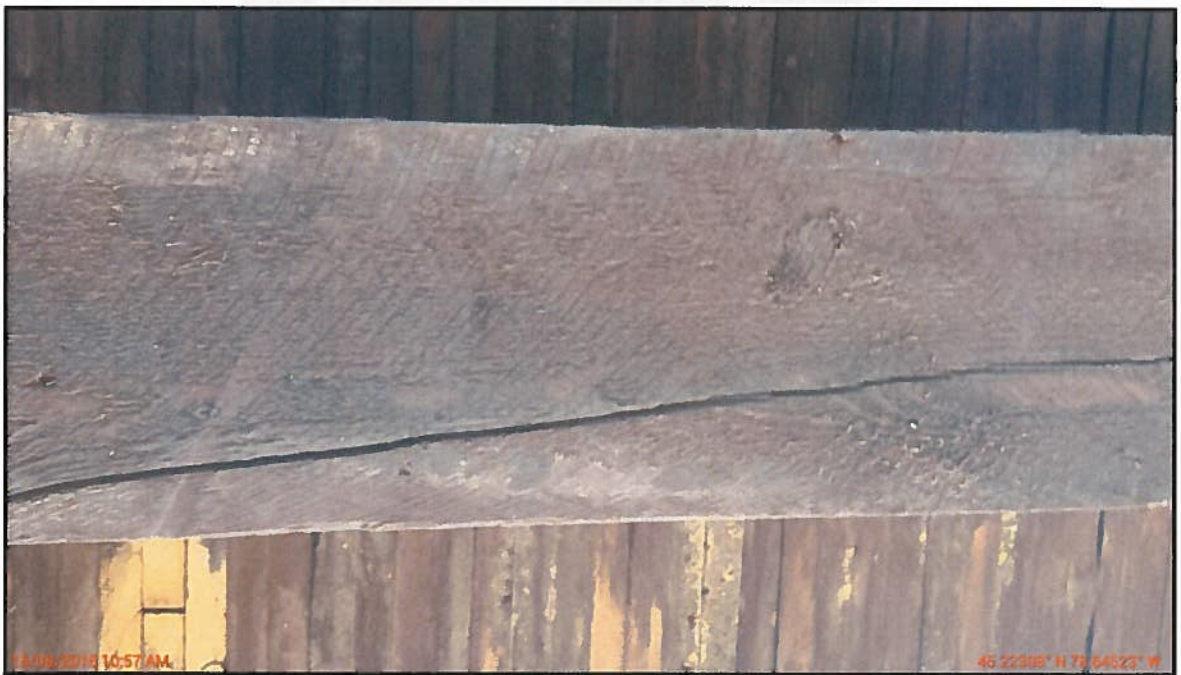
Photo 8: Longitudinal Cracking of Wood Beam (4<sup>th</sup> from North face) – Close Up View

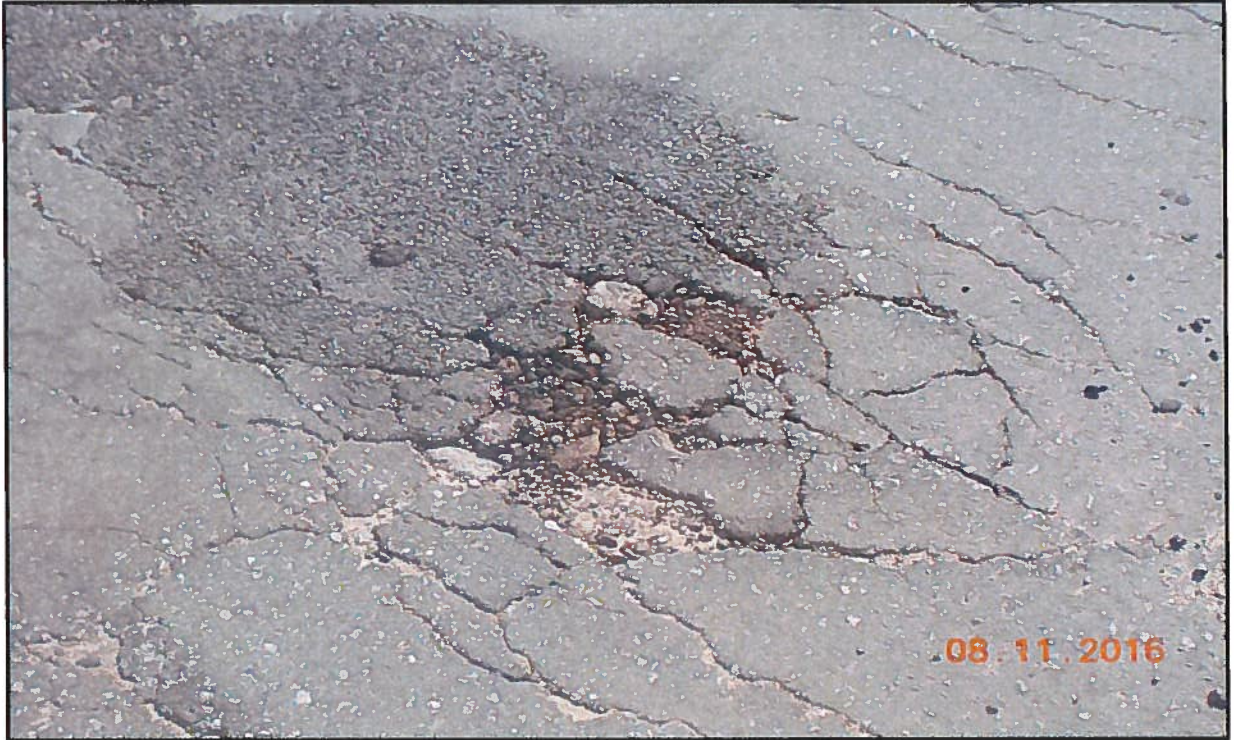
Photo 5: Loss of Bond & Map Cracking in Deck– Northwest Quadrant

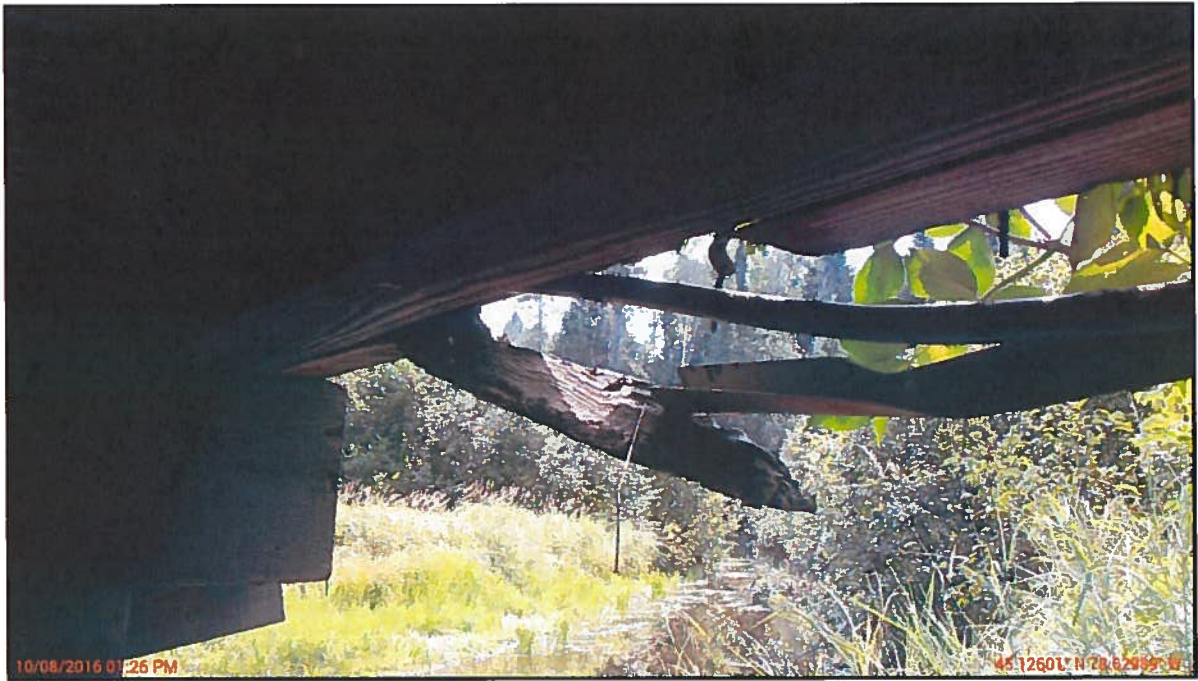
Photo 5: Damaged Exterior Wood Beam – Northwest Quadrant

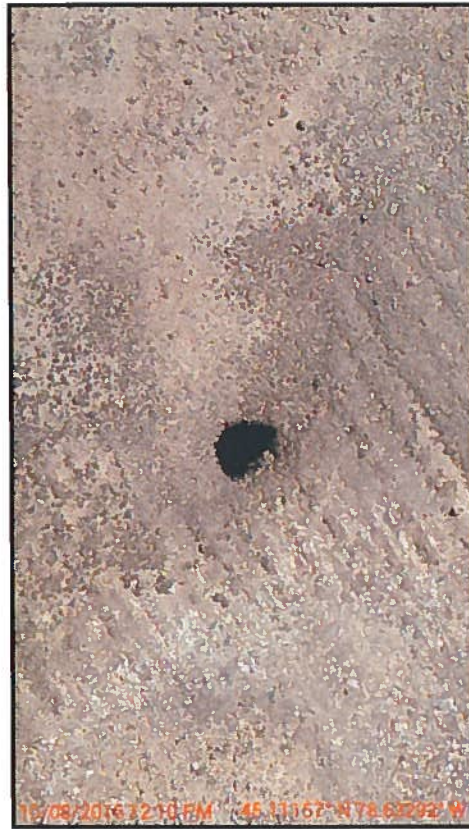
Photo 5: East Approach Wearing Surface – Undermined Asphalt Zone (Sinkhole)

- It is highly recommended that the root cause of the hole at the east approach be investigated.

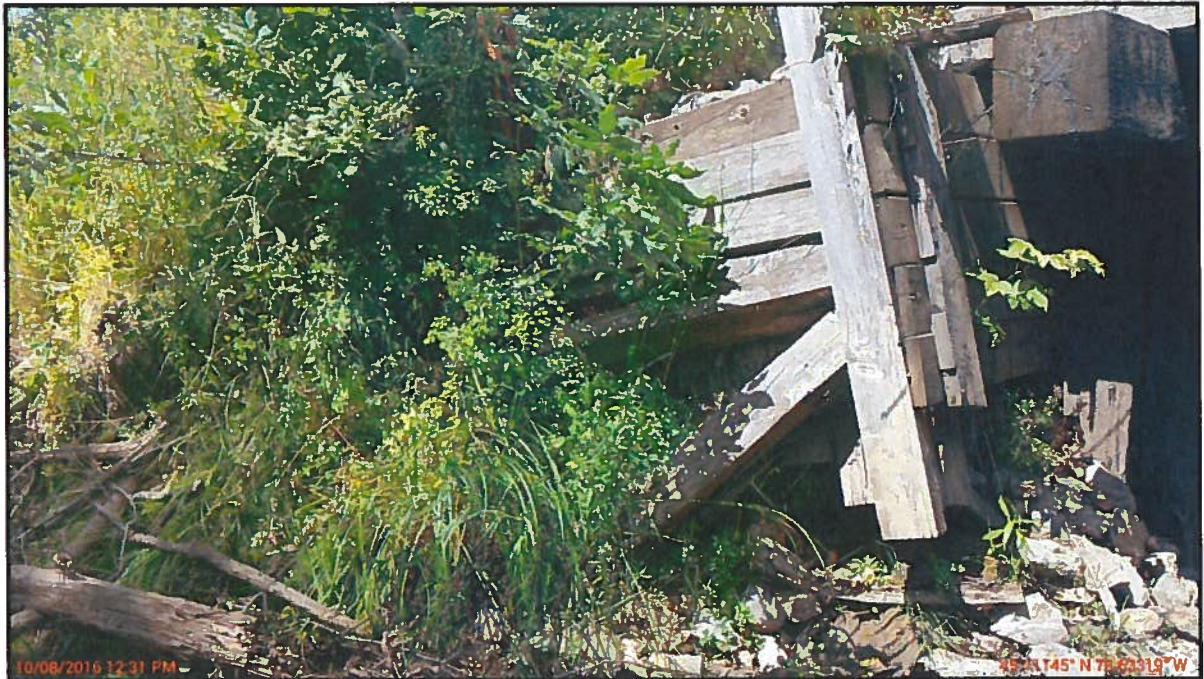
Photo 6: Undermined Ballast Wing Wall – Southwest Quadrant

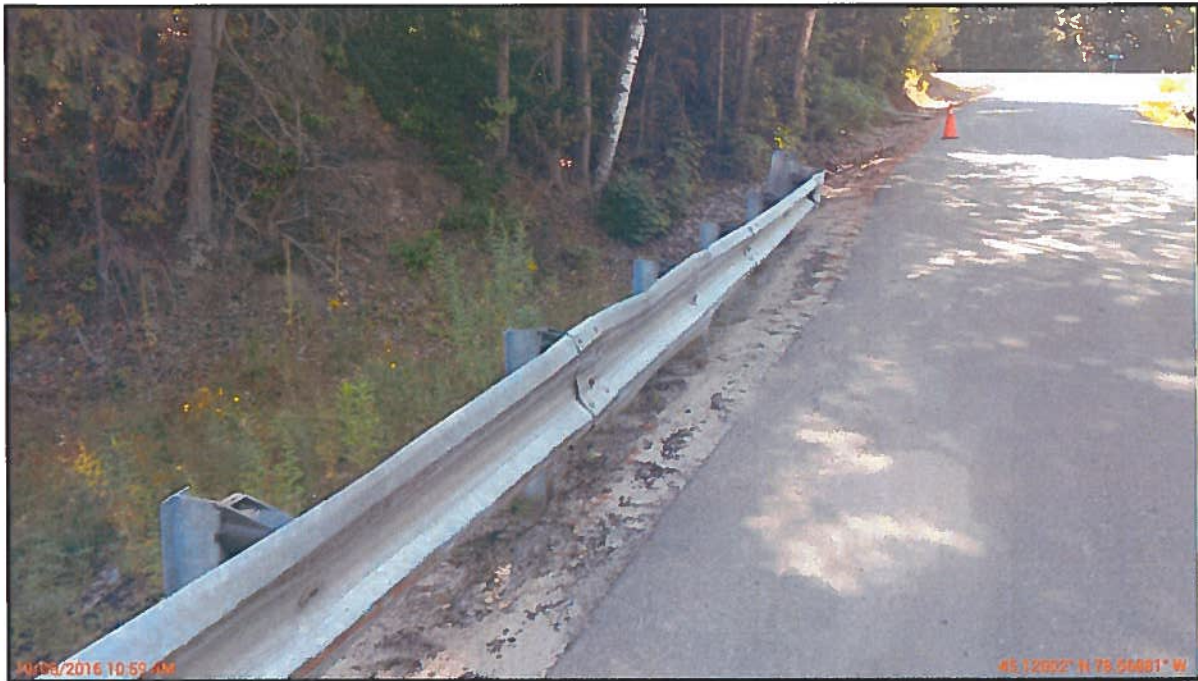
Photo 5 : Guiderrail Impact Damage - Southeast Quadrant

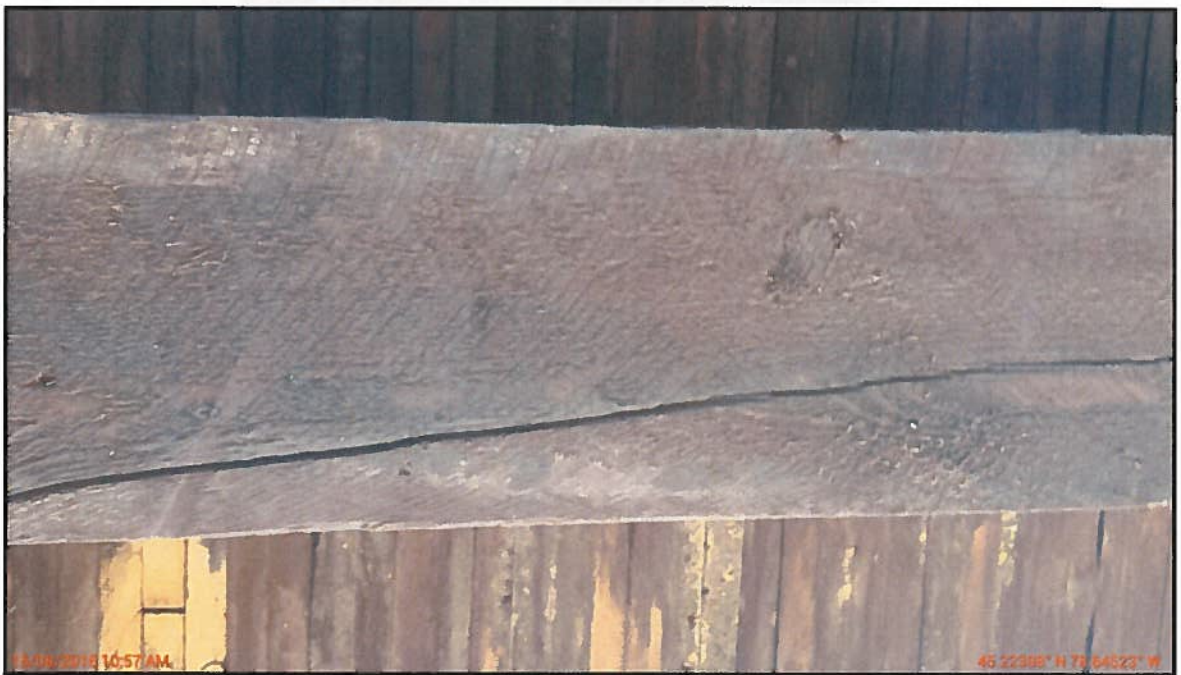
Photo 8: Longitudinal Cracking of Wood Beam (4<sup>th</sup> from North face) – Close Up View

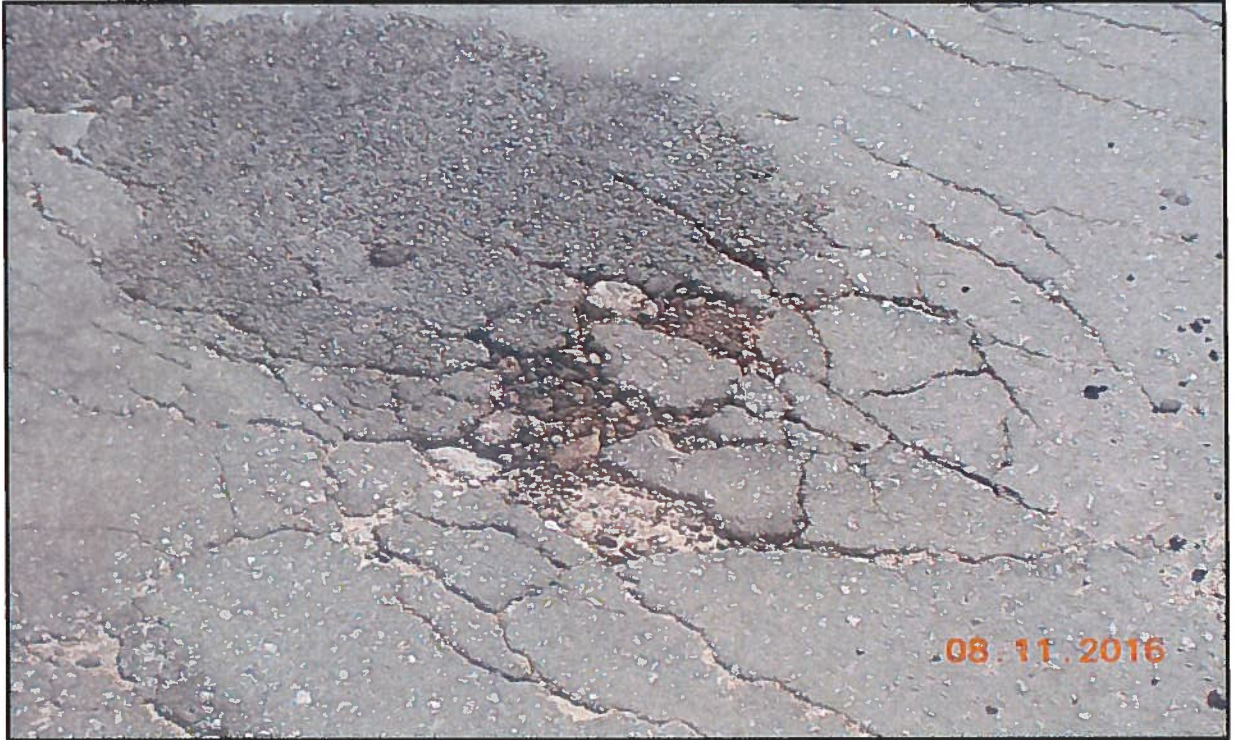
Photo 5: Loss of Bond & Map Cracking in Deck– Northwest Quadrant

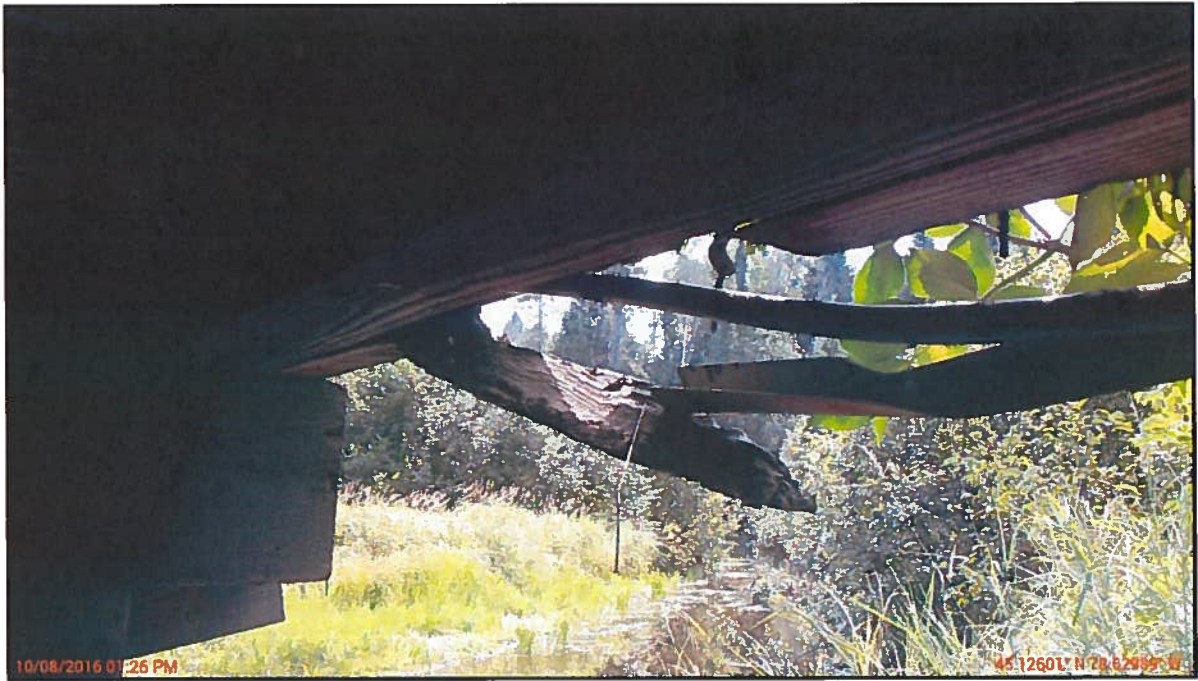
Photo 5: Damaged Exterior Wood Beam – Northwest Quadrant

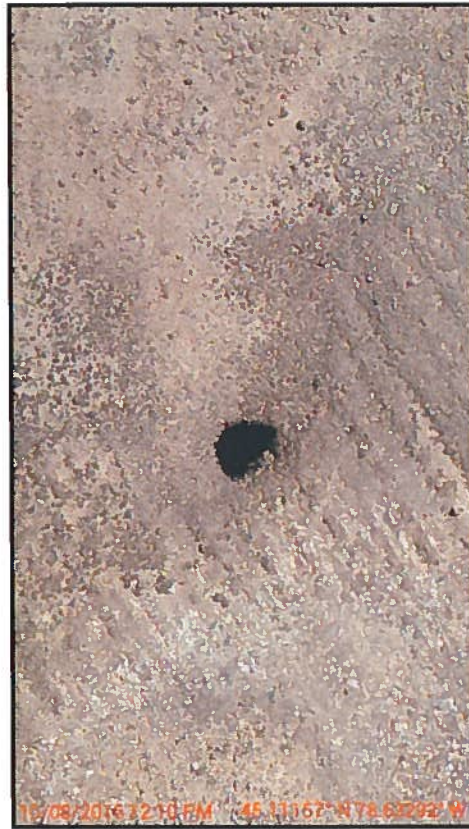
Photo 5: East Approach Wearing Surface – Undermined Asphalt Zone (Sinkhole)

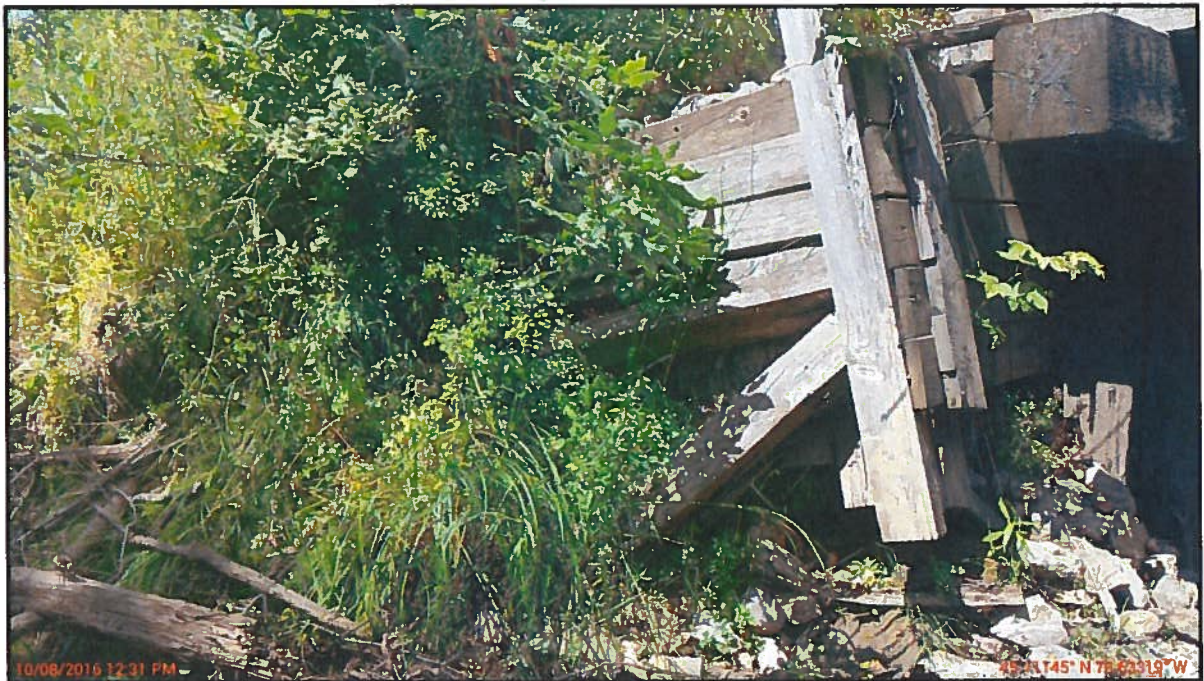
Photo 6: Undermined Ballast Wing Wall – Southwest Quadrant

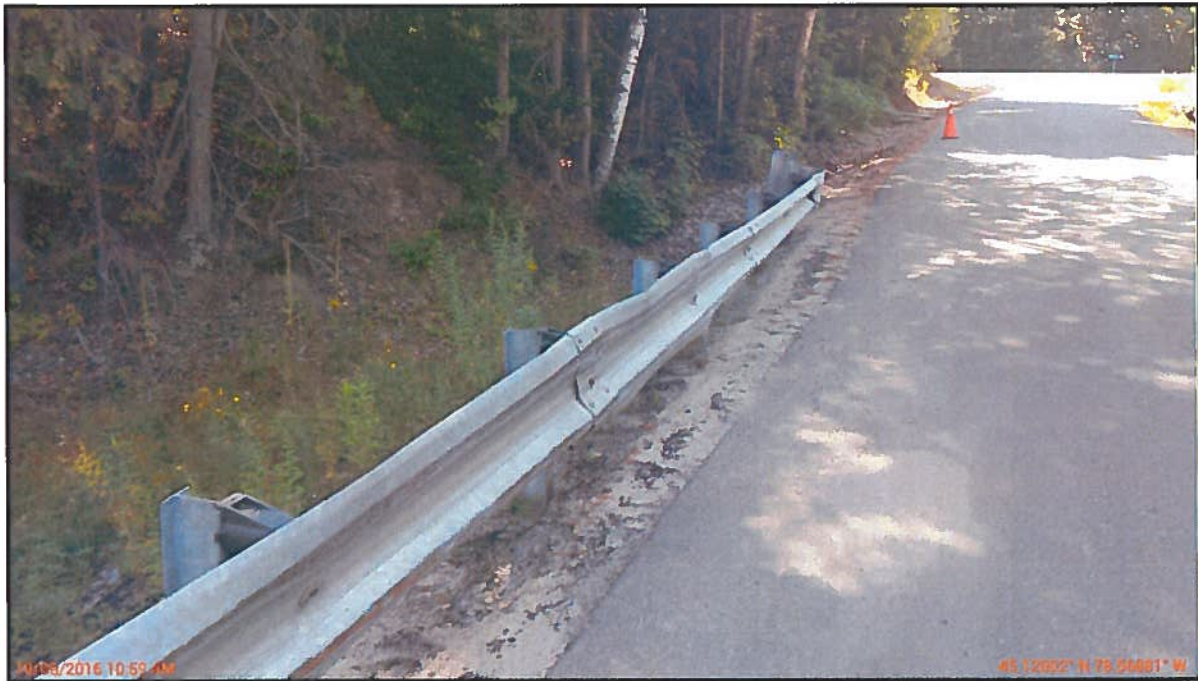
Photo 5 : Guiderrail Impact Damage - Southeast Quadrant

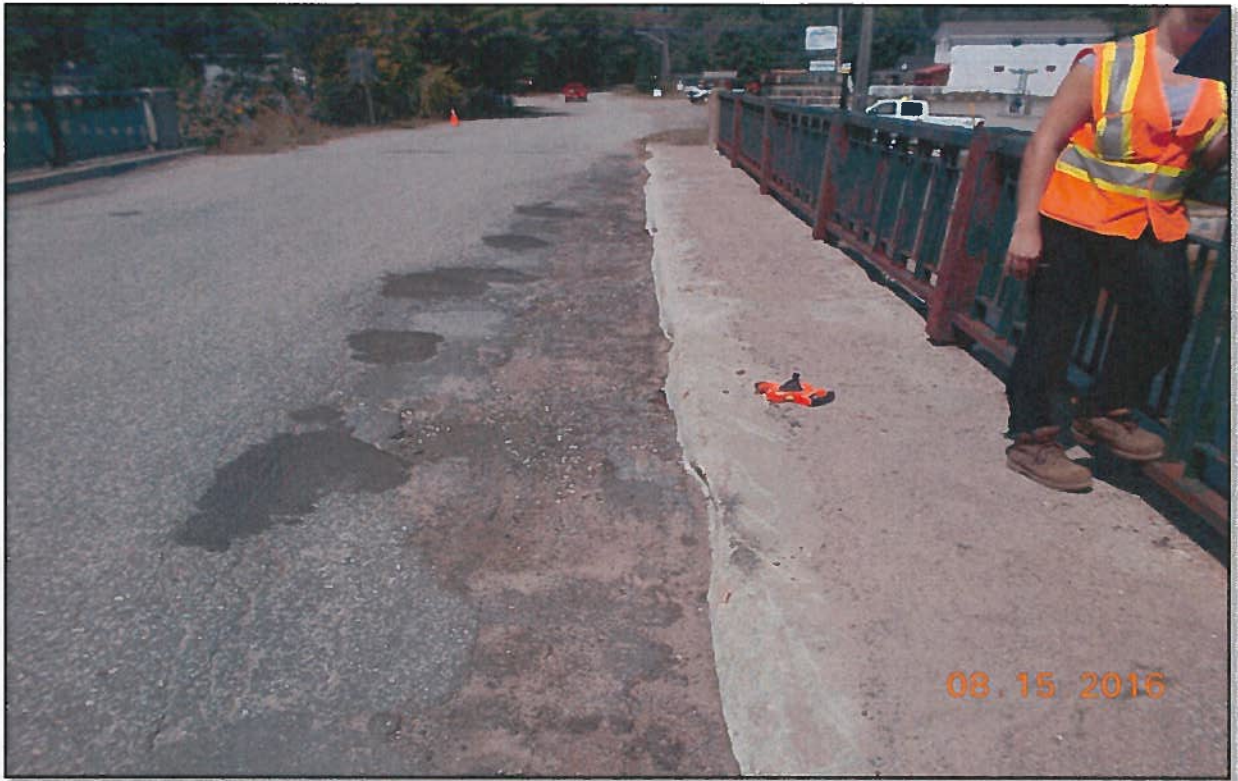
Photo 3 : Asphalt Wearing Surface and Curb Deterioration - East Lane Looking North

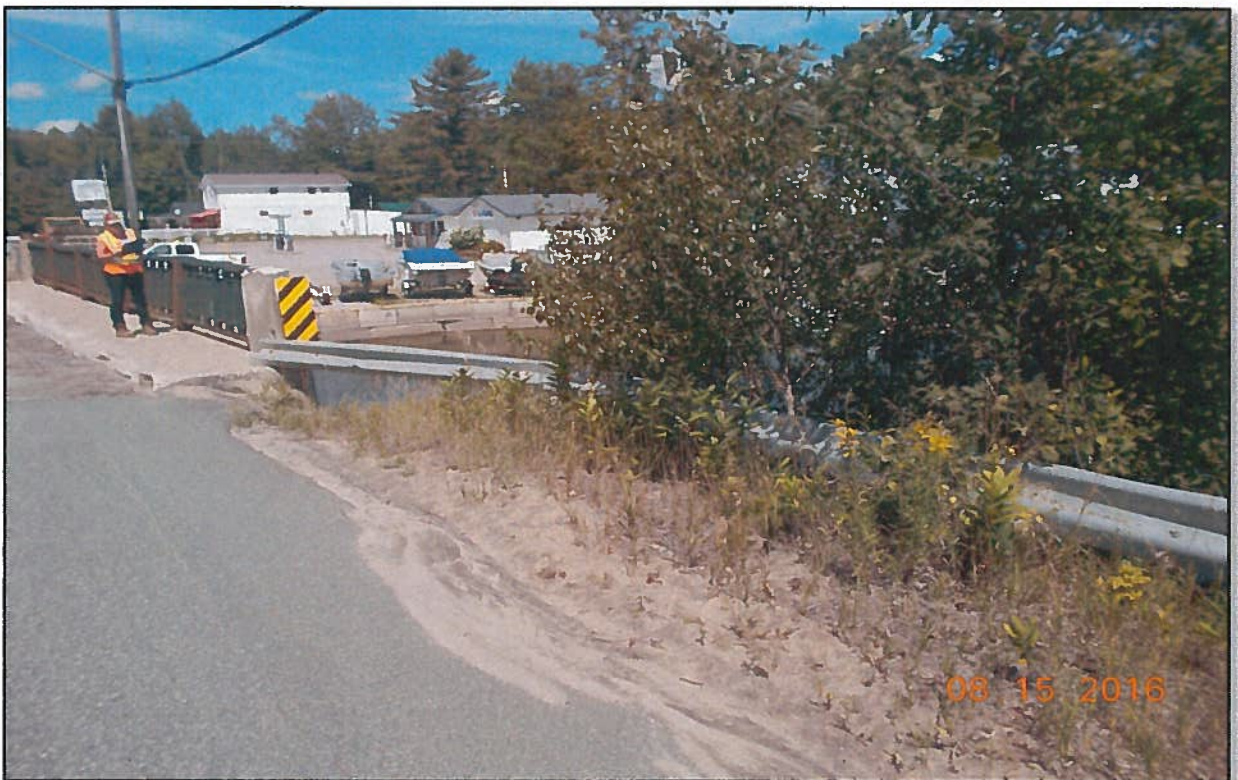
Photo 4 : Deformed Guiderail System Missing Supports - Southeast Quadrant

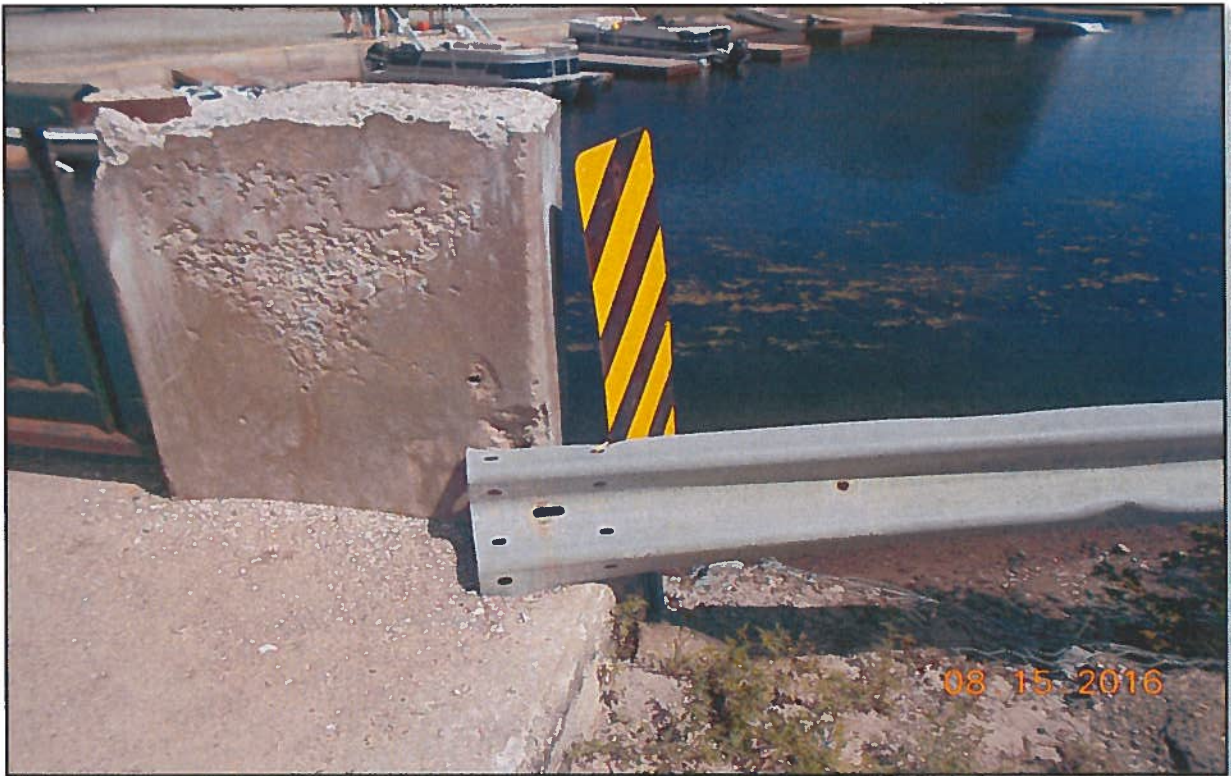
Photo 5 : Detached Guiderail System - Southeast Quadrant

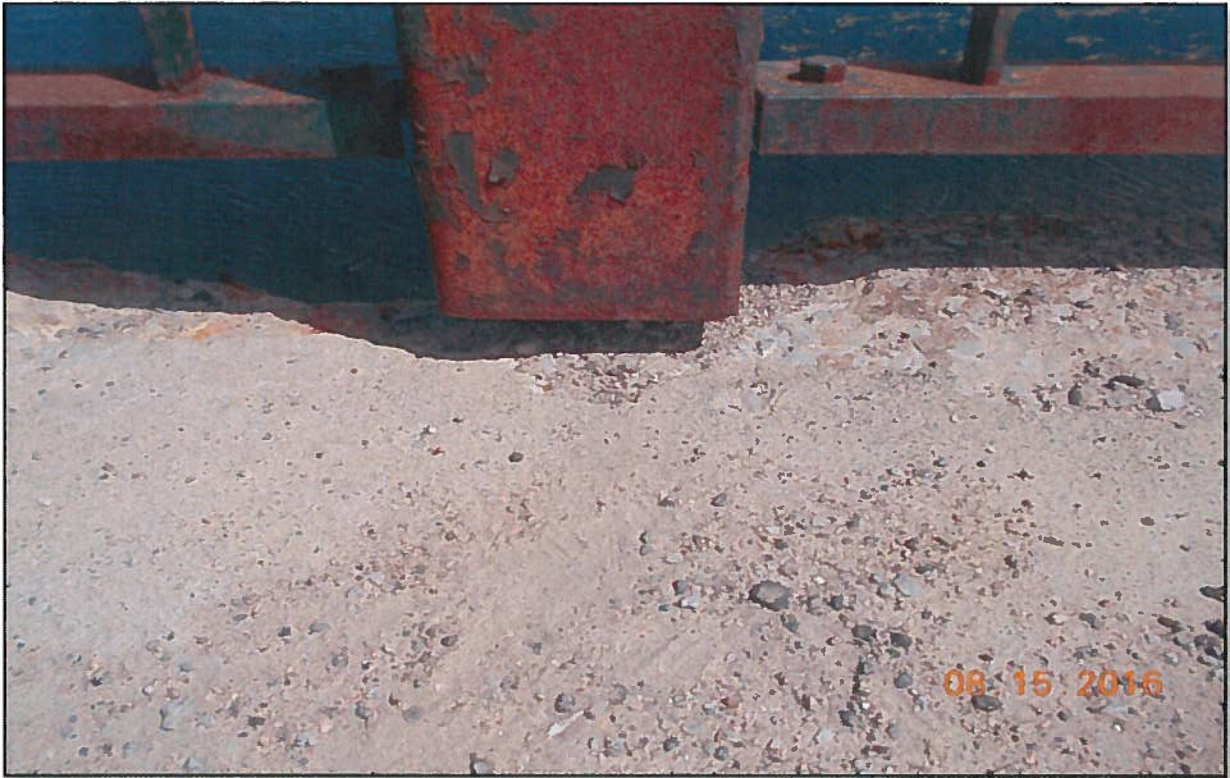
Photo 7 : Inadequate Load Carrying Capacity at Handrail Posts - Typical View

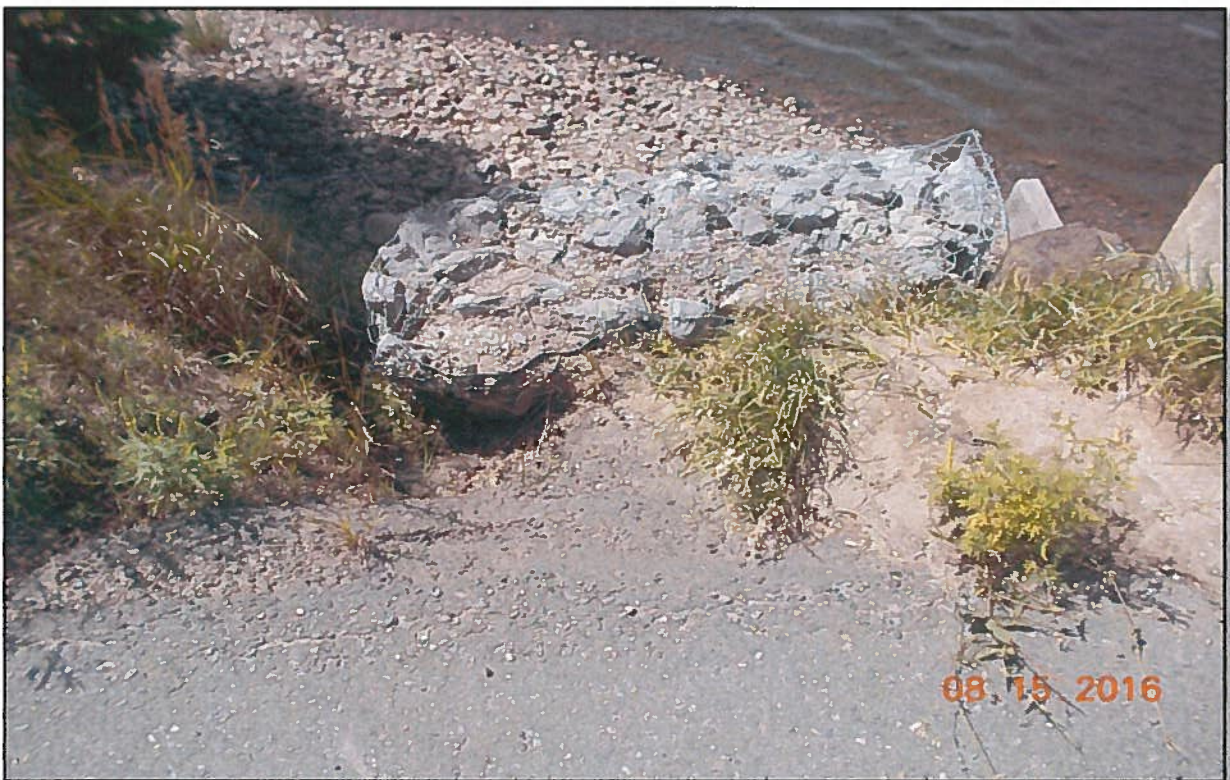
Photo 8 : Erosion at Gabion Basket Retaining Wall - Southwest Quadrant

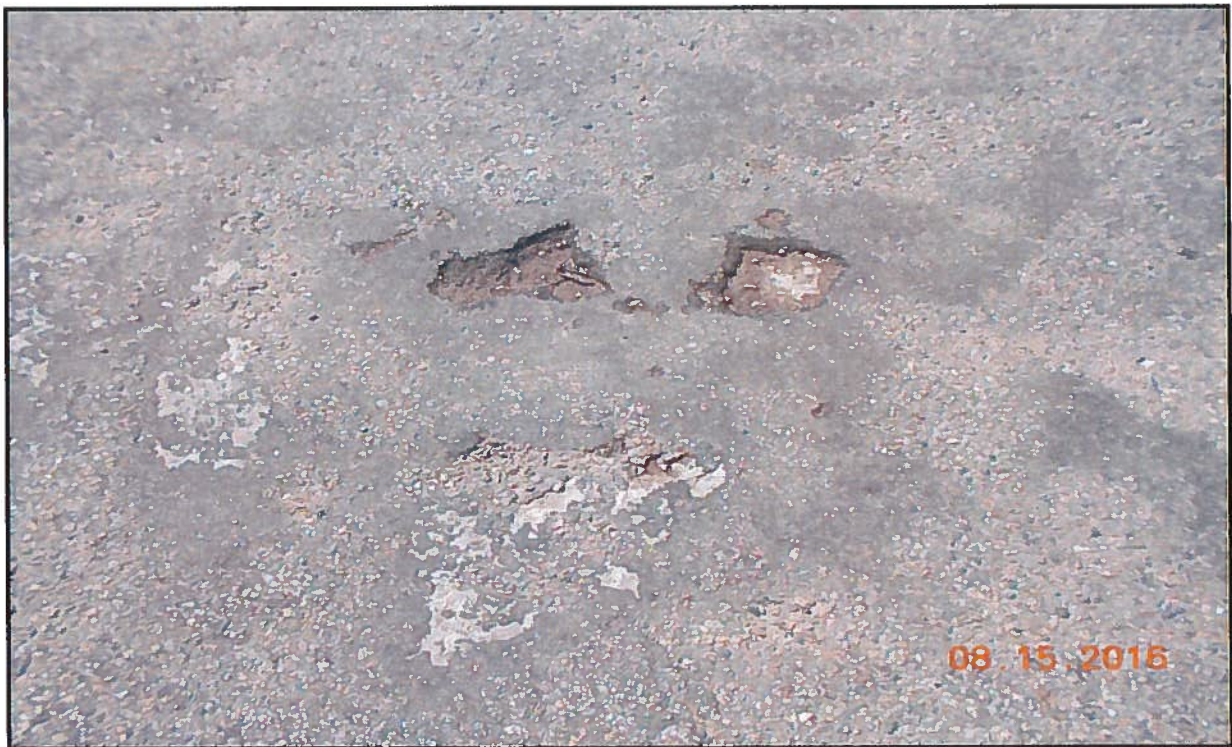
Photo 6 : Deck Wearing Surface - Localized Potholes

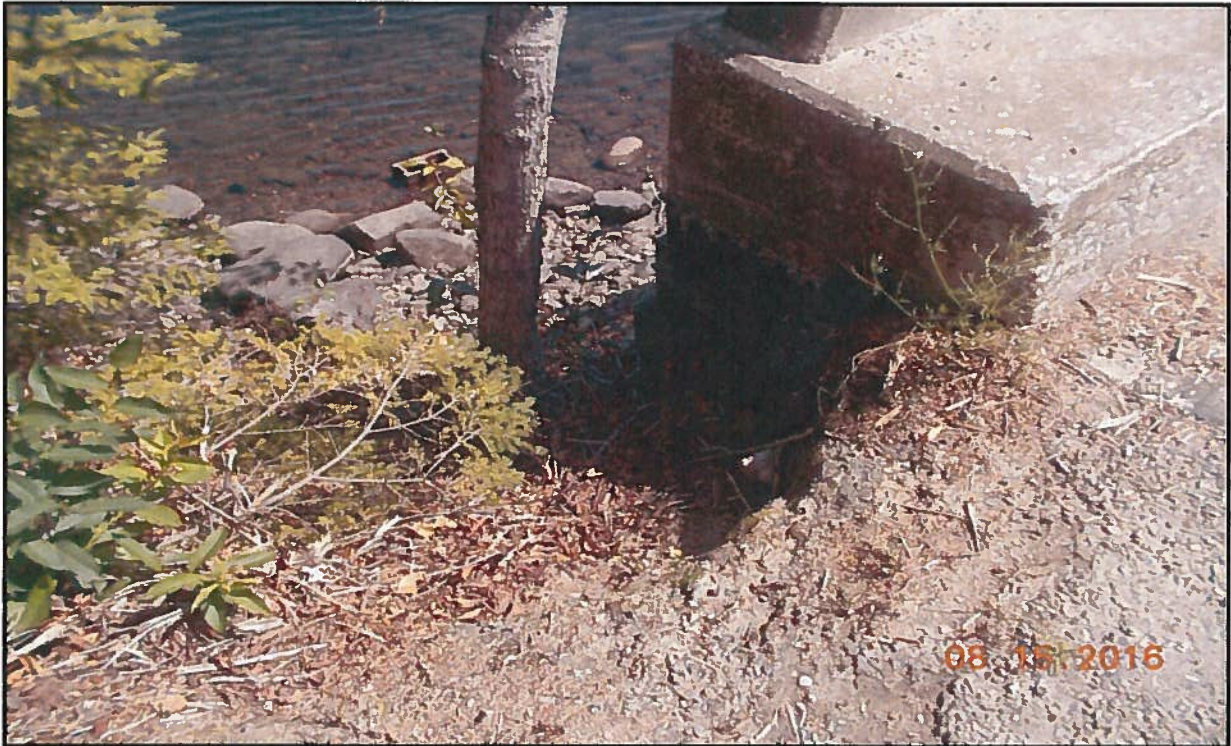
Photo 7 : Erosion of Embankment - Northwest Quadrant

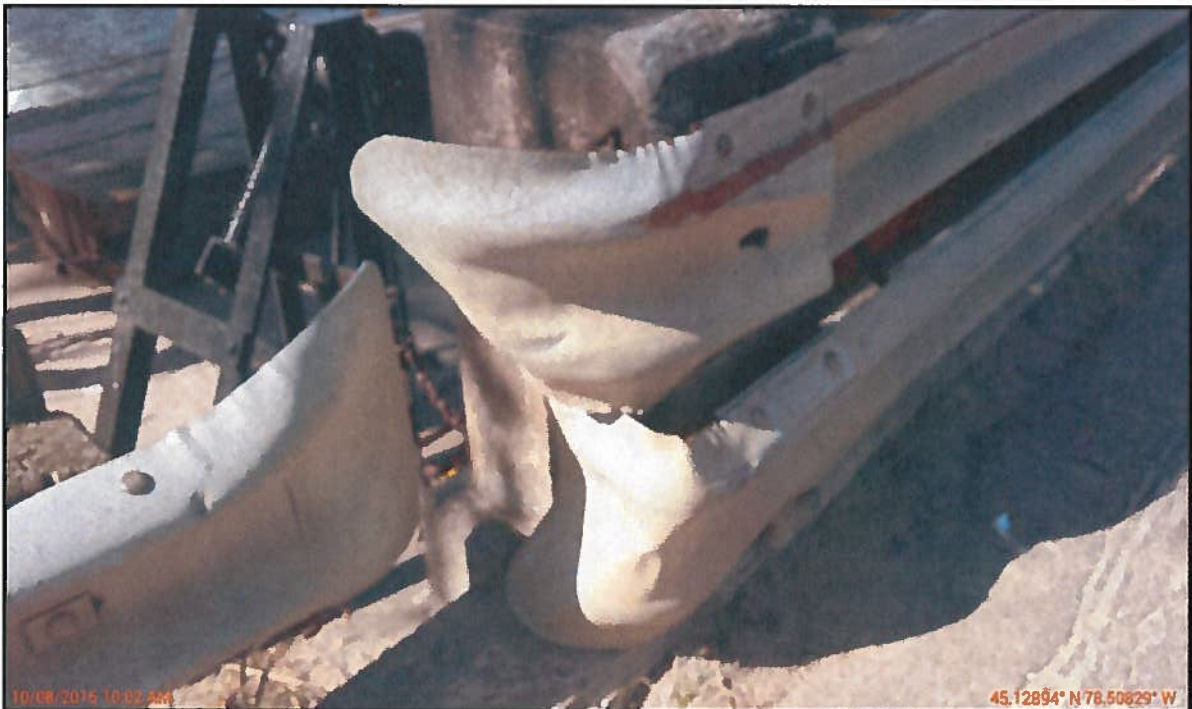
Photo 16 : Damaged Guiderail System – Southwest Quadrant

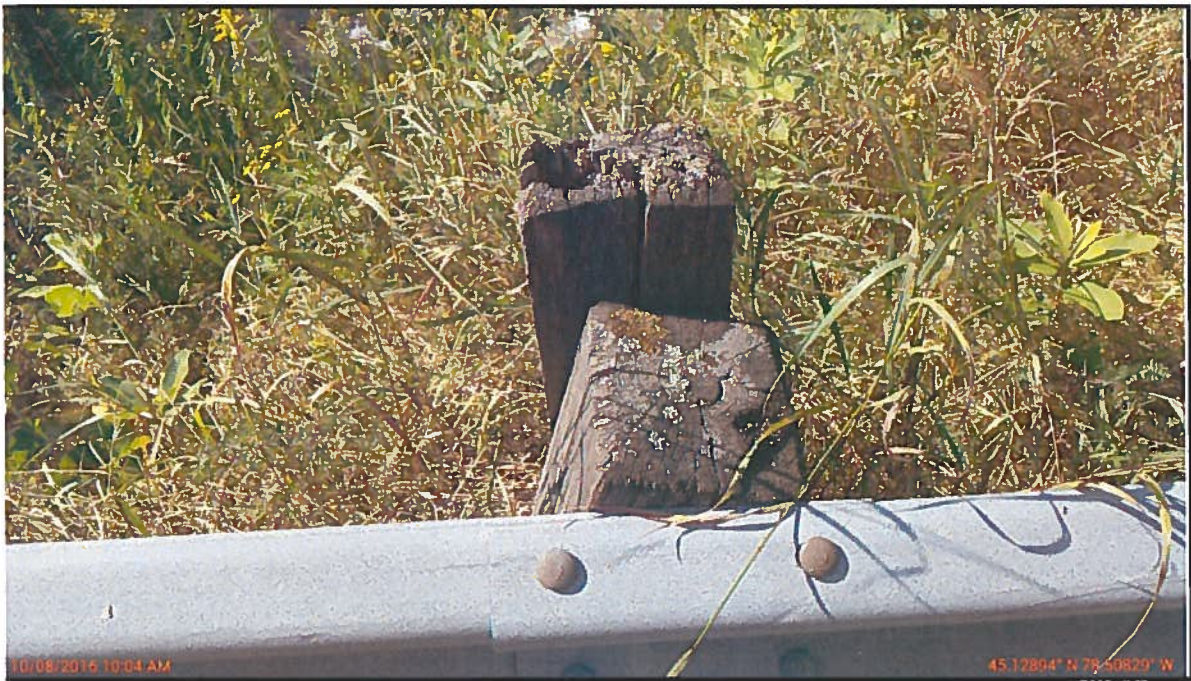
Photo 17 : Typ. Rotted Post – Southwest Quadrant

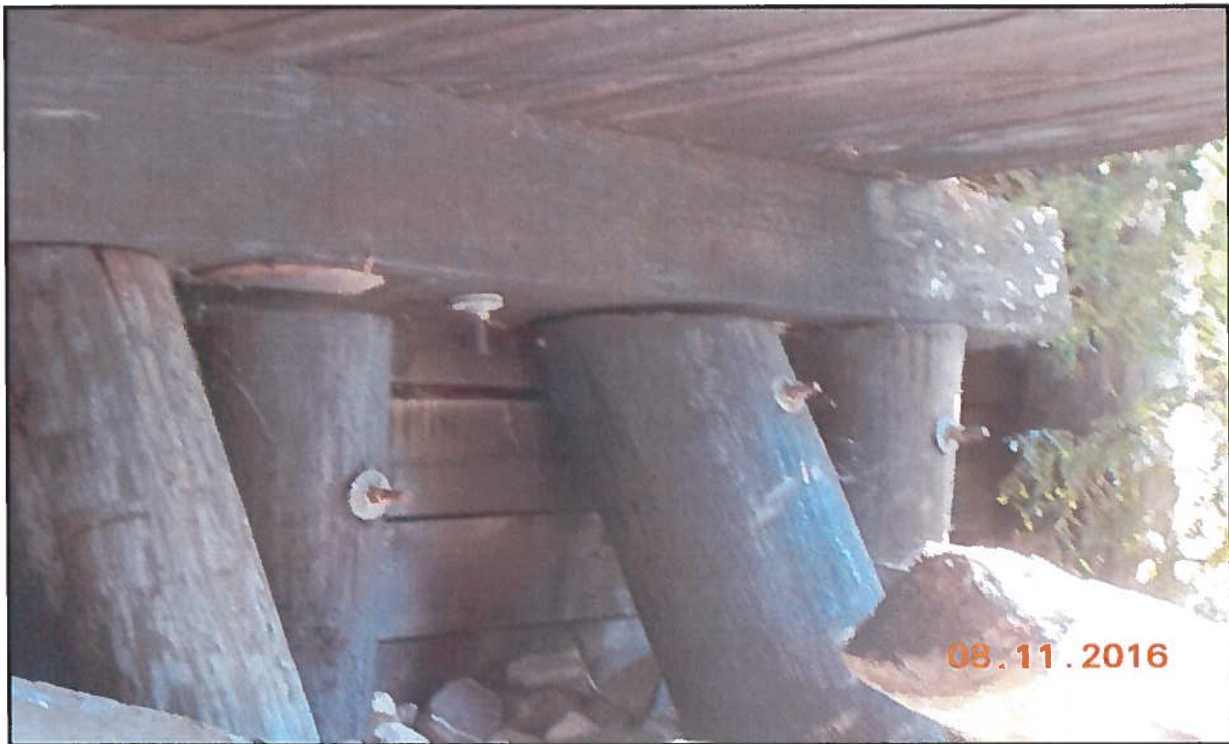
Photo 5 : Gaps Between Piles and Capping Beam – Northeast Quadrant

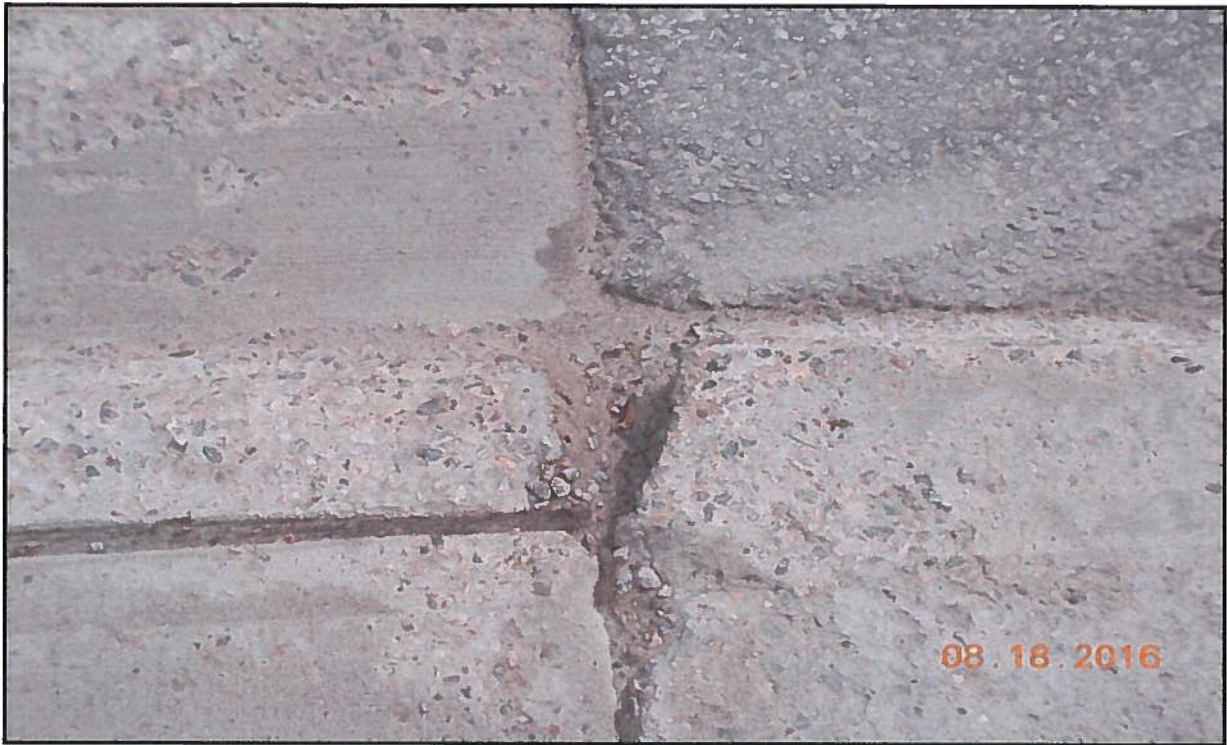
Photo 7 : Curb Deterioration – Southwest Quadrant

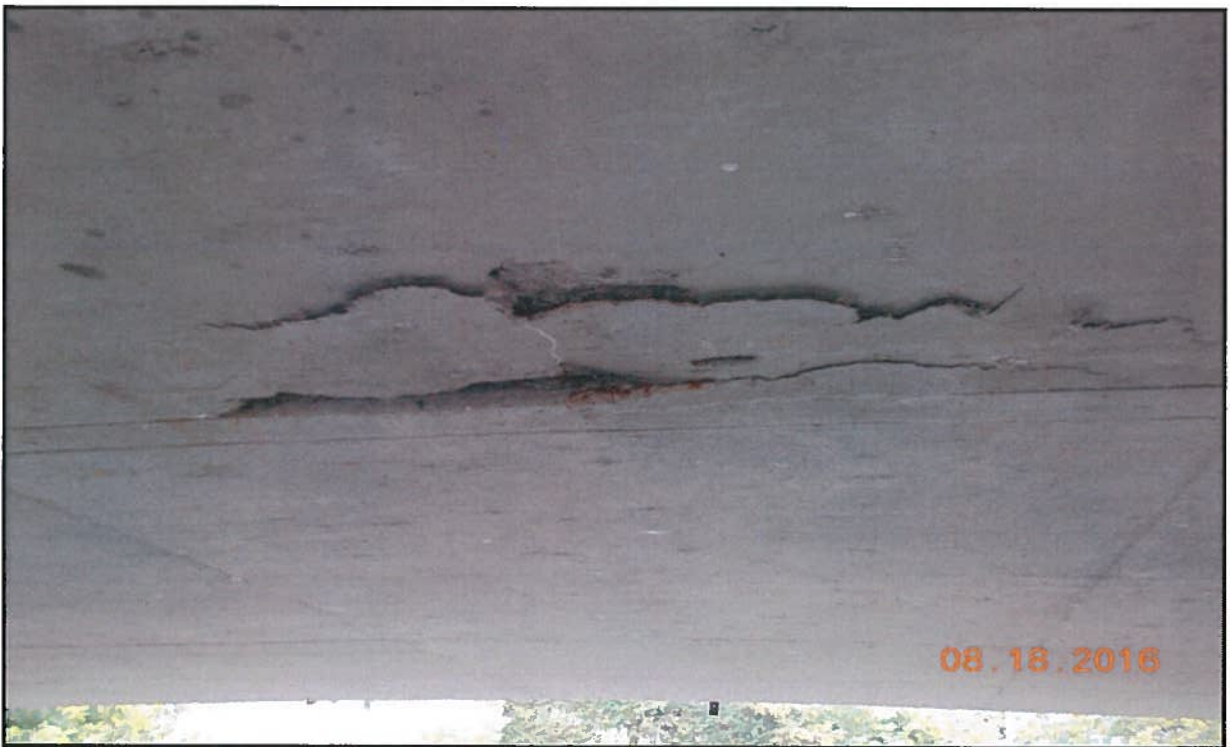
Photo 8 : Spalling Concrete – Mid Span of Soffit Looking East
