Re: Review of Drainage Conditions Relative to a Municipally-identified Watercourse Constraint, Haliburton Landscape Supply, 1159 Kennisis Lake Road, Municipality of Dysart et al, County of Haliburton; Our File 1925

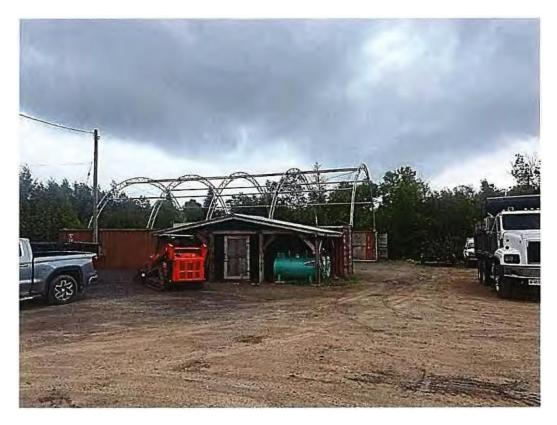
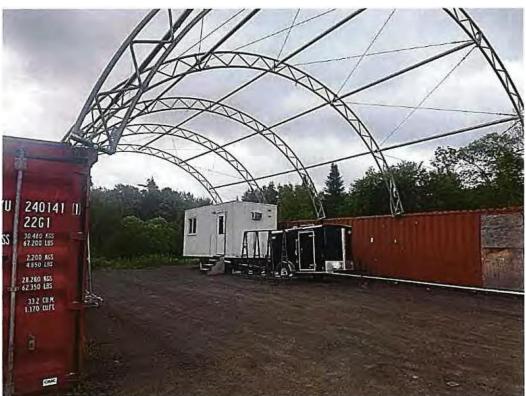
Photographs 1 and 2 provide views of the subject property and the partially installed garage/storage building which is the subject of this review. Photograph 3 provides an additional view of this partially installed structure from the south. As is evident from Photographs 1 and 2, as well as the aerial photography included in Appendix A, the subject property is largely a level work yard, with fill having been imported in the past to level it out (per my review of older aerial photography, these lands were cleared prior to 2015 and were filled prior to 2022). The proposed garage/storage building, the initially installed components of which can be seen in 2024 Google Earth imagery (final aerial photograph in Appendix A), is located towards the southwest comer of the subject property, as also approximately illustrated on Figure 1 (the rearmost portion of the proposed building on this drawing, aligning with the rear of the one set of shipping containers, accurately reflects that on the 2024 Google Earth imagery). This proposed garage/storage building sit<; on top of granular fill material, with it being my understanding that the intention of this building is simply to provide a dry storage area for vehicles and equipment that are necessary to this landscape company's operations (i.e., other than providing for a roofed area over such equipment, it will not result in any changes to existing land use activities associated with this landscape company's operations).

Photographs 1 and 2. PartiaJly installed garage/storage building that applicant is seeking approval for (June 28, 2025).

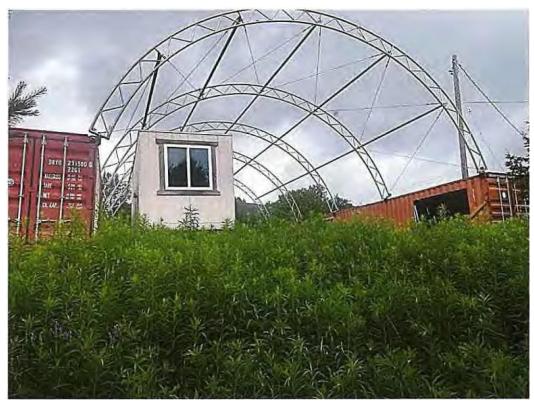
Photograph 3. Additional view of partially instaUed garage/storage building (June 28, 2025).

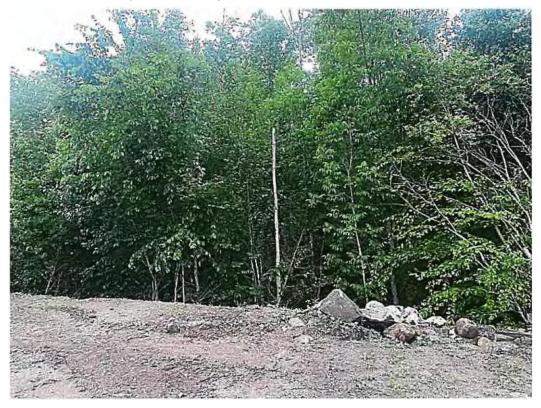
**Photograph 4** provides a view of the western-most portion of the level area of fill within the subject property, which terminates approximately 10 m east of that property boundary, and with 1:2 slopes between it and an adjacent area of lowlying woodland/treed swamp that begins very close to the west property limit; that area of natural vegetation is delineated in green on **Figure 1**. **Photograph 5** provides a view of the steep and partially vegetated slopes along the rear of the property, grading down to the adjacent more lowlying area of vegetation.

Photograph 4. To the rear of proposed garage/storage building, the commerciaJ yard slopes steeply to an area of lowlying woodland/treed swamp (June 28, 2025).

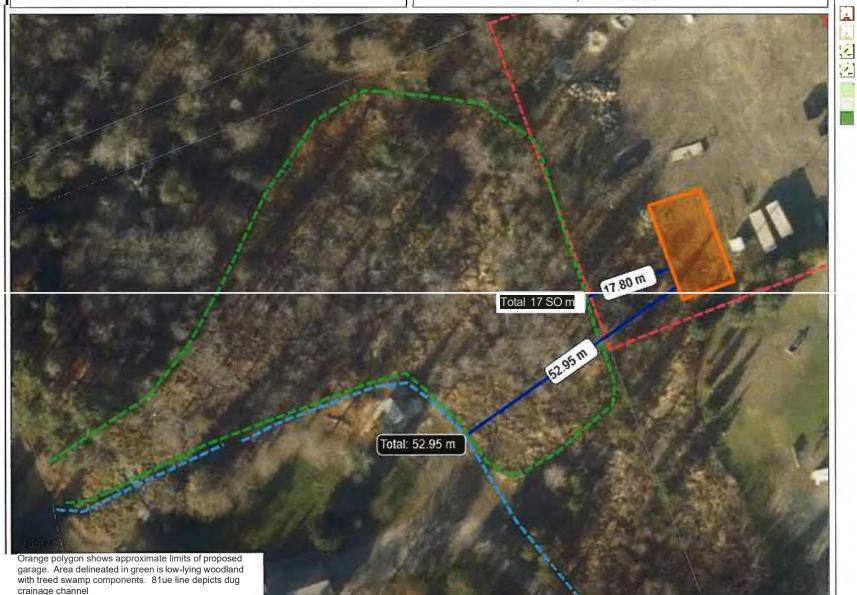
## t-Igure 1. Kelat1onsn1p ot Proposed liarage to **Adiacent Natural Features**

**Figure 1** provides a good sense of the relationship of the proposed garage/storage building to the adjacent areas oflowlying woodland/treed swamp and the drainage feature. By my calculations, the area oflowlying woodland is a minimum of approximately 18 m away from that proposed structure, whereas the drainage course is over 50 m away. hnportantly, with that proposed structure being installed on ground surface on top of an already level area of fill, it will require absolutely no earthworks. The roof design will allow rain to sheet flow to either side of the structure, where it will fall onto a generally permeable yard, allowing for infiltration and diffuse outletting of any surface runoff towards the adjacent area of lowlying woodland/treed swamp, exactly as occurs today (with my having seen no evidence of any concentrated

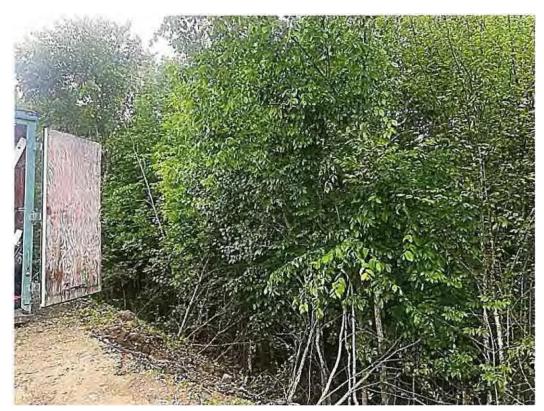
Photograph 5. View of partially vegetated sJopes at western end of yard, and adjacent lowlying woodland/treed swamp (June 28, 2025).

• the owner monitor conditions adjacent to the structure after its installation. If there is any evidence that sheet flow off the roof is creating any localized erosion or more concentrated runoff across the yard, then a splash pad of cobble-sized stone is to he installed beneath those specific areas where this is identified.

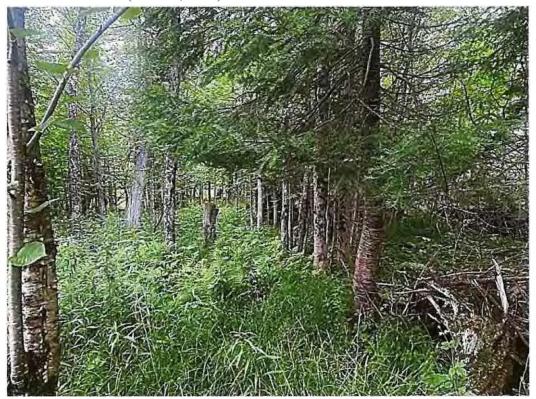
**Photographs** 6 - 8 provide views of the lowlying woodland/treed swamp that begins along the western edge of the subject property. That area is largely shown as unevaluated wetland in the Province's natural heritage map base, as can be seen in the second map included in **Appendix** A. The boundary of that wetland is somewhat accurately depicted on that map and it is located entirely outside of the subject property. Further, the lands immediately adjacent to the subject property include a transitional zone of lowland forest containing Yellow Birch, Balsam Fir and Ash in an area of apparent rnoderately high water table, grading to an area where lhe water table is right at surface, where ground conditions are more hummocky, and

Photograph 6. View of lowlying woodland/treed swamp to the west of the commercial yard (June 28, 2025).

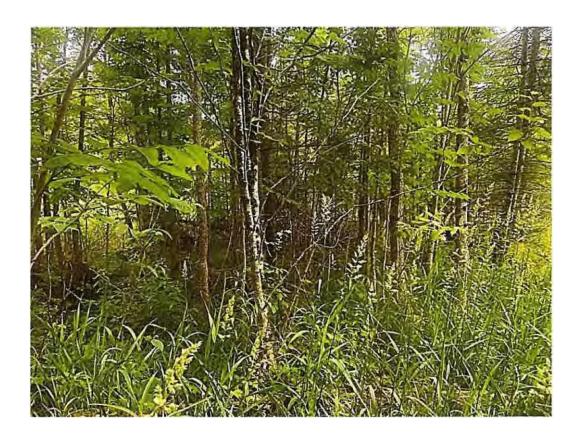
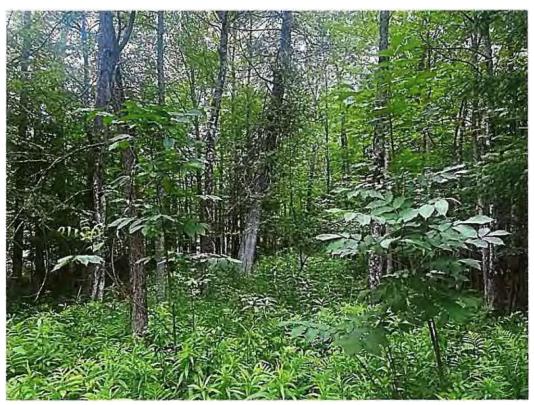
Photographs 7 and 8. Additional views of lowlying woodland/treed swamp (June 28, 2025).

which is best characterized as treed swamp. The transition from lowland forest to treed swamp is somewhat variable but generally occurs ±15 m west of the property boundary. For the purposes of this assessment, the exact location of where lowland woodland ends and treed swamp begins is unimportant, as there is little functional difference between these two areas. In this regard, both areas have a high water table but with no evidence of seasonal ponding and with vegetation differences being quite subtle. Drainage conditions within this lowlying area have been modified by past fill placement within both the subject property and adjacent properties, including the residential property to the southwest. This lowlying area grades towards a small drainage course to its southwest, then ultimately to the Gull River, a short distance above the confluence of that river with Green Lake. It receives localized drainage only, which includes minor roadside drainage from Kennisis Lake Road that is conveyed by culvert directly into this woodland area. There is no evidence that high seasonal water levels in either Green Lake or the Gull River have any influence on water levels within this area of lowlying woodland/treed swamp.

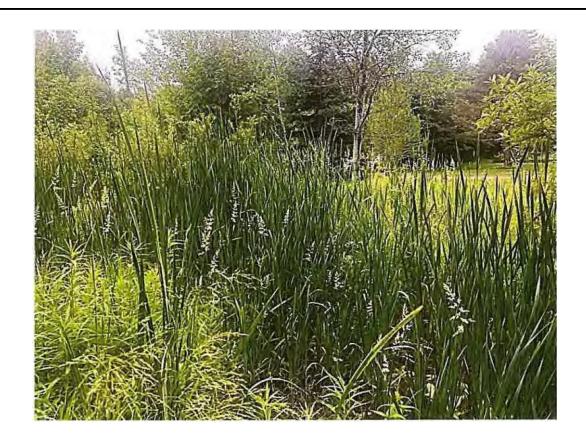
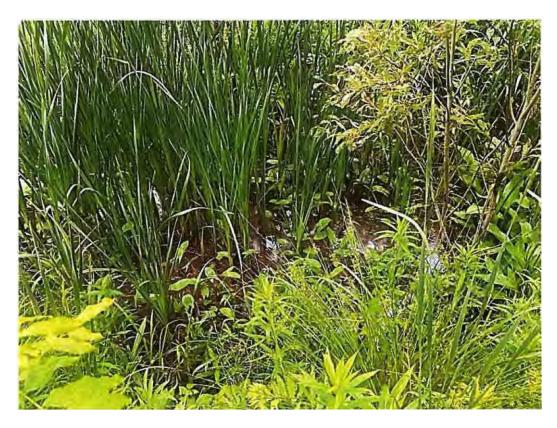
As previously noted, the area of lowlying woodland/treed swamp grades towards a small watercourse, the approximate location of which is shown on Figure 1. Photographs 9 and 10 provide views of this drainage feature, which shows clear evidence of having been dredged in connection with the development of a residential lot to its southwest (there is an area of dredge spoils along the northwest side of the drainage feature). This drainage feature is best described as a swale given the clear evidence of past works on it to create positive drainage from the adjacent residential property. That said, it is very likely that those drainage improvements were made to a more poorly defined natural drainage feature. Regardless, the modified channel is  $\pm 0.8$  m wide at its base and had a very marginal flow of water through it, visually estimated to be <0.1 Lis (about half of the flow of a typical garden hose) at the time of my visit. The bottom of this drainage swale is filled with Narrow-leaved Cattail and Arrowhead, species of aquatic vegetation which indicate that it is typically wet. However, it has a water depth of 2 cm or less, lacks any pools and is fully choked with vegetation, eliminating any fish habitat potential. Accordingly, this drainage feature's functions are limited to the conveyance of flows from this area, with its shallow, heavily vegetated character providing for some cleansing of such flows through detention, evapotranspiration, biological uptake and filtration through vegetation prior to that runoff entering the nearby Gull River and downgradient Green Lake. The area of lowlying forest/treed swamp that is to the rear of the subject property grades to this drainage feature and provides complimentary water quality and water quantity benefits through detention, evapotranspiration, biological uptake and filtration of localized runoff.

Photographs 9 and 10. Views of drainage feature along the southwest edge of the lowlying woodland/treed swamp (June 28, 2025).
