## BIENNIAL BRIDGE INSPECTIONS

FINAL INSPECTION REPORT  
Municipality of Dysart et al

October 2016

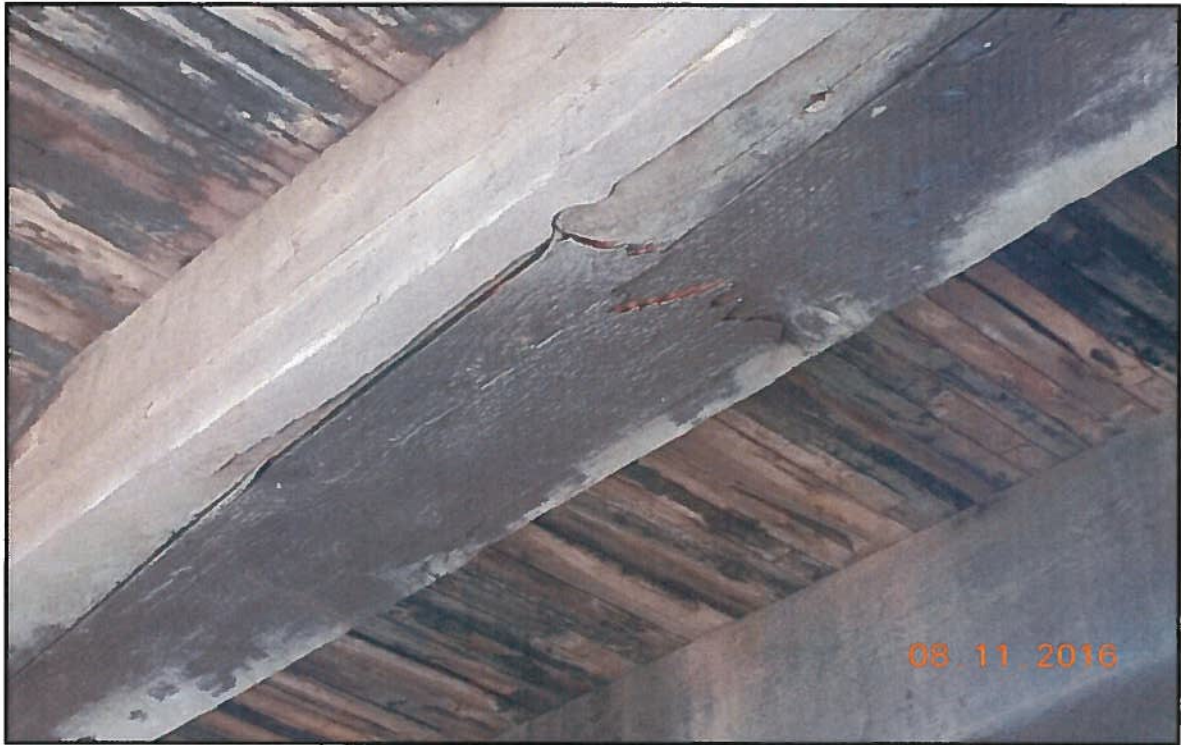
Photo 7: Splintering of Wood Beam (4<sup>th</sup> from North face) – Close Up View

- A design remedy should be provided to repair or replace the damaged girder(s) and deck. Rehabilitation work as a minimum is required to repair damaged girder. Depending on the outcome of the structural evaluation it may be required to replace all girders.
- The deck and approach wearing surfaces, and the wing wall /retaining walls, are in poor to fair condition and should be replaced within 1-5 years or at time of girder replacement.

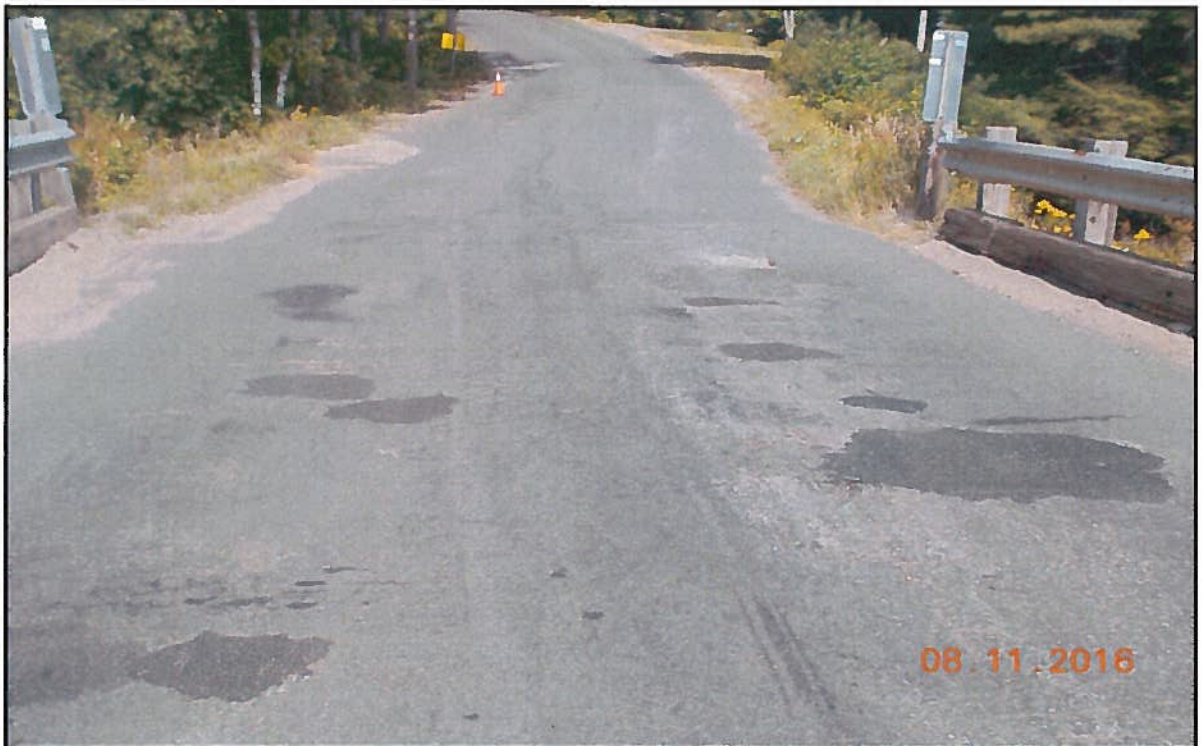
Photo 4: Deck Wearing Surface – Looking West

- The wearing surface should be replaced within 1-5 years.

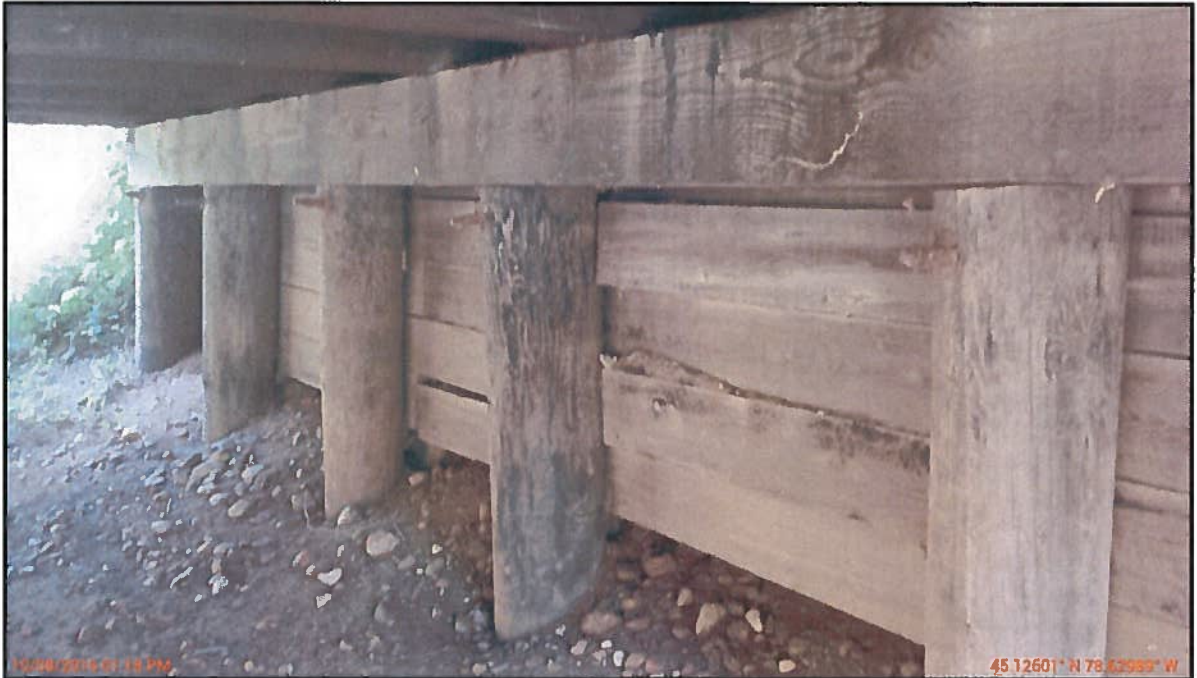
Photo 3: General Arrangement – South Ballast Wall

- Repair ballast wall timbers.
- Repair / replace damaged guiderail post.
- Clean the bridge deck and deck drains under the curb.
- Debris should be cleaned from stream in northwest quadrant.

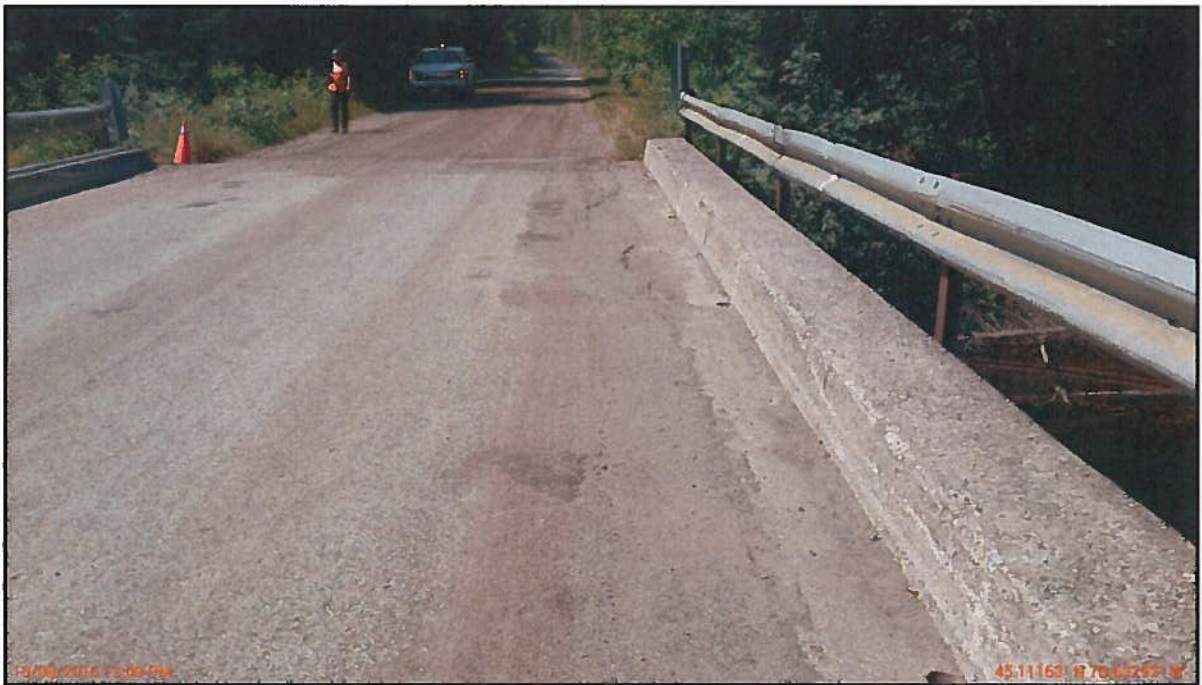
Photo 4: Deck Wearing Surface – Looking West

- It is recommended that the structure undergo a minor rehabilitation in 1-5 years to repair the ballast walls, embankments, pad and resurface the approaches, deck wearing surface and replace the railing over the structure.
- The undermined east approach wearing surface should be investigated further and repaired immediately as a matter of safety (this could be capital or maintenance depending on root cause).

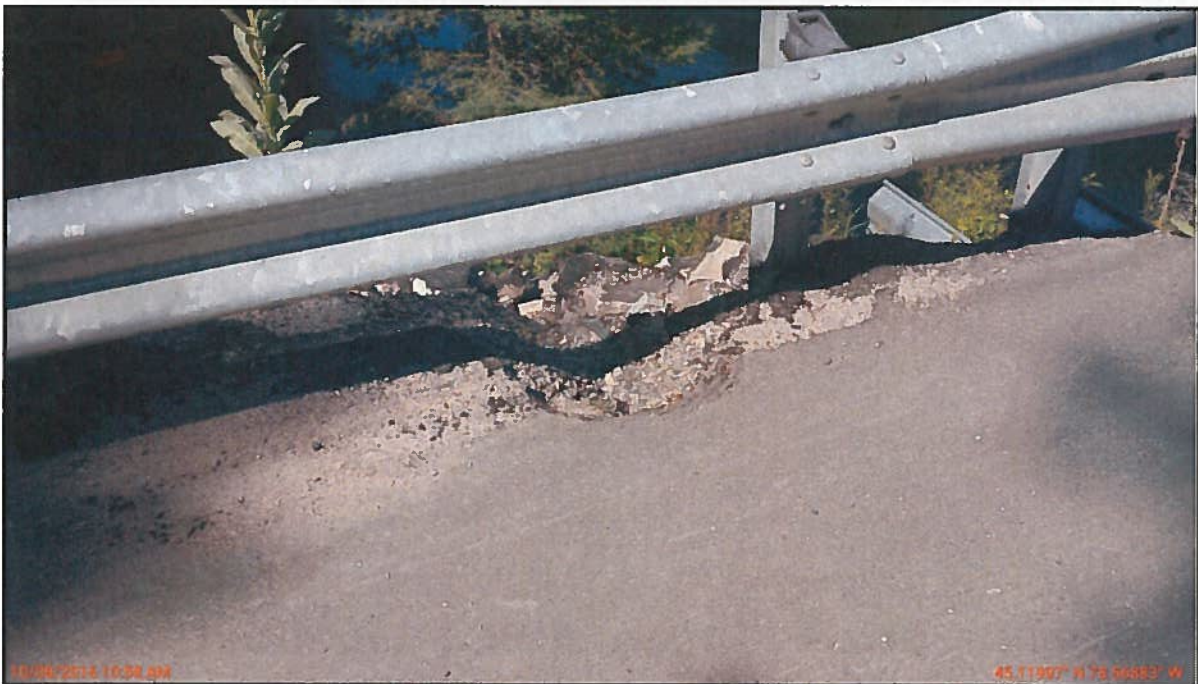
Photo 4 : Asphalt Wearing Surface Edge of Pavement – Southwest Quadrant

- Address erosion of shoulders near deck ends.
- Route and seal transverse cracks.
- Install hazard signage.

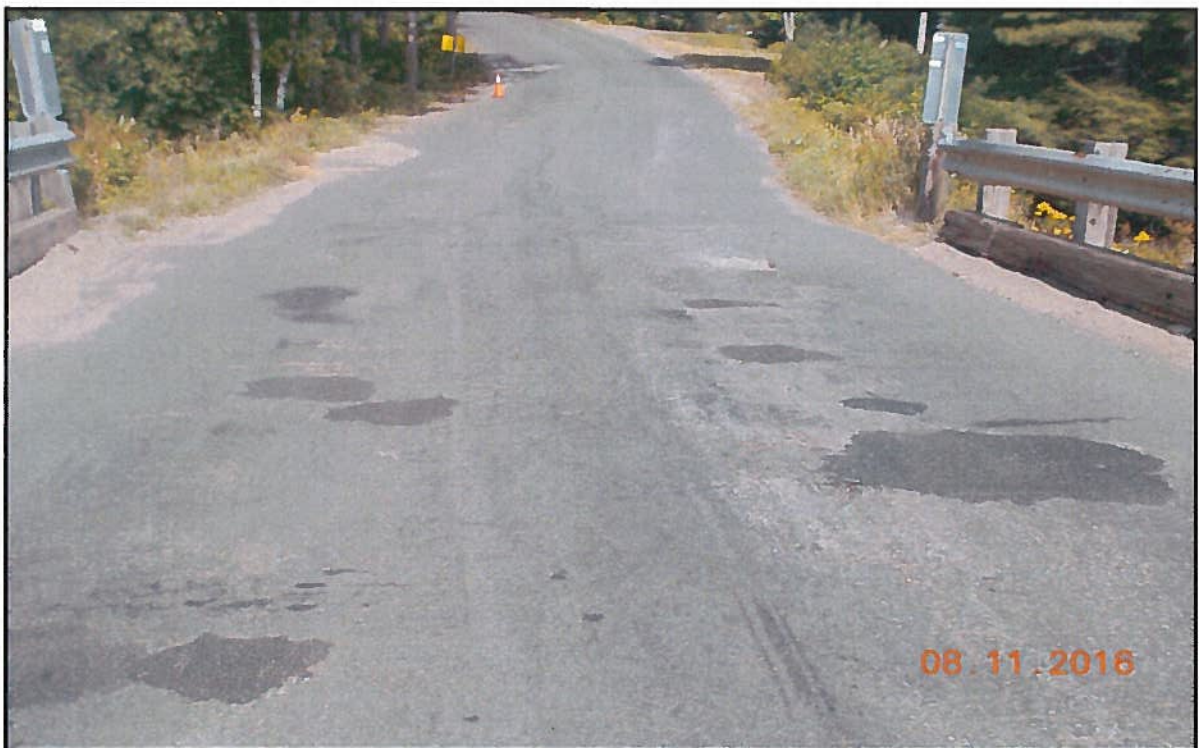
Photo 4: Deck Wearing Surface – Looking West

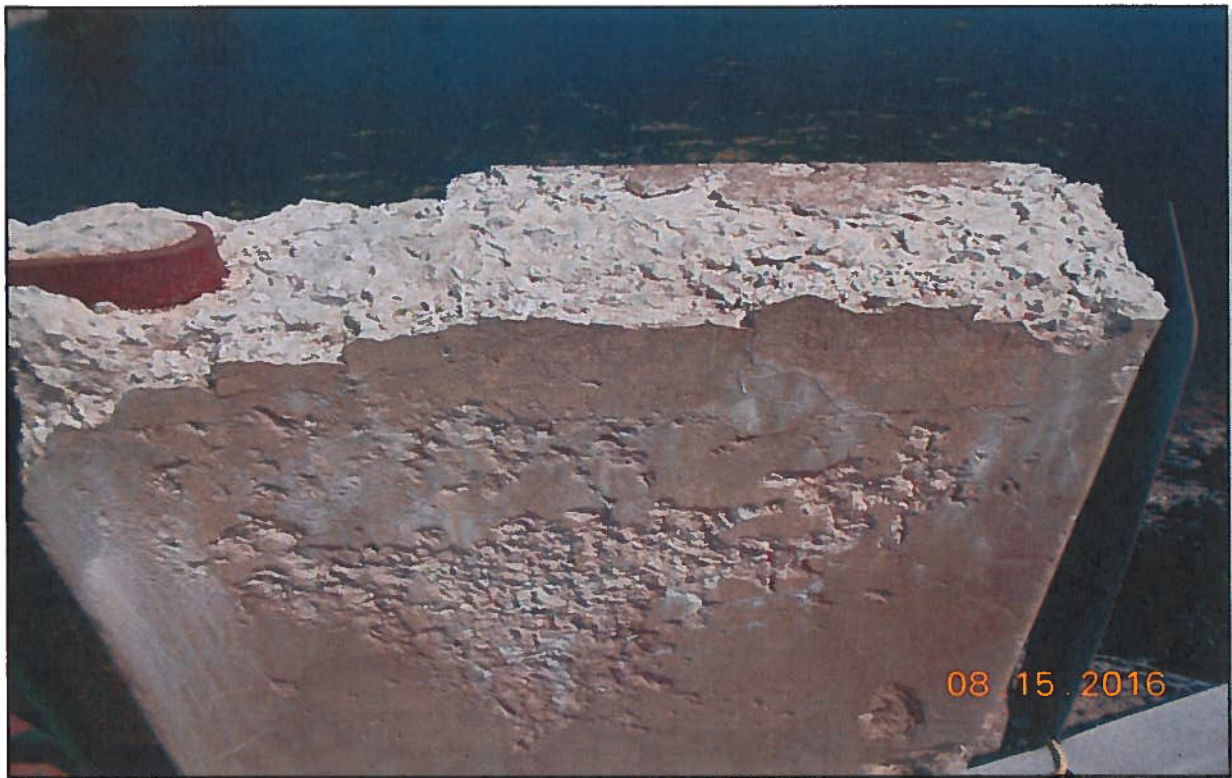
Photo 6 : Typical Concrete End Post of Handrail System - Southeast Quadrant

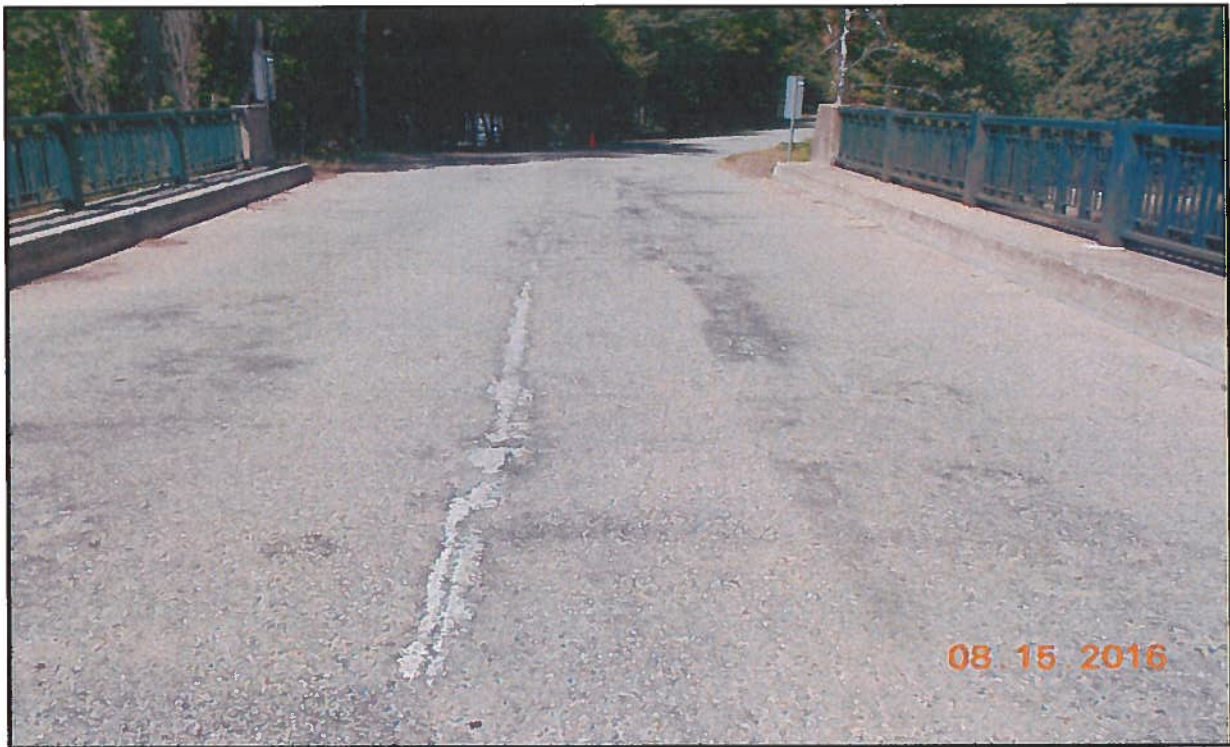
Photo 5 : Deck Wearing Surface – Looking West

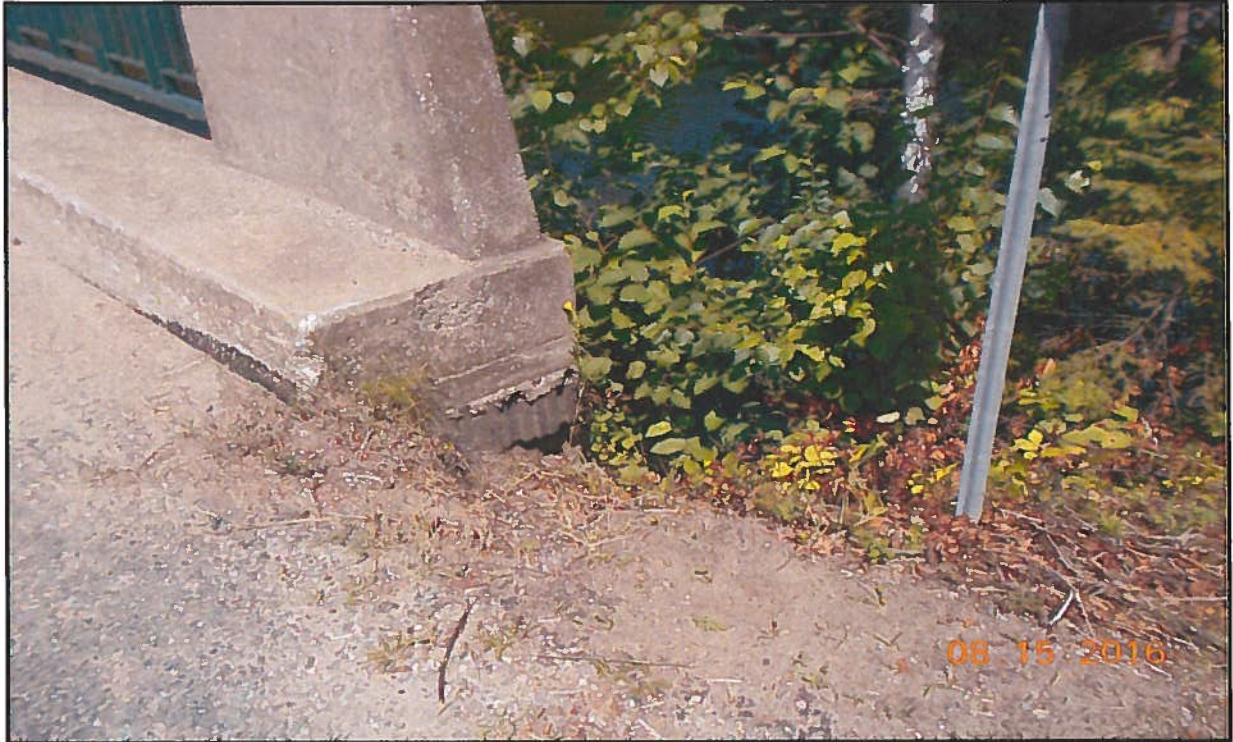
Photo 9 : Erosion of Embankment - Northeast Quadrant

The structure requires a minor rehabilitation including installation of erosion protection on the approach embankments, rebuilding and resurfacing of the approaches and repairs to the deck. This work should be completed in the 6-10 year period. Guiderail extension on the approaches should be undertaken in the future when the structure undergoes a major rehabilitation.

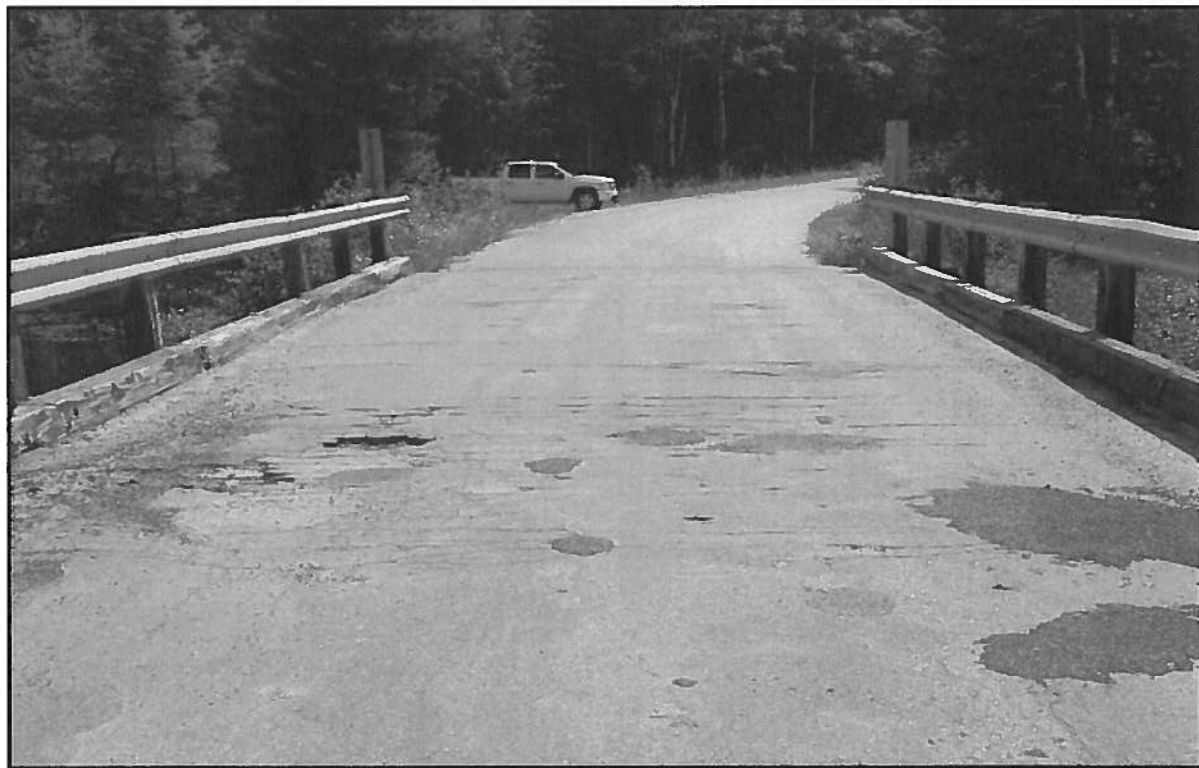
Photo 4 : General Arrangement – Deck Wearing Surface Looking South

The structure requires a minor rehabilitation within a 1-5 year period including: rebuilding of eroded embankments and installation of proper erosion protection on approach side slopes, stabilization of embankments at deck ends with gabion baskets, replacement of the surface treated wearing surface and address guiderail height. Maintenance should be undertaken to replace the missing guiderail post and clean the bridge deck to promote proper drainage.

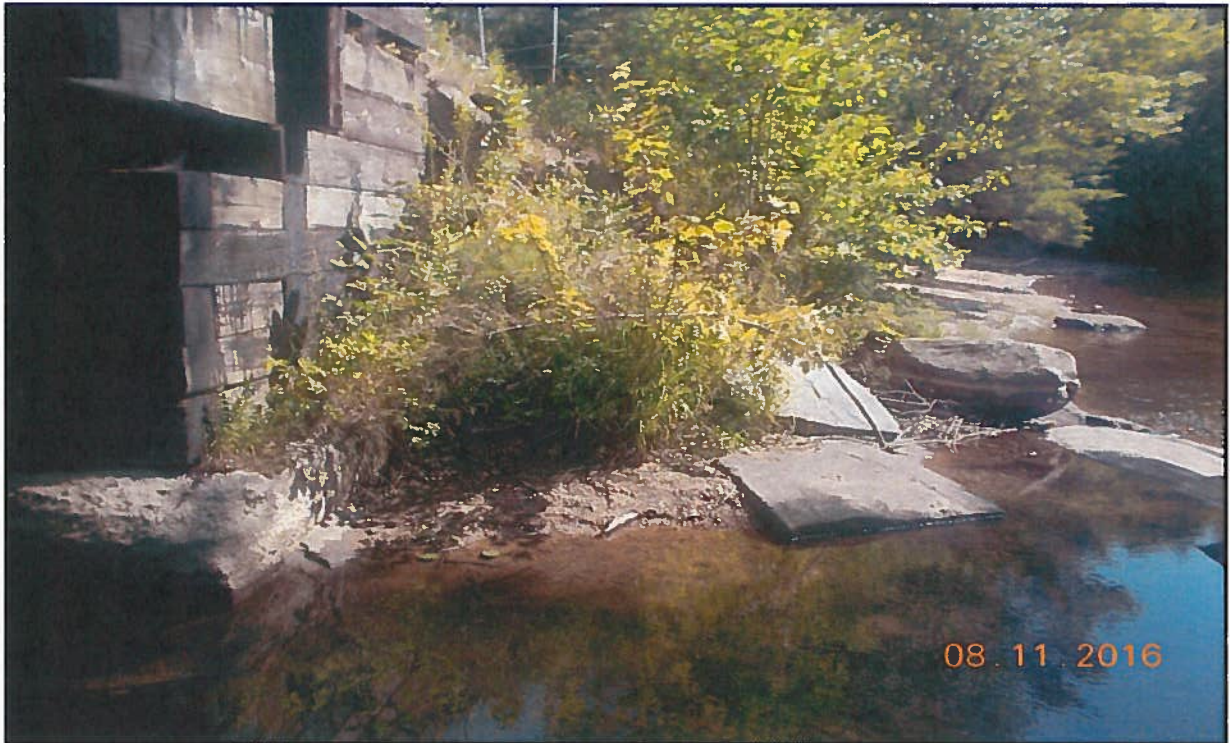
Photo 3 : Northeast Embankment – Looking North

The structure requires rip-rap erosion protection around both abutments to prevent further scour of the foundations and to provide embankment protection. Guiderail extension on the approaches should be undertaken in the future when the structure undergoes a major rehabilitation. The build-up of debris on the deck should be removed as part of maintenance.

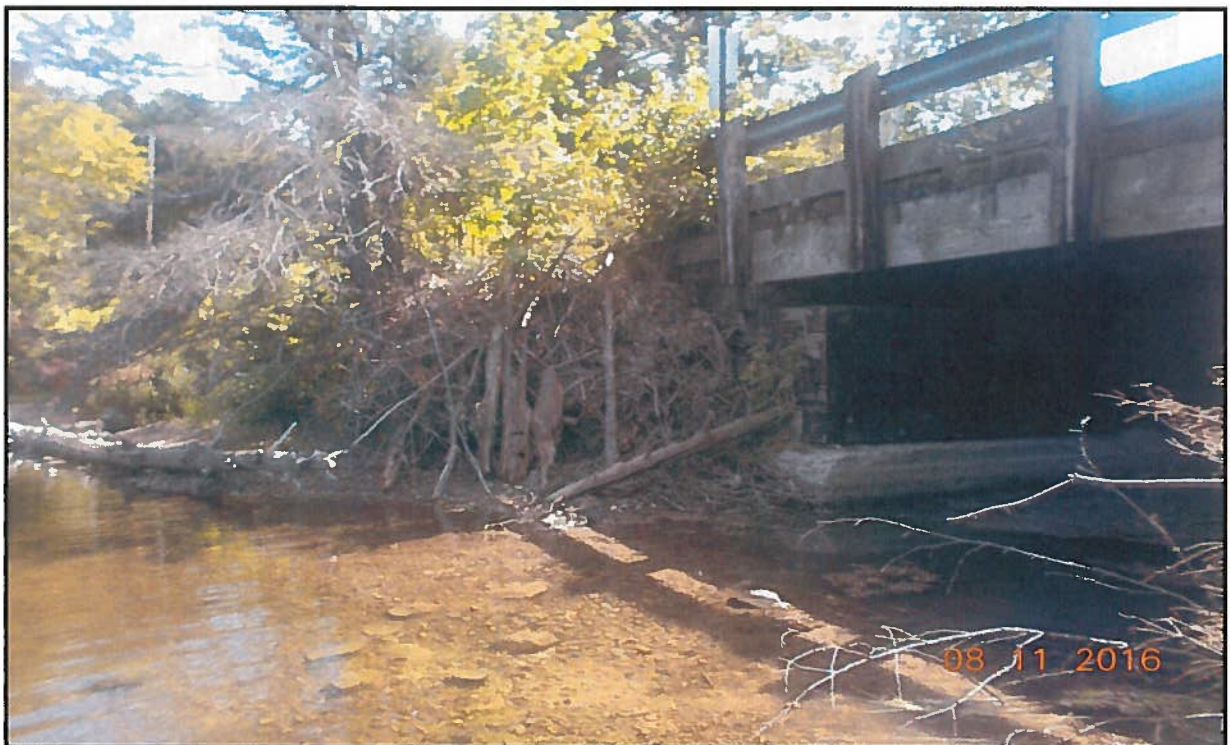
Photo 4 : Northwest Embankment – Looking North

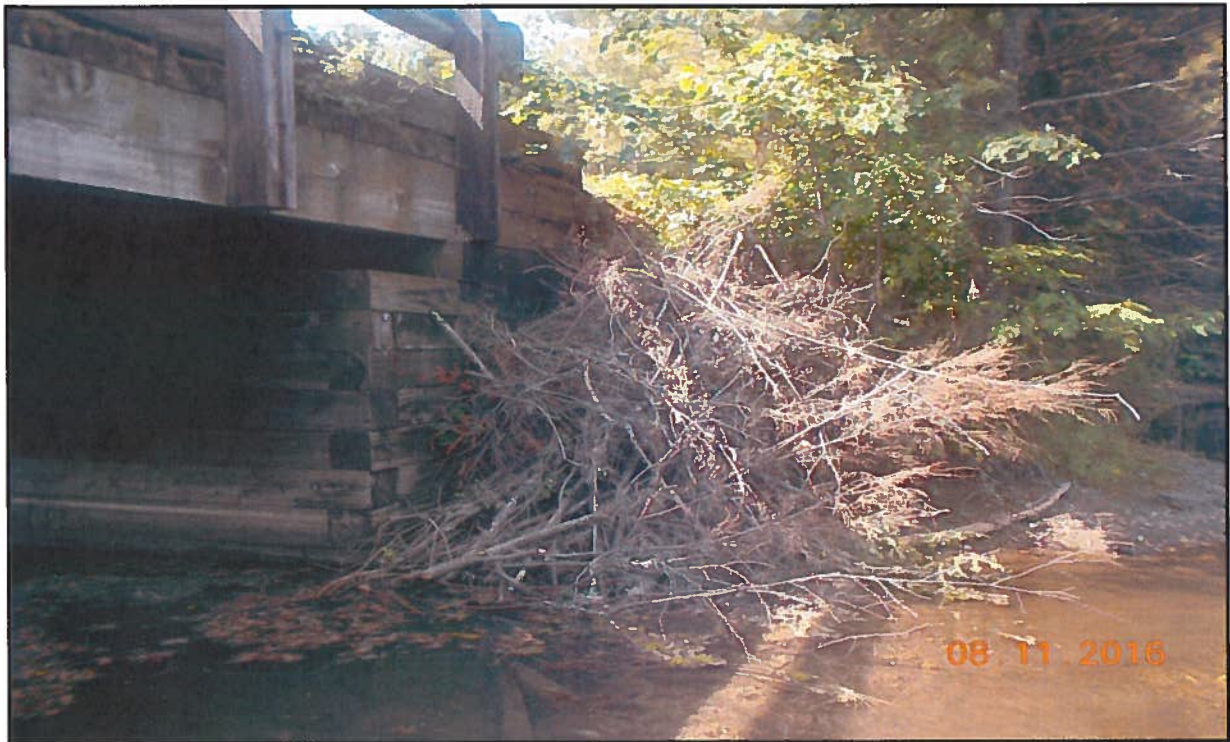
Photo 5 : Southwest Embankment – Looking South

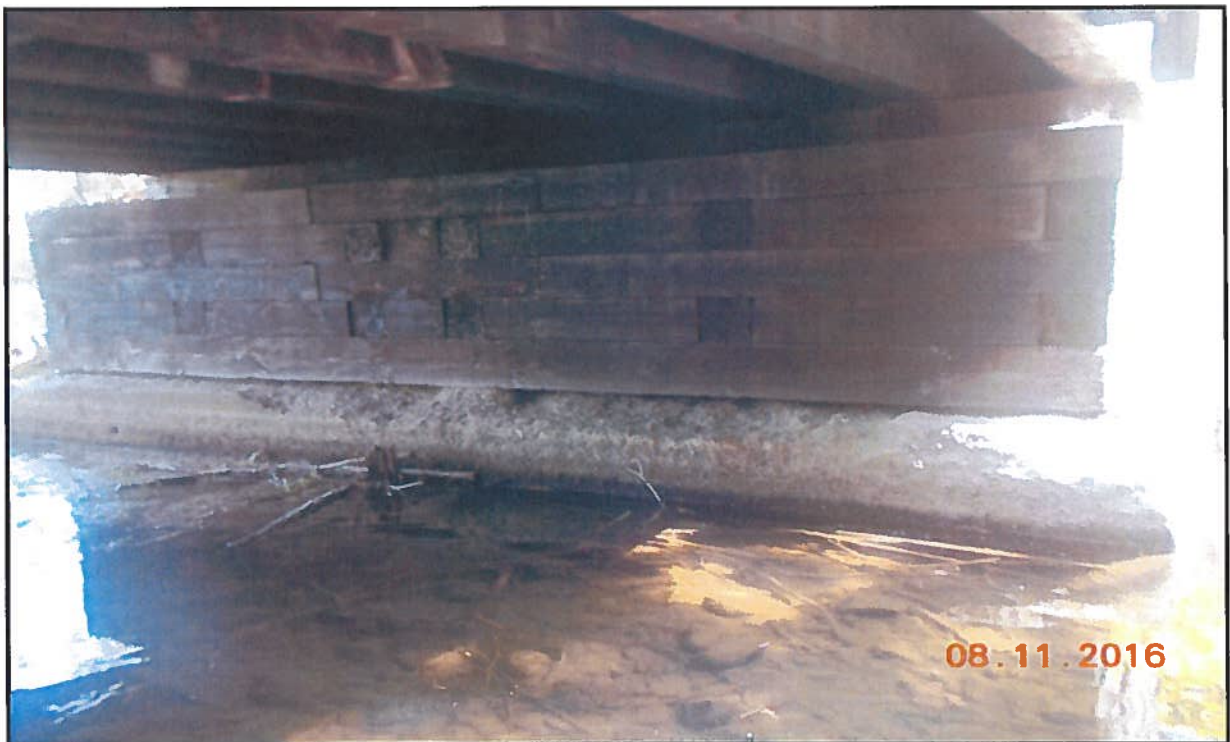
Photo 6 : North Abutment – Looking North

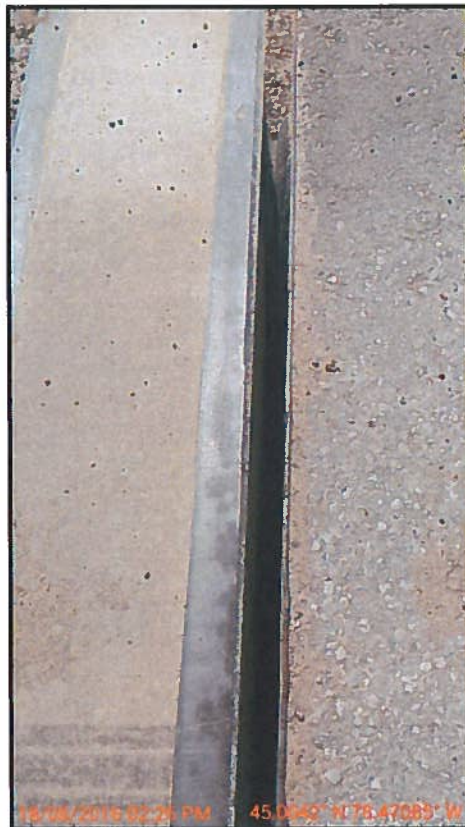
Photo 6 : South Expansion Joint at Deck / Approach Intersection

The structure requires no major improvements at this time. Maintenance is required to replace the damaged expansion joint seal.

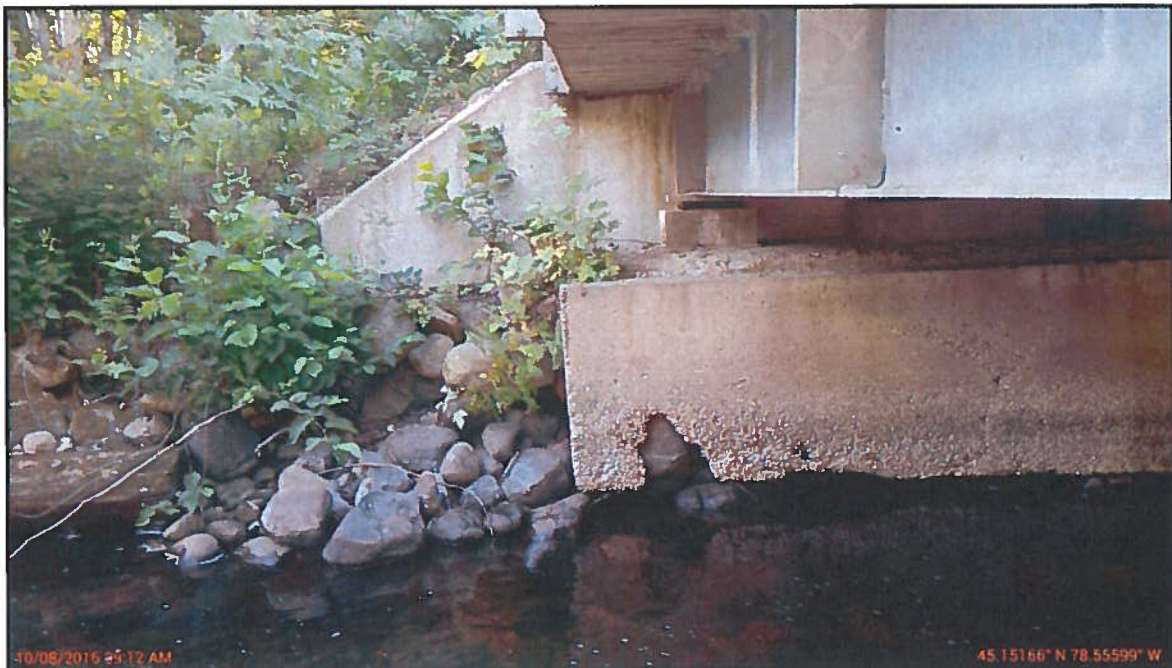
Photo 6 : General Arrangement – Southeast Embankment at Abutment

The structure requires a minor rehabilitation to repair undermined abutments and wing walls, especially at the northeast quadrant. Also including installation of erosion protection at the abutment faces, repair of concrete abutments and replacement of surface treated wearing surface. This work should be completed in 1-5 years. Maintenance is required to repair the damage guiderail and posts.

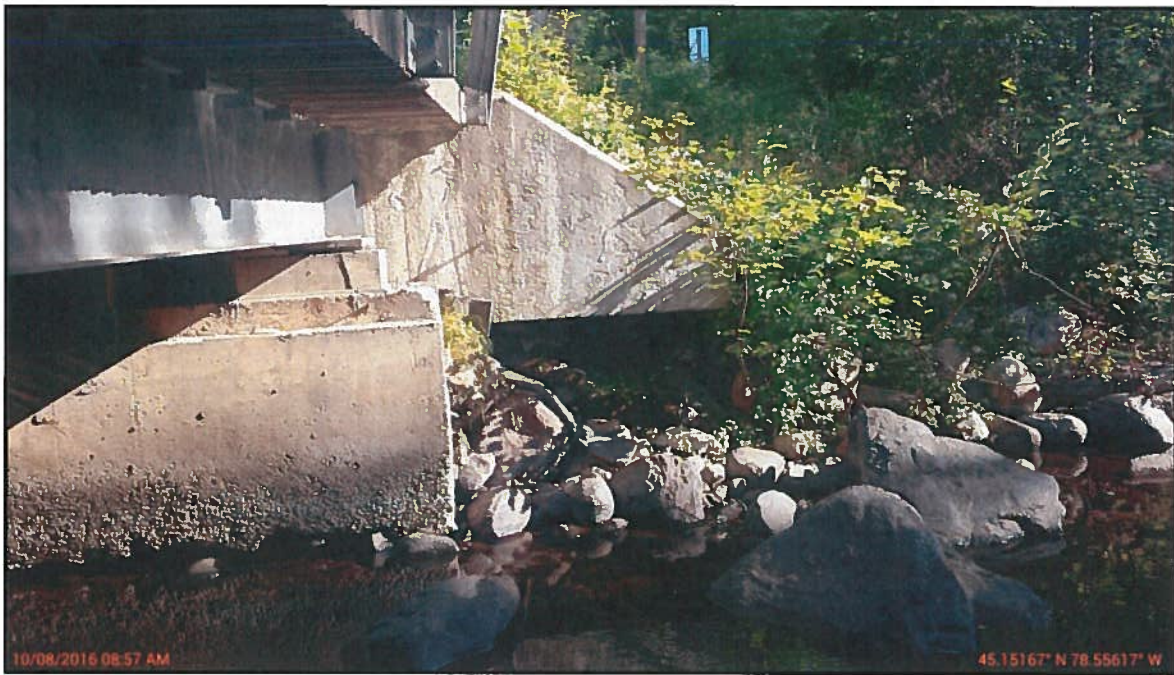
Photo 7 : General Arrangement – Northeast Embankment at Abutment

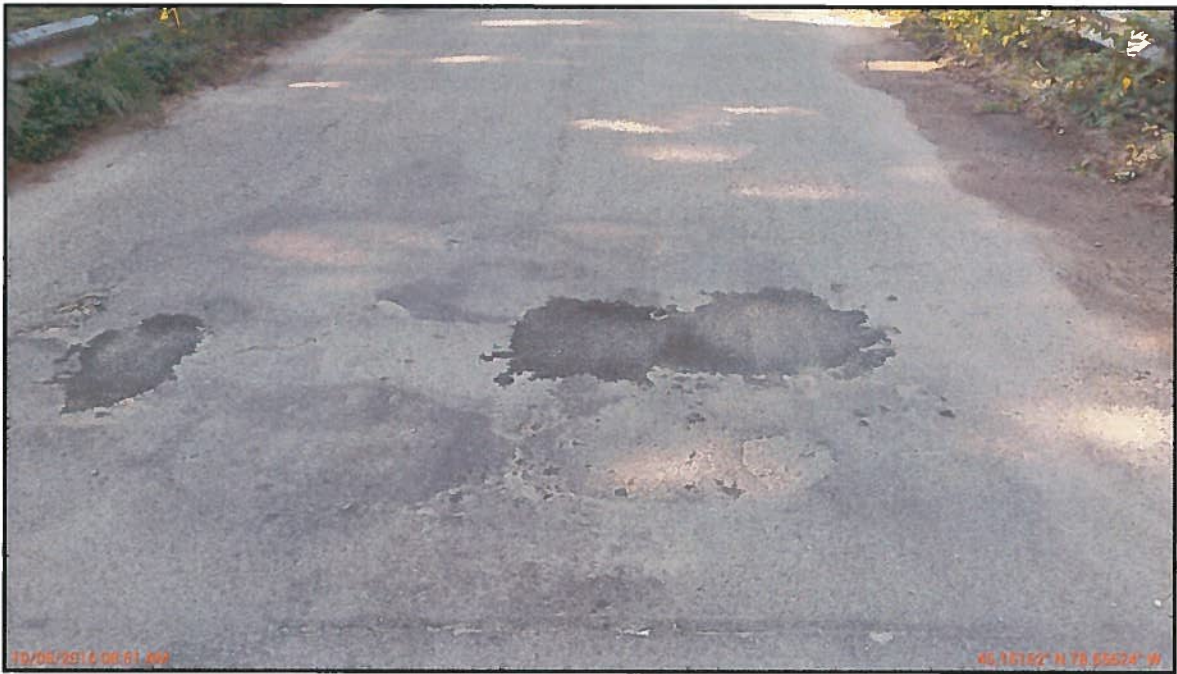
Photo 11 : South Approach Wearing Surface – Looking South

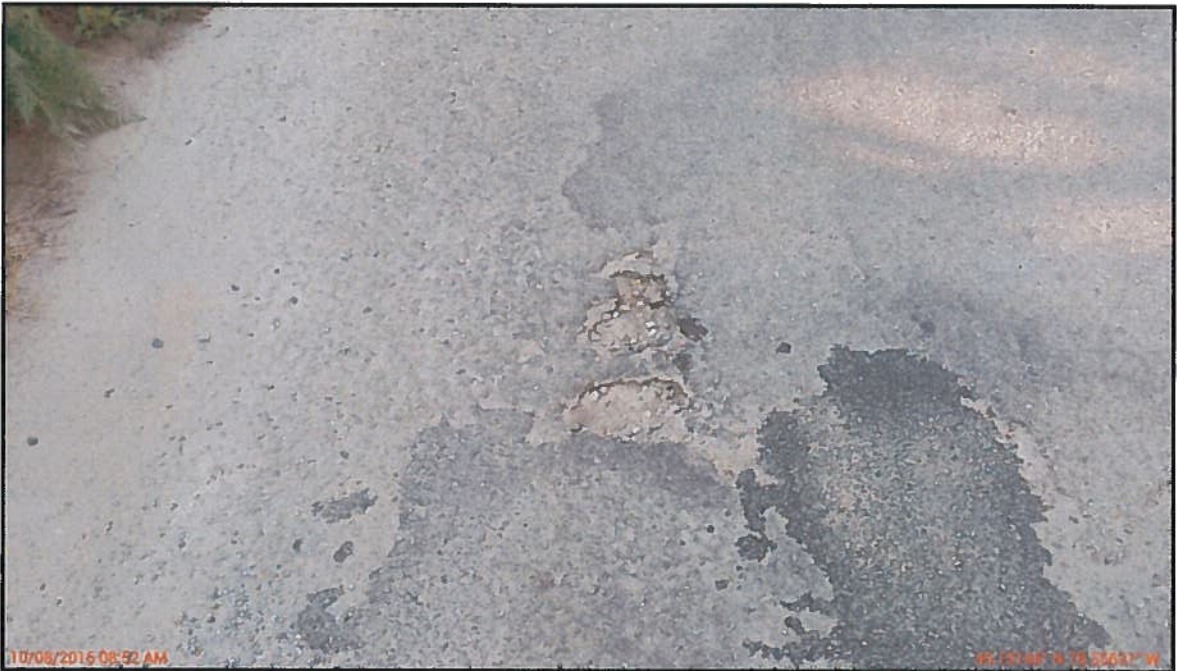
Photo 12 : South Approach Wearing Surface – Looking South

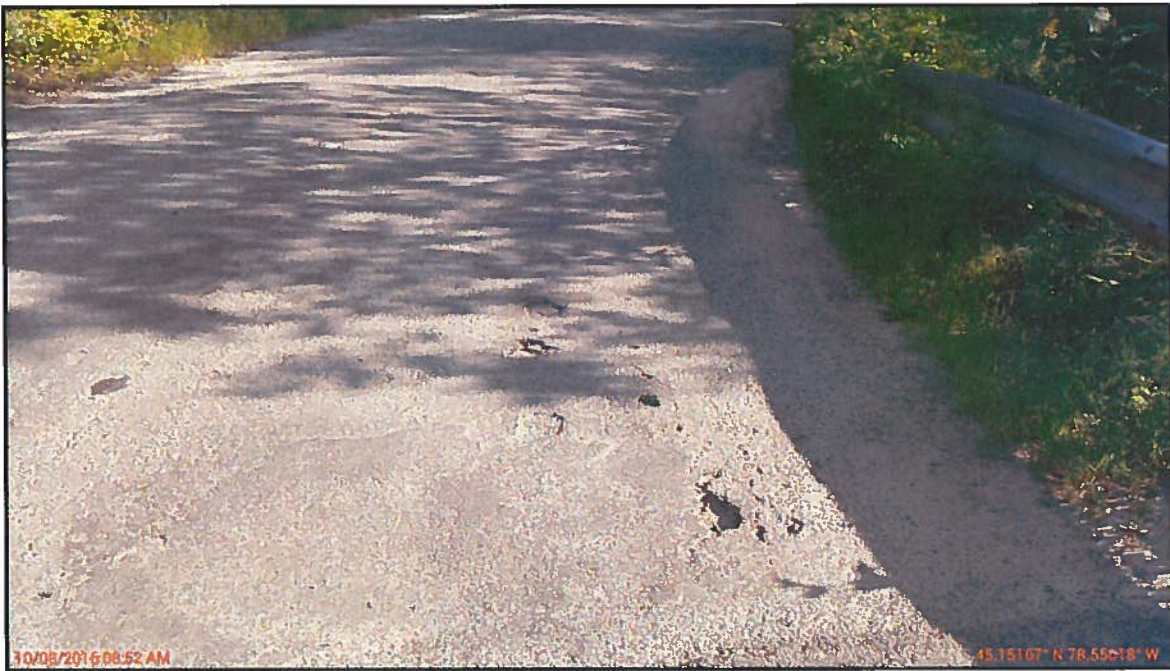
Photo 13 : North Approach Wearing Surface – Looking North

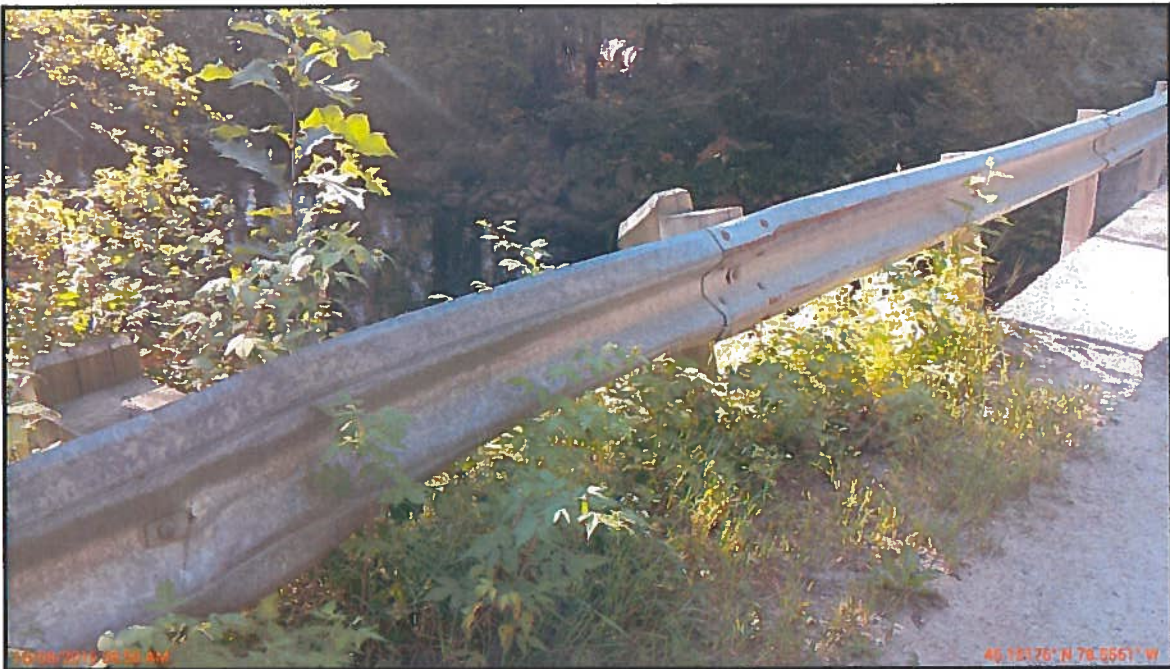
Photo 14 : Approach Guiderail – Northeast Quadrant

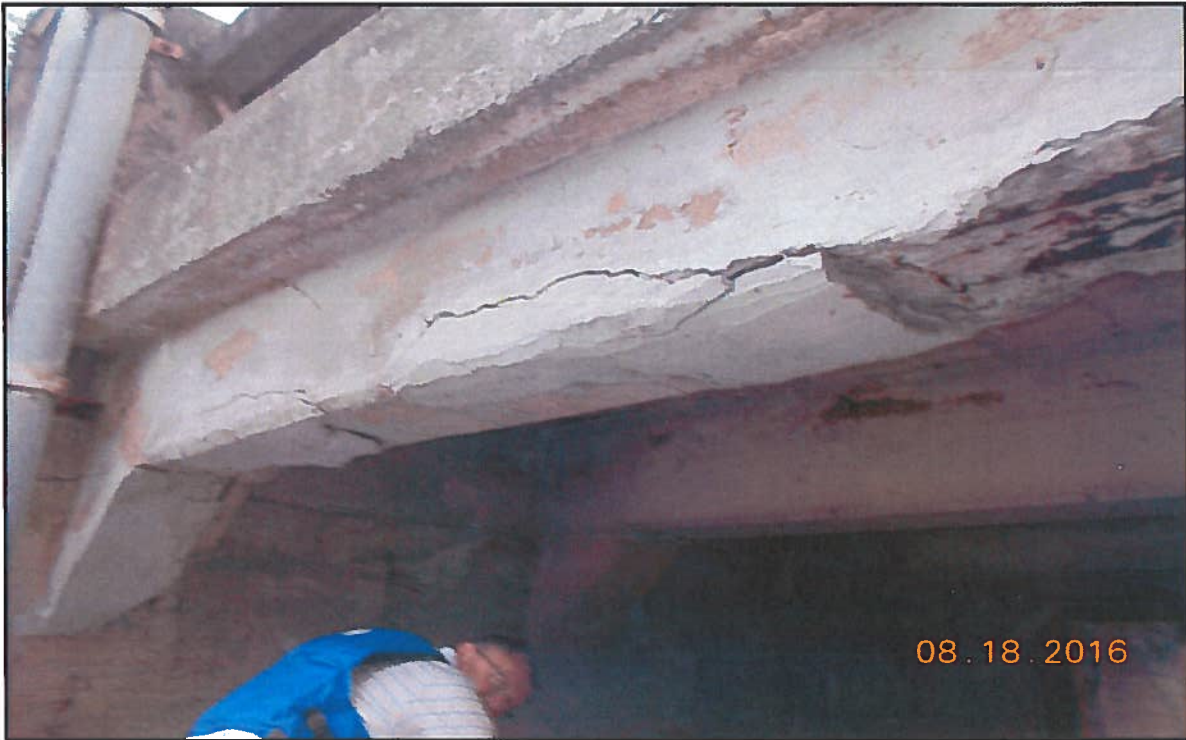
Photo 5 : General View – N. Elevation Exterior Girder at East Abutment

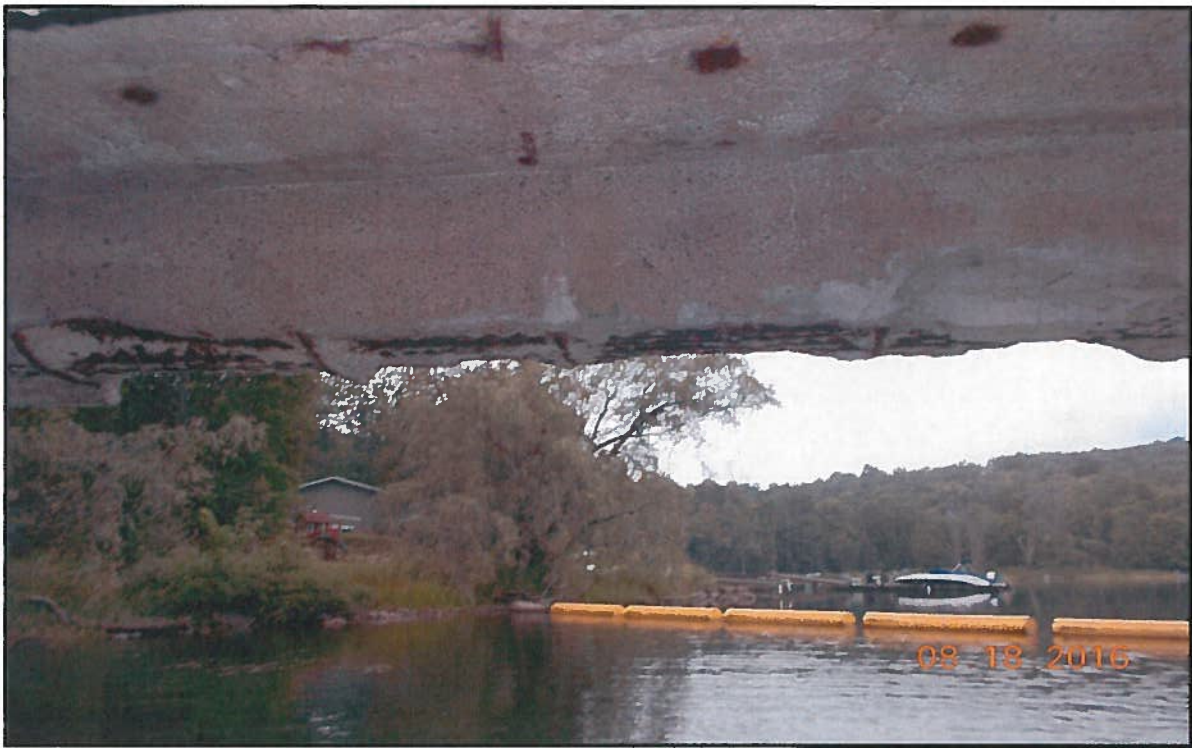
Photo 7 : North Exterior Girder at Mid Span – Looking North

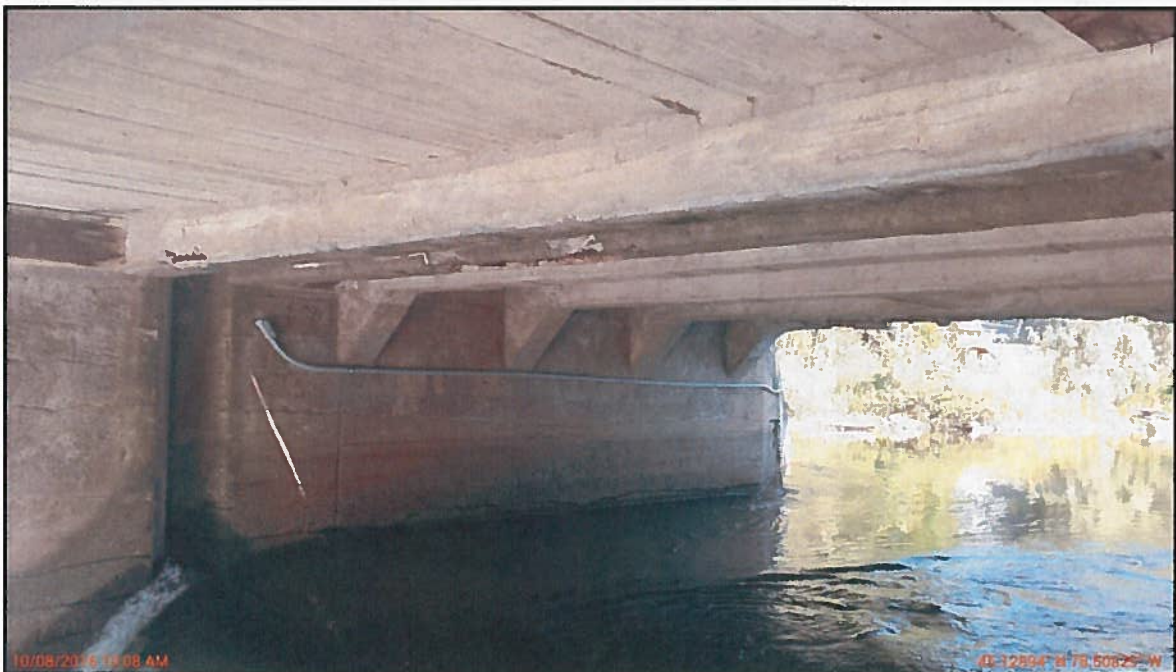
Photo 8 : General Girder Arrangement – Looking Northwest

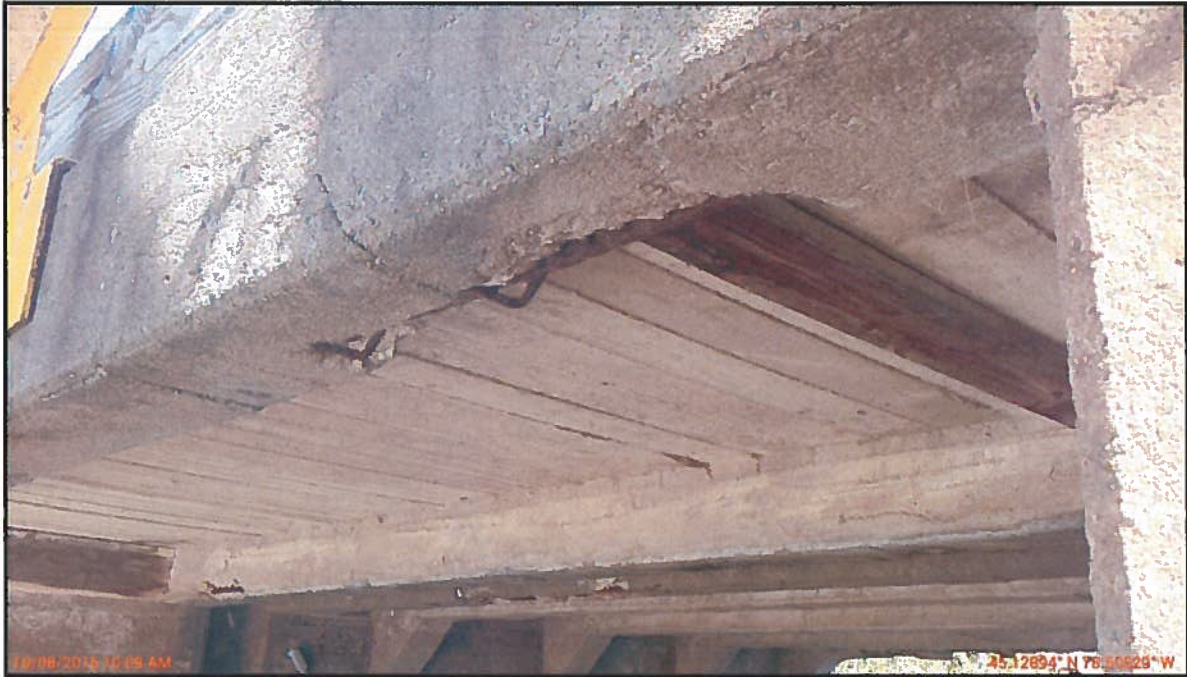
Photo 9 : South Exterior Girder at East Abutment – Looking Northwest

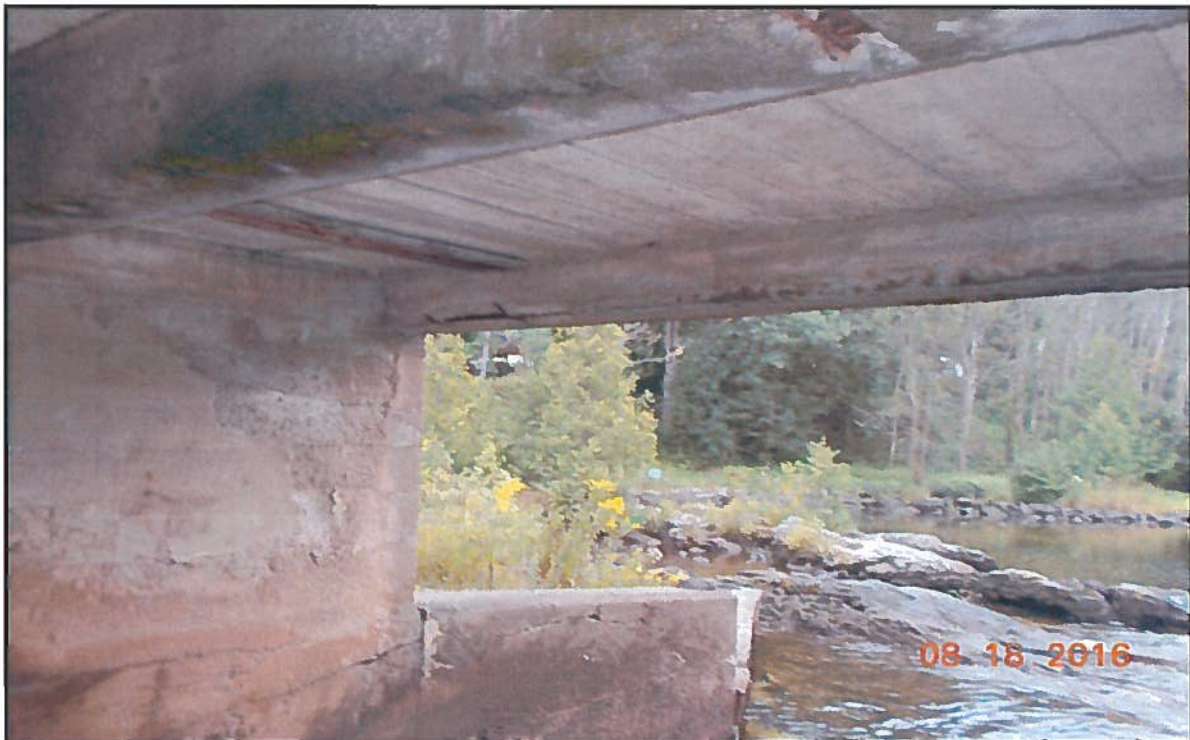
Photo 10 : South Exterior Girder at East Abutment – Looking Southeast
