## BIENNIAL BRIDGE INSPECTIONS

FINAL INSPECTION REPORT  
Municipality of Dysart et al

October 2016

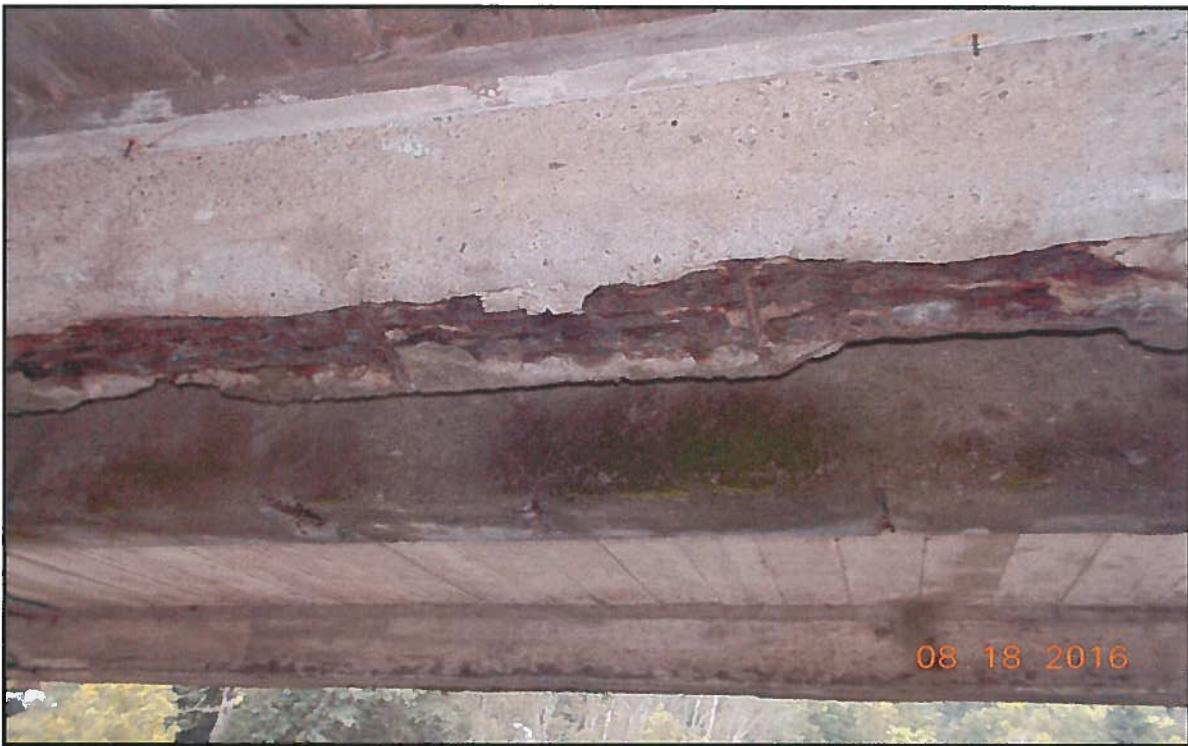
Photo 11 : South Interior Girder (2<sup>nd</sup> from End) Mid-Span – Looking South

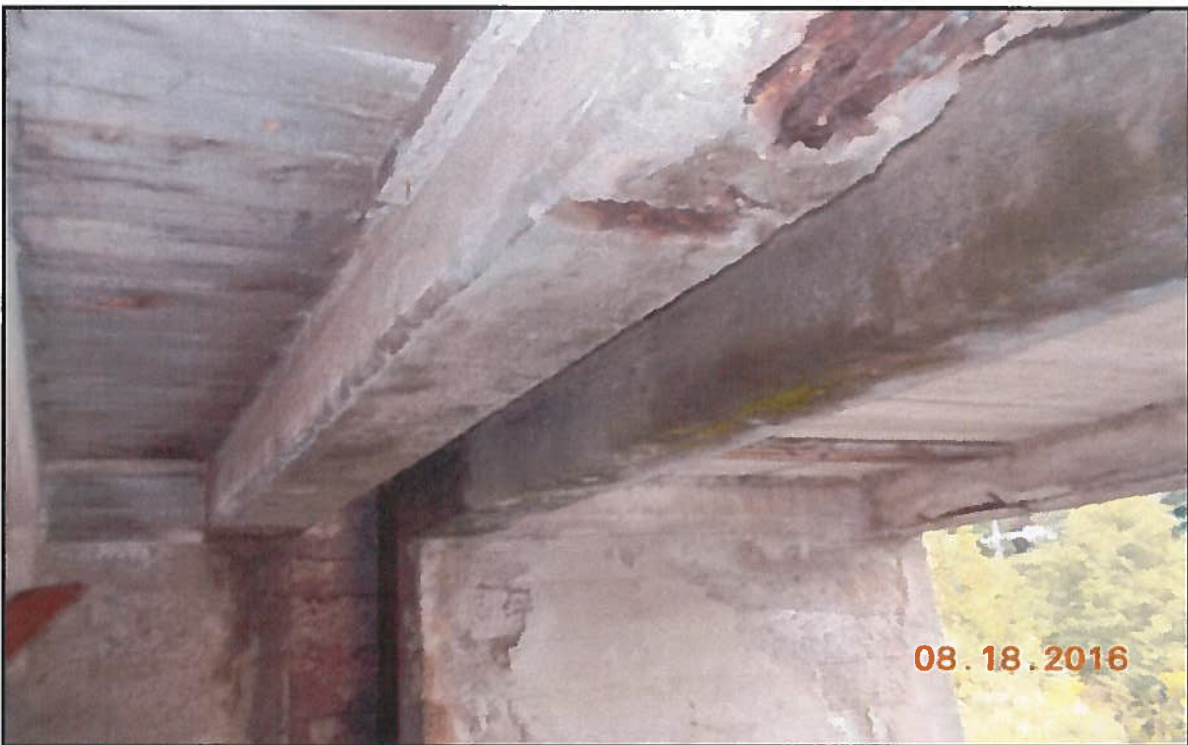
Photo 12 : South Interior Girder (2<sup>nd</sup> from End) Mid-Span – Looking Southeast

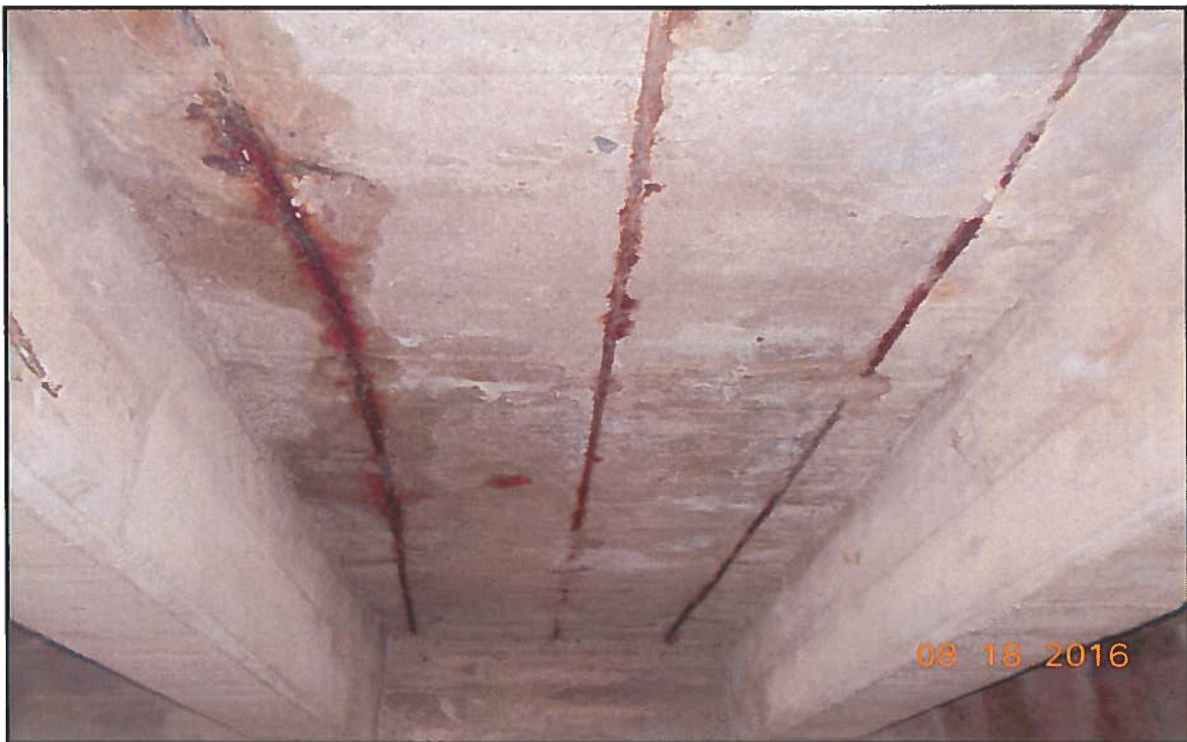
Photo 13 : Interior Soffit (2<sup>nd</sup> Bay From North Face) – Looking East

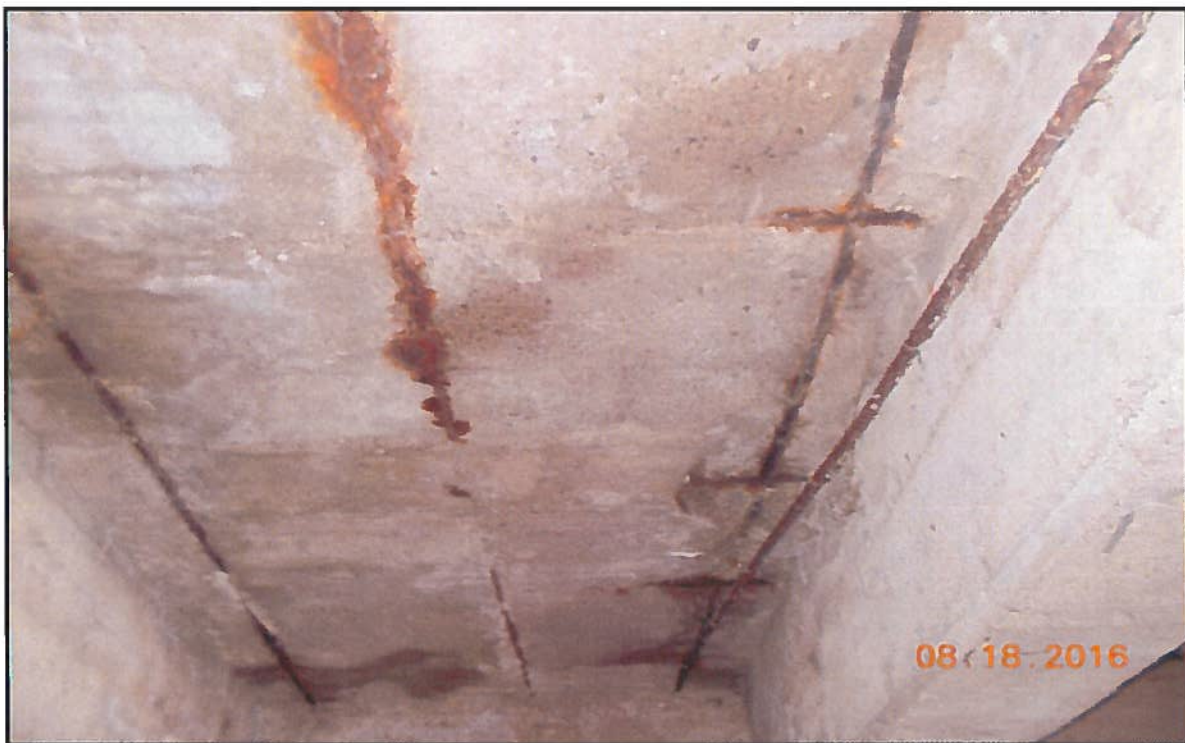
Photo 14 : Interior Soffit (2<sup>nd</sup> Bay From North Face) – Looking West

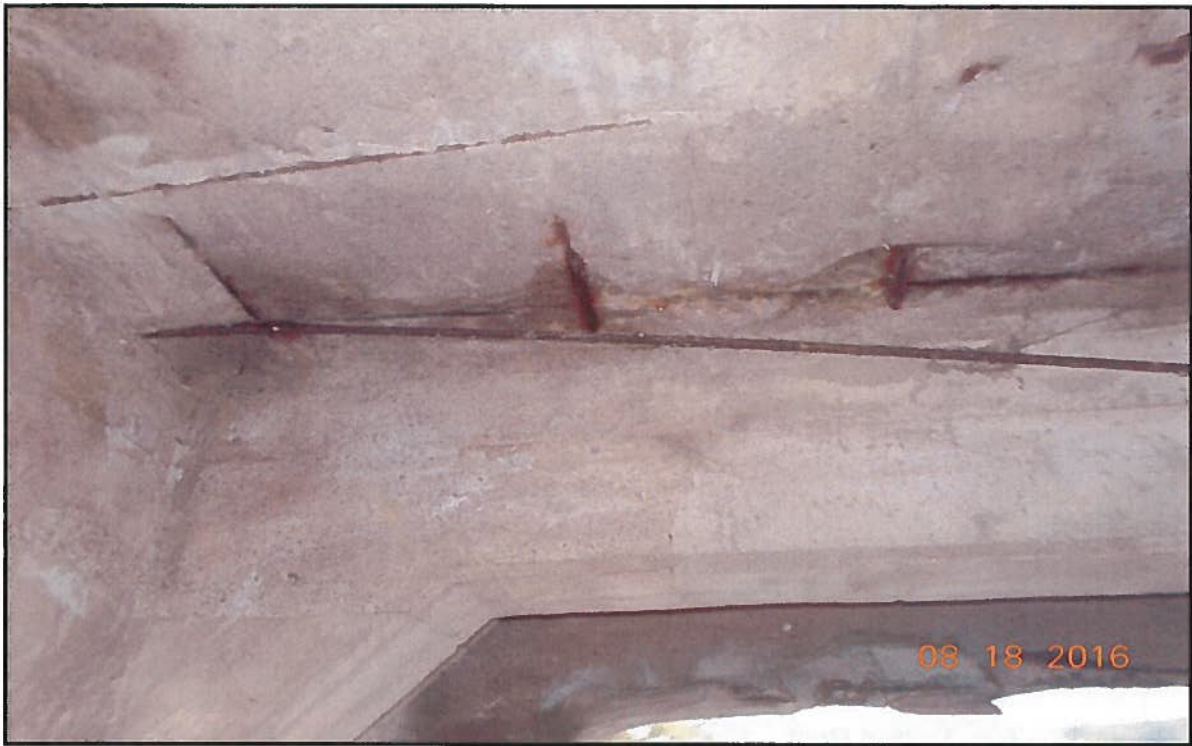
Photo 15 : Int. Soffit at W. Abutment (2<sup>nd</sup> Bay From North Face) – Looking North

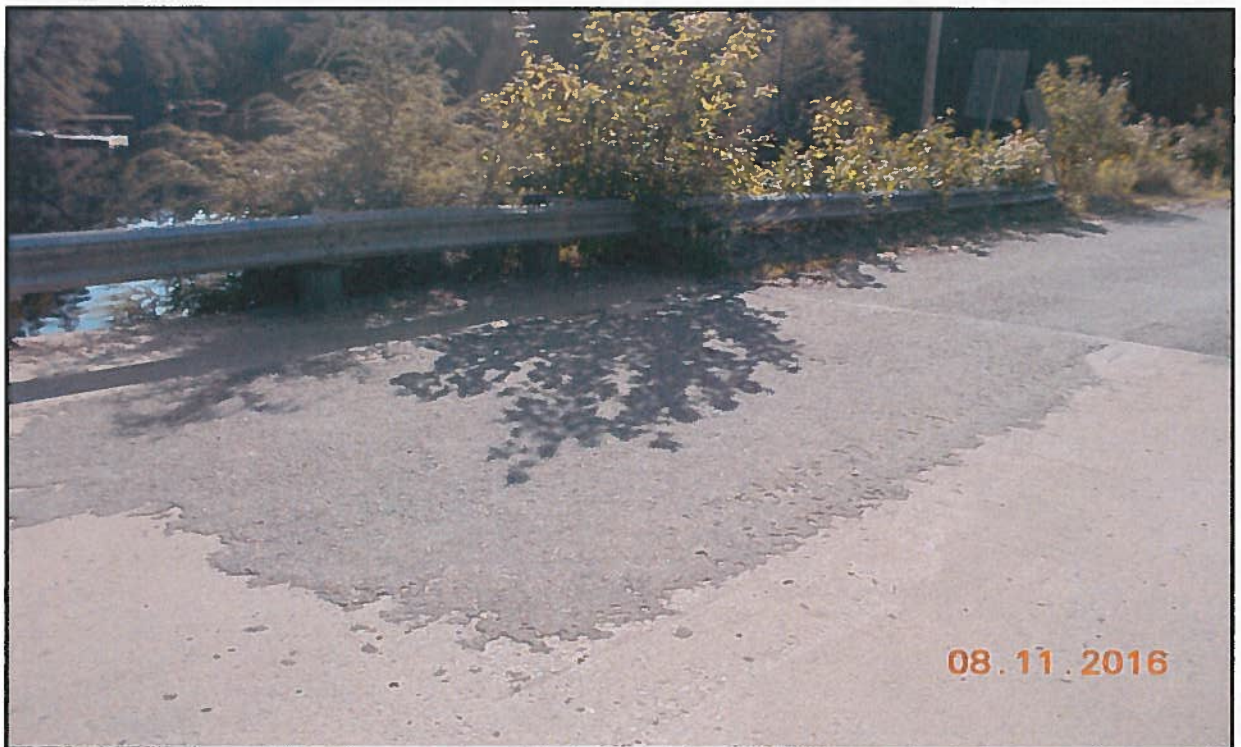
Photo 4 : Deck Wearing Surface – Asphalt Patching

The structure requires a minor rehabilitation to repair the abutment faces and wingwalls, stabilize the piles with wood blocking. This should be undertaken in 1-5 years. Maintenance is required to repair the loose/damaged guiderail posts and to clear vegetation along shoulder of approaches and guiderails.

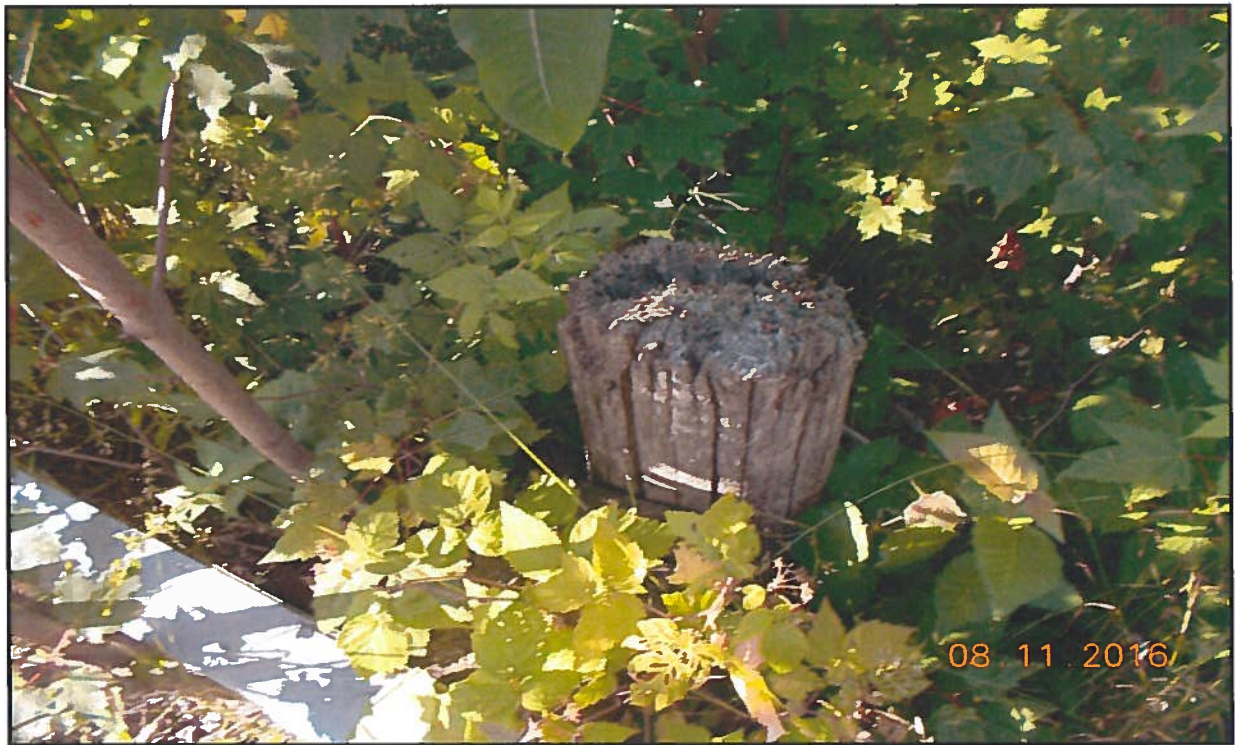
Photo 6 : Typ. Approach Barrier Post with Severe Splits – Southeast Quadrant

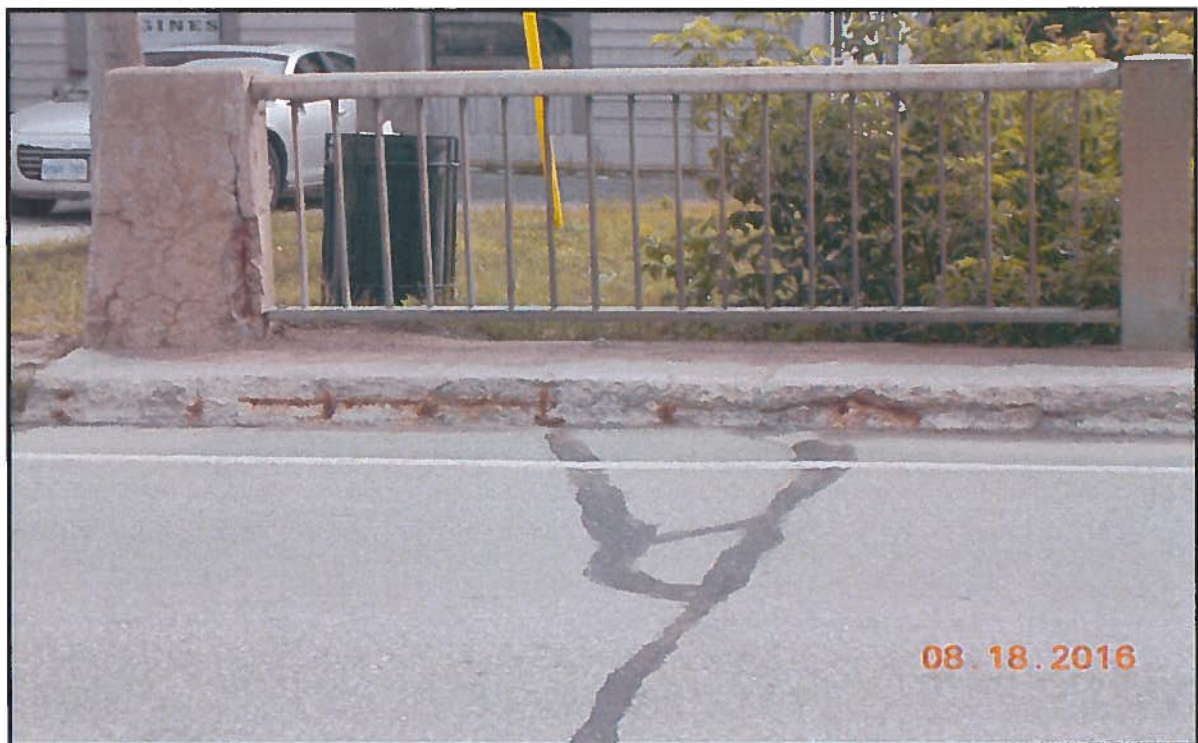
Photo 6 : Curb / Sidewalk and Railing System / End Post – Northeast Quadrant

The structure requires minor rehabilitation to repair concrete soffit, sidewalk, curb and end posts. Full depth crack repair should be completed at the deck ends to prevent water penetration. Maintenance is required to place erosion protection at the retaining wall in the NE quadrant to prevent erosion. Hazard signage to Provincial Standards should be installed at the terminations of the guiderail. For aesthetics reasons, the steel railing system could be re-coated.

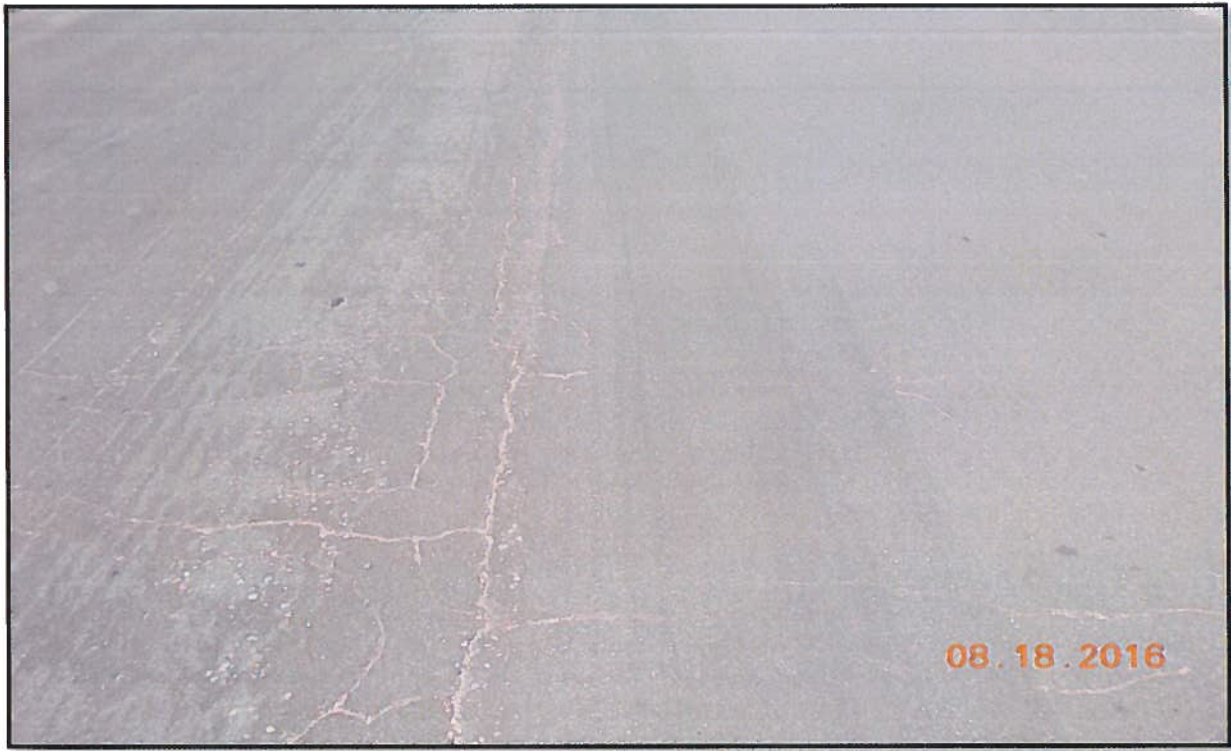
Photo 1 : Deck Wearing Surface - Looking South

The structure requires minor rehabilitation to the roadway curbs to address the deterioration of the concrete. This should be undertaken within a year to prevent further deterioration of sidewalk and to promote water flow to catch basins. Deck surface area requires routing and sealing of transverse cracks. Maintenance is required to repair/replace damaged guiderail posts and blocks. Investigation of the condition of the culvert invert is required to confirm condition. Due to high water levels and flows (downstream dam) this area could not be inspected during the OSIM inspection and will require an enhanced investigation with small boat.

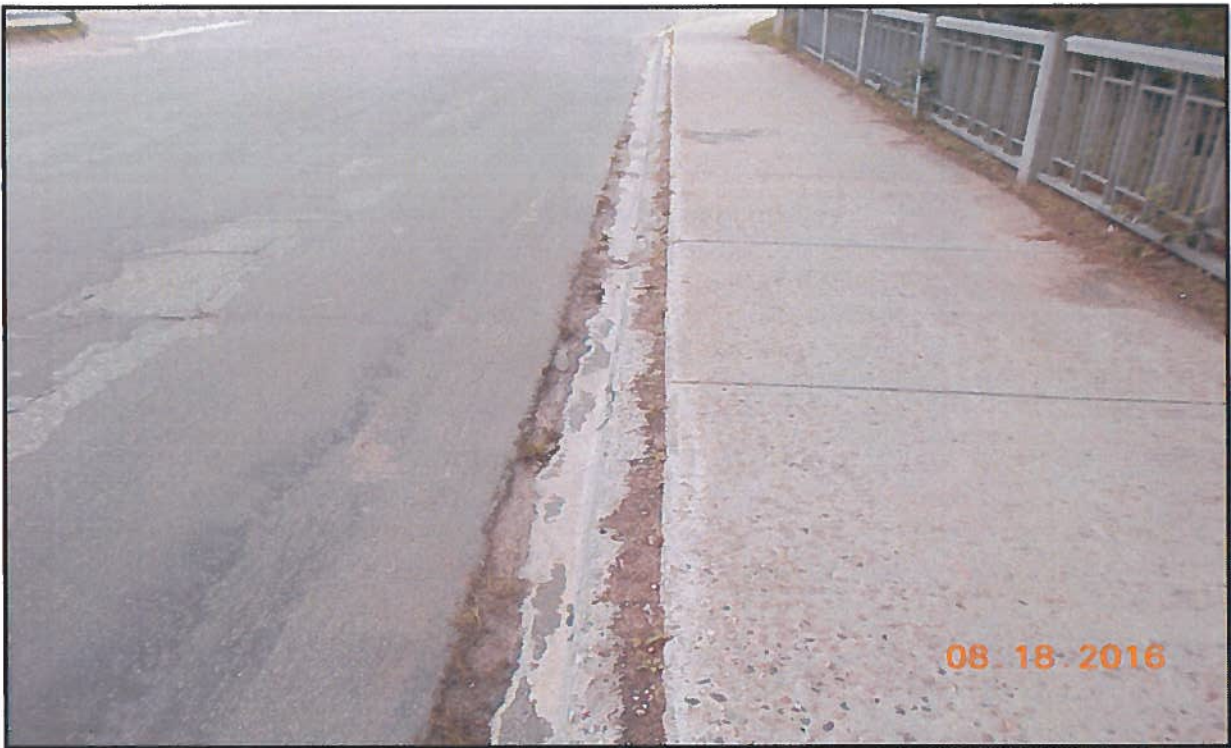
Photo 2 : Edge of Concrete Deck & Curb System - Looking South

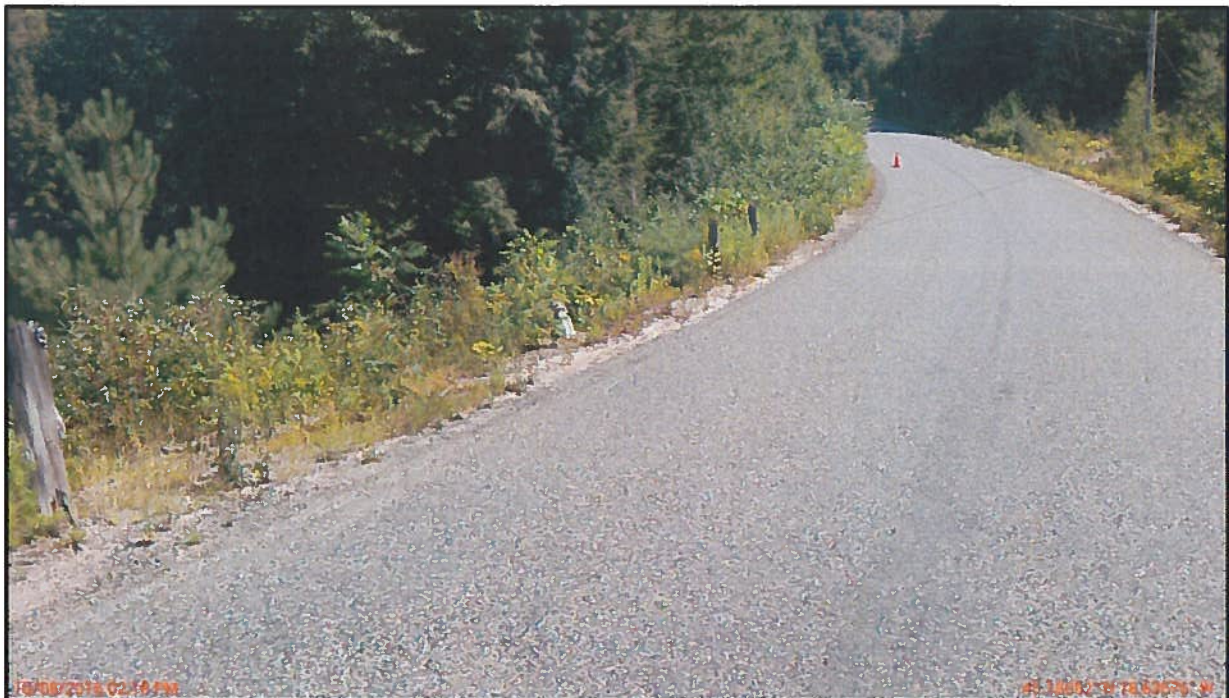
Photo 6: Typical Guide Rail System & Wearing Surface – Looking Southwest

The structure requires no rehabilitation work itself. A guiderail system should be installed on either side of the structure and to extend past the approaches in accordance with provincial highway standards.
