BIENNIAL BRIDGE INSPECTIONS

FINAL INSPECTION REPORT Municipality of Dysart et al

December 2018

File No. 18-4011

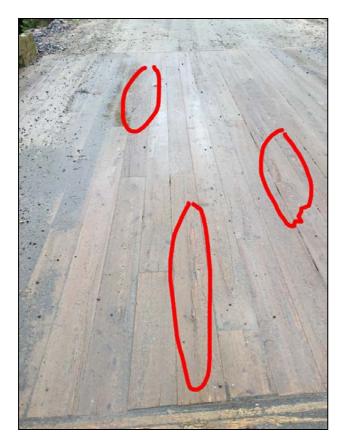
Decks / Wearing Surface

Description: Light checks on deck wearing surface.

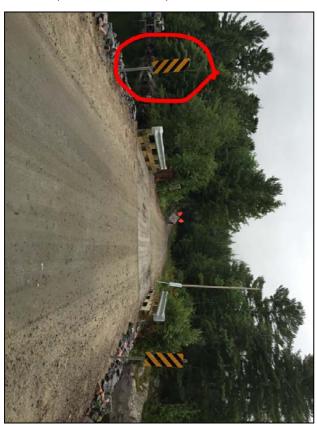
Accessories / Signs

Description: SE hazard damaged,

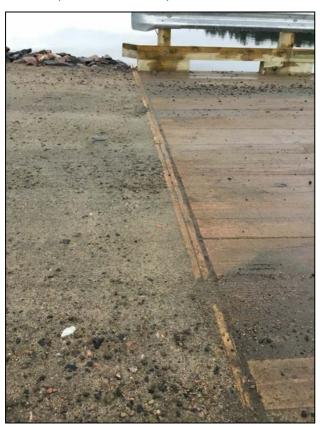
Approaches / Wearing surface (East and West)

Description: Light settling at joints throughout (west joint pictured).

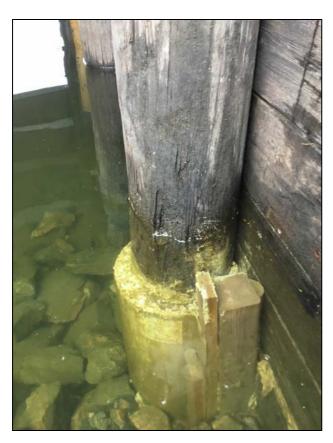
Pier / Pile Bents (East and West)

Description: Rehabilitated pile, northwest quadrant, in good condition.

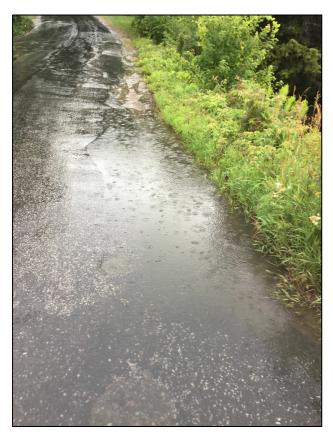
Approaches / Wearing Surface (East and West)

Description: Ponding at northwest approach.

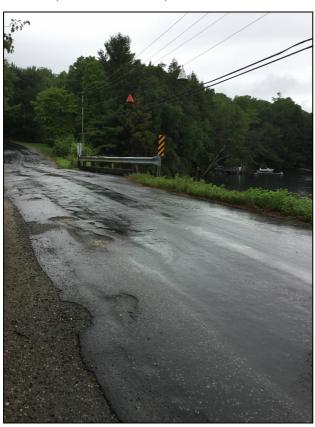
Approaches / Wearing Surface (East and West)

Description: East approach, potholes.

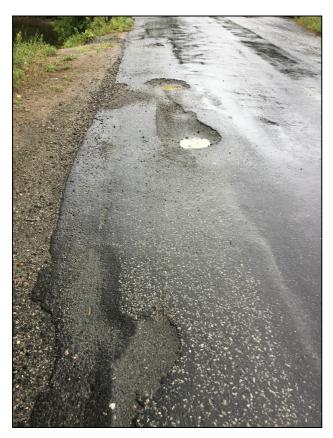
Approaches / Wearing Surface (East and West)

Description: Large pot holes, some ravelling, east approach.

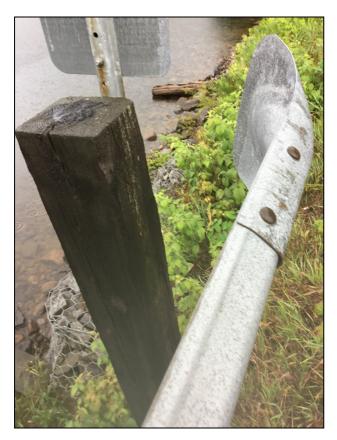
Barriers / Railing Systems (Across structure only)

Description: Northeast fishtail end not attached to post.

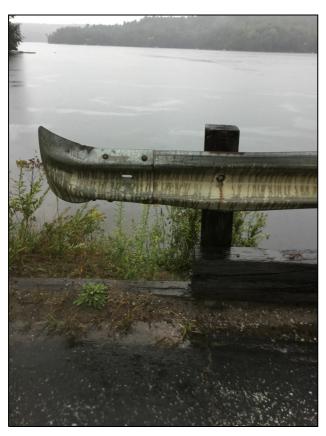
Barriers / Railing Systems (Across structure only)

Description: Minor impact damage, north side.

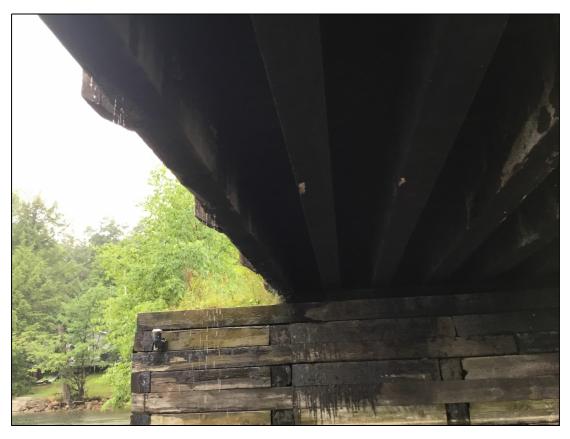
Beam / MLE / Girders (E/W)

Description: Deck drainage causing wet end girders and some checking.

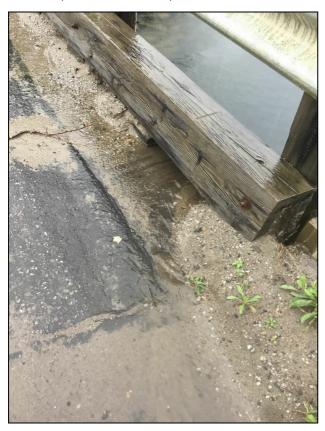
Sidewalks/curbs / Curbs (North and South)

Description: Build up of sand, south draining well, north curb slots obstructed.

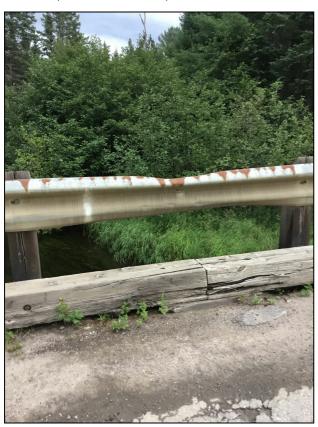
Barriers / Railing Systems (E /W)

Description: Impact damage on north side.

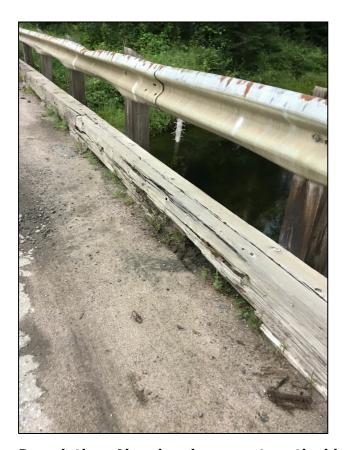
Description: Abrasion damage at north side.

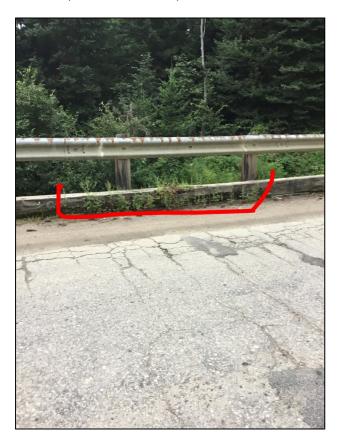
Sidewalks/curbs / Curbs (North and south)

Description: Rot with abrasion damage at south side.

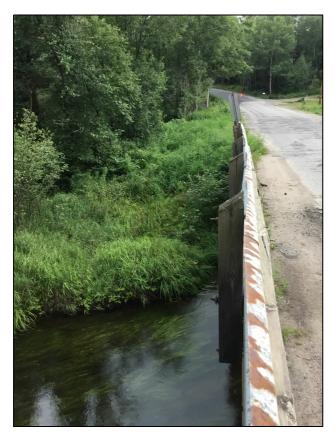
Sidewalks/curbs / Curbs (North and south)

Description: Some signs of erosion at northwest quadrant.

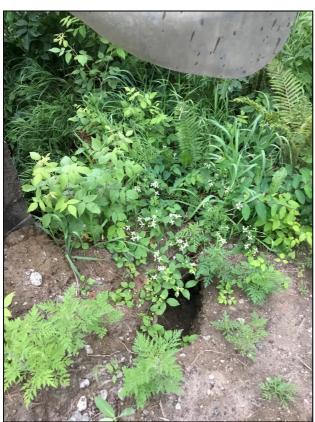
Streams & Embankments / Slope Protection (All quadrants.)

Description: Norhtwest erosion (detail).

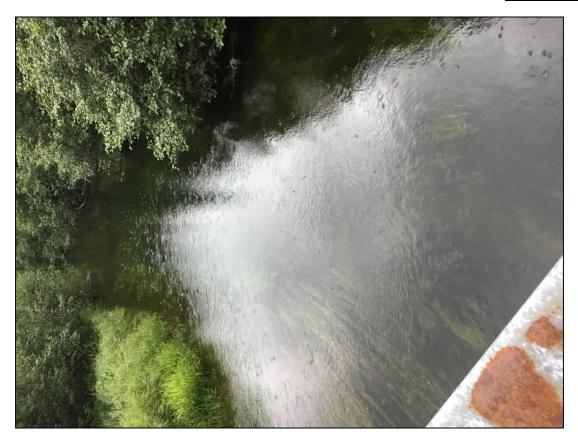
Streams & Embankments / Slope Protection (All quadrants.)

Description: Downstream.

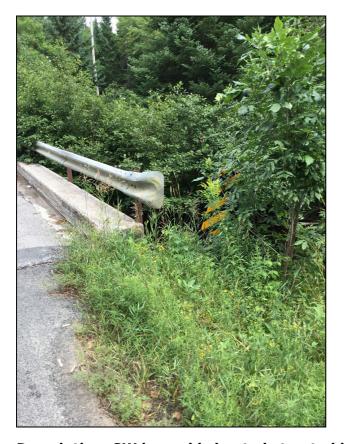
Accessories / Signs (All quadrants.)

Description: SW hazard is bent obstructed by vegetation.

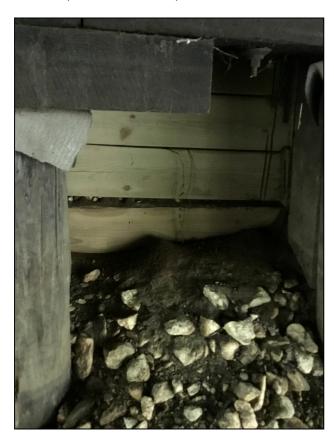
Abutments / Ballast walls (East and west)

Description: Lagging separation at west side.

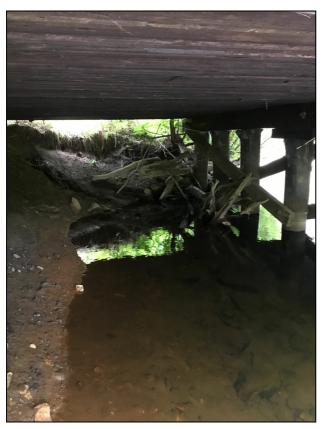
Abutments / Ballast walls (East and west)

Description: Erosion and channel meander change at southeast wingwall.

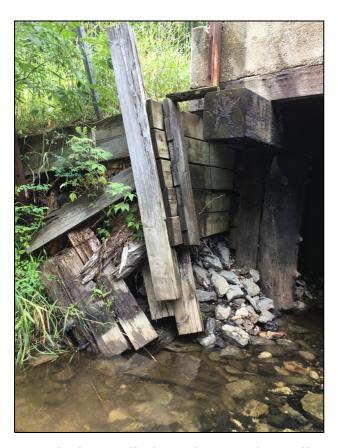
Abutments / Wingwalls (All quadrants.)

Description: Failed southwest wingwall.

Repair and Rehabilitation R	Priority					Estimated	
Element Repair and Rehabilitation Required		> 10 years	6 - 10 years	1 - 5 years	Now < 1 year	Urgent	Cost
Railing System, Posts	Replace posts at deck.		✓				\$2,000.00
Railing System	Replace railing system across deck.		1				\$10,000.00
Approach, Wearing surface	Repave wearing surface.			✓			\$40,000.00
Wingwall	Replace southwest wingwall.			✓			\$20,000.00
						Total	\$72,000.00

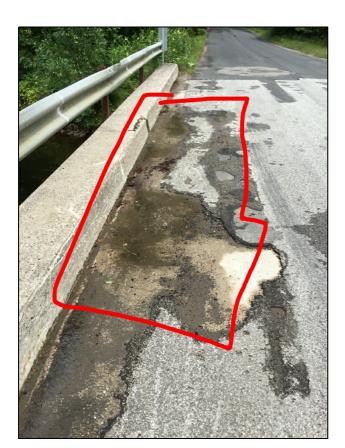
Decks / Deck Top

Description: Pooling on north side of deck.

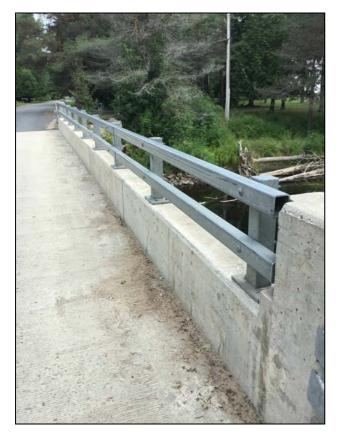
Barriers / Hand Railings (E/W)

Description: East handrail, Impact scraps of handrails causing light corrosion

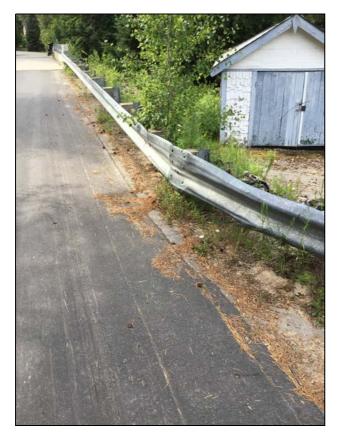
Description: Impact damage at NW barrier Approaches / Barriers

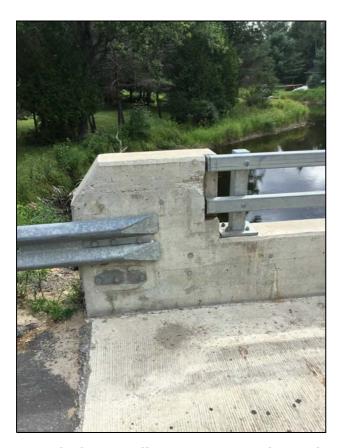
Description: Spall at NE parapet due to impact. **Barriers / Barrier/Parapet Walls**

Repair and Rehabilitation Re	quired			Estimated			
Element	Repair and Rehabilitation Required	> 10 years	6 - 10 years	1 - 5 years	Now < 1 year	Urgent	Cost
Signs	Install two (2) hazard signs at north end					✓	\$5,000.00
Barriers / Parapet	Patch Spalls and cracks		✓				\$500.00
						Total	\$5,500.00

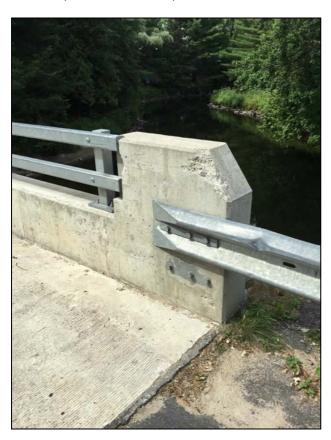
Barriers / Barrier/Parapet Walls

Description: Spall at NW parapet due to impact.

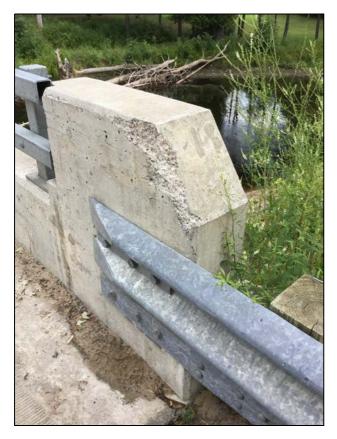
Description: Spall at SE parapet wall due to impact
Barriers / Barrier/Parapet Walls

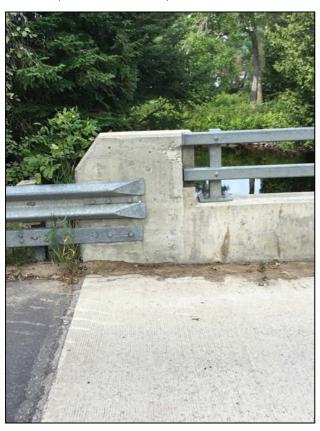
Barriers / Barrier/Parapet Walls

Description: Spall at SW parapet wall due to impact..

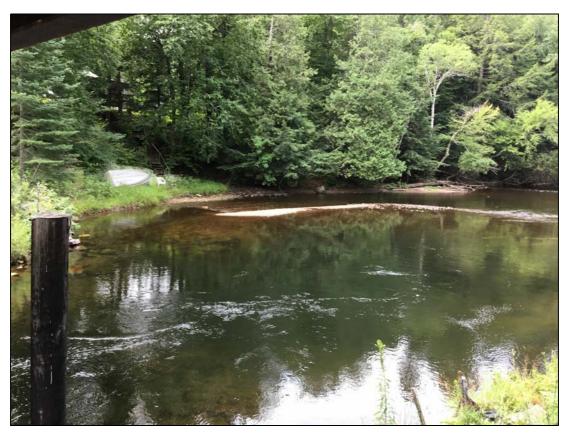
Description: Sediment deposition west downstream, forcing flow along roadway Embankments & Streams / Streams and Waterways (E/W)

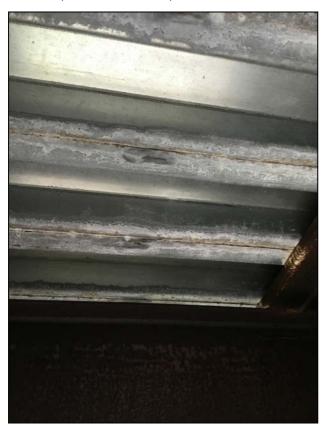
Decks / Soffit - Thin Slab

Description: Staining at joints from salt exposure.

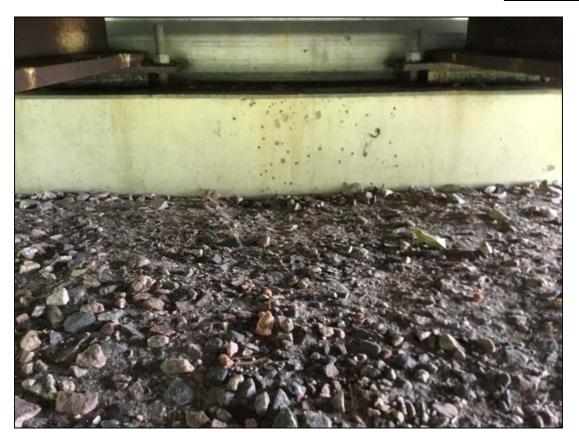
Description: Small section of bug holes between centre girders Abutments / Abutment walls (N/S)

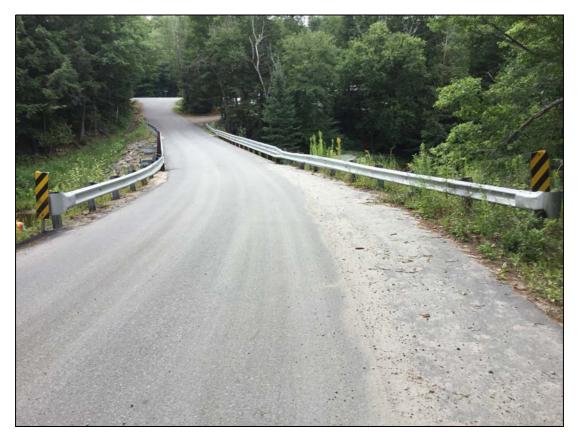
Description: North east sign is incorrect
Accessories / Signs (NE/NW/SE/SW)

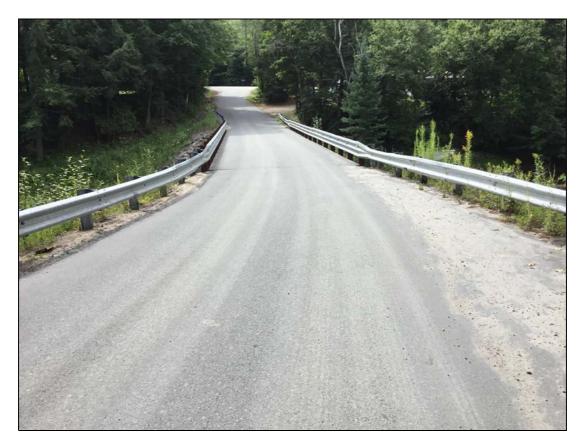
Approaches / Wearing surface (N/S)

Description: North side

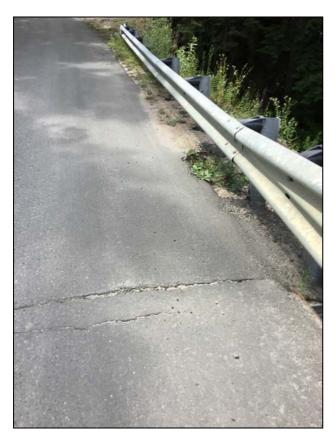
Description: SW erosion / cracking
Approaches / Wearing surface (N/S)

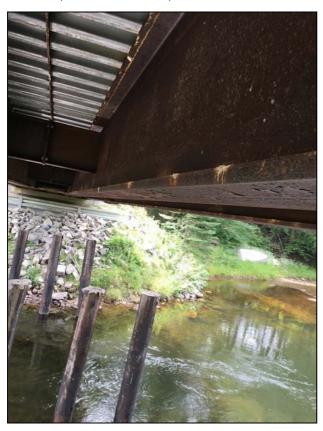
Beams/Main Longitudinal Elements / Girders (N/S)

Description: Centre west girder

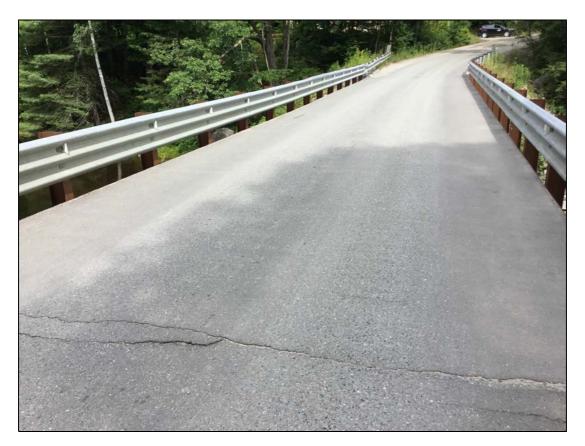
Description: Deck top Decks / Deck Top

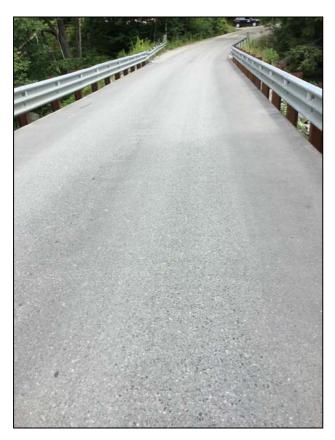
Decks / Wearing Surface

Description: Wearing surface looking north

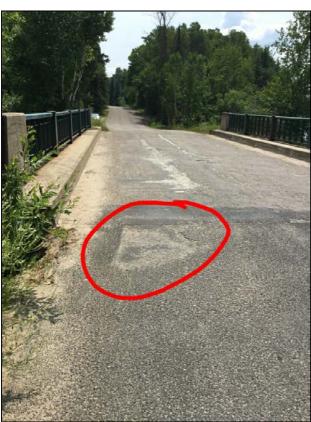
Approaches / Wearing Surface (East and West)

Description: North side of west approach

Туре Т	ming												
Element Group:	Appr	oaches							Length:	6.0 (m)			
Element Name:	Wear	ring Surf	ace						Width:	7.5 (m)			
Location:	East	and We	st						Height:	(m)			
Element Description:	Asph	alt surfa	ice						Count:	2			
Material:									Total Quantity:	90.0 (sq.m)			
Element Type:									Not Inspected:				
Environment:	□ Ве	enign, 🗆	Modera	ate, ☑ S	Severe)			Limited Inspectio	n: 🗆			
Protection System:				1					Perform. Deficien	icies			
Condition Data:	Un	its	Exc.	Goo	od	Fair	Pod	or*					
	sq	.m	0.00	45.	0	43.5	1.	5	BCI TEV: 540.0	BCI CEV: 306.9			
Comments:	Medi	um pitti	ng. Det	teriorati	ion an	d alliga	tor crad	cked a	asphalt at north side	of west approach.			
Recommended work:									Maintenance Nee	ds:			
Comments													
Repave approaches.					□ 1 year, □ 2 year □ Urgent	S,							
Туре	Timing												
□ Rehab, □ Repair, ☑ Replace □ 1 - 5 years, □ Now < 1 year, □ 6 - 10 years, □ Urgent

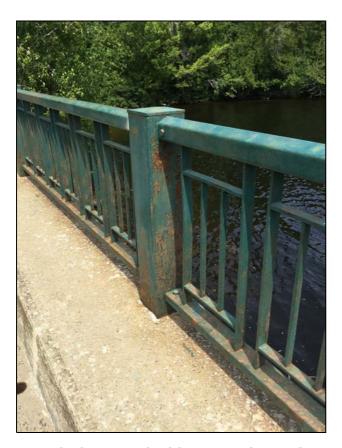
Description: North side, second post from the west Barriers / Hand Railings (North and South)

Location:	North and	South				Height:	1.1 (m)
Element Description:	Steel sheat	thed CIP of	concrete po	ost.		Count:	2
Material:	Steel					Total Quantity:	36.0 (m)
Element Type:						Not Inspected:	
Environment:	☐ Benign,	□ Modera	ate, ☑ Seve	ere		Limited Inspection:	
Protection System:	Galvanized	(Paint)				Perform. Deficiencies	
Condition Data:	Units	Exc.	Good	Fair	Poor*		
	m	0.00	31.0	5.0	0.00	BCI TEV: 3600.0	BCI CEV: 2525.0
Comments:	Overall fair north side				nd cracking o	n 3 of 8 posts: (2 centre pos	its on south side, 1 on
Recommended work:						Maintenance Needs:	
Comments							
Replace steel railing post cor	nponents.	☐ 1 year, ☐ 2 years,					
Tymo						3	
Туре	Timing						
Replace steel railing post cor		☐ 1 year, ☐ 2 years, ☐ Urgent

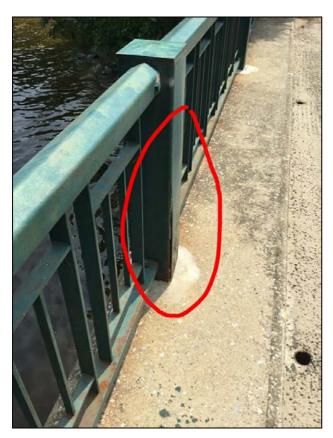
Description: North side second post from the west Barriers / Hand Railings (North and South)

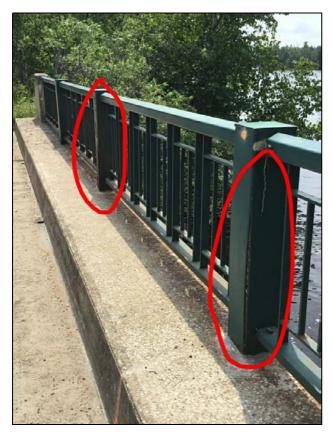
Description: Cracking of both centre posts on south side
Barriers / Hand Railings (North and South)

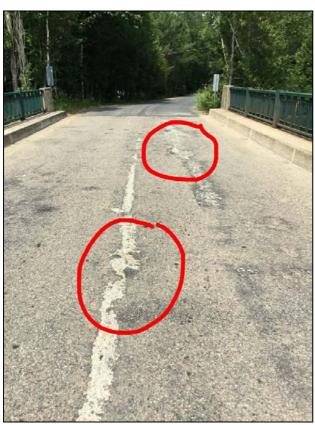
Decks / Deck Top (Top of deck under wearing surface.)

Description: Exposed concrete deck with spalls outlined

Element Group:	Decks					Length:					
Element Name:	Deck Top					Width:		7.8 (m)			
Location:	Top of ded	ck under w	earing su	rface.		Height:		(m)			
Element Description:	Cast-in-pla deck.	ace concre	ete on top	of laminate	ed wood	Count:		1			
Material:	Cast In Pla	ace Concre	ete			Total Qu	antity:	161.5 (se	q.m)		
Element Type:						Not Insp	ected:				
Environment:	☐ Benign,	□ Modera	ate, 🗹 Sev	ere	Limited	Inspection:	7				
Protection System:						Perform	. Deficiencies				
Condition Data:	Units	Exc.	Good	Fair	Poor*	09. Roug	h riding surface				
Condition Data:	sq.m	0.00	0.00	159.6	1.9	BCI TEV	: 19380.0	BCI CEV	7: 7660.8		
Comments:	Limited inspection due to overlaying wearing surface. Condition based on visible portions of deck top. Localized abrasions where asphalt has deteriorated. Overall fair condition.										
Recommended wor	k:		ance Needs:								
Comments											
Repair concrete.			□ 1 year	r, □ 2 years, t

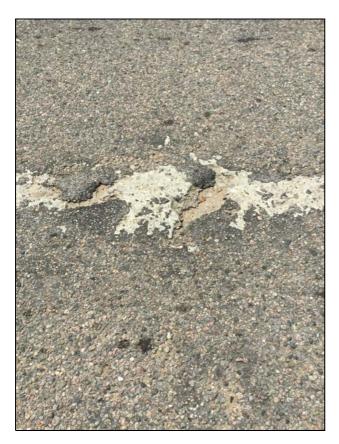
Decks / Deck Top (Top of deck under wearing surface.)

Description: East deck spall

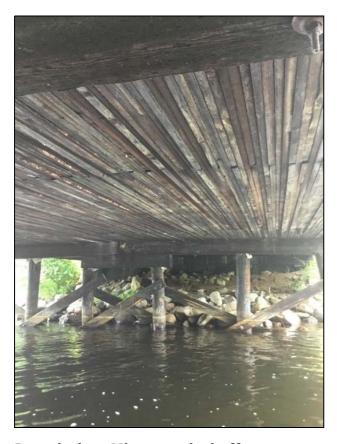
Decks / Soffit (Underside of Deck - Interior)

Description: Minor vertical offsets

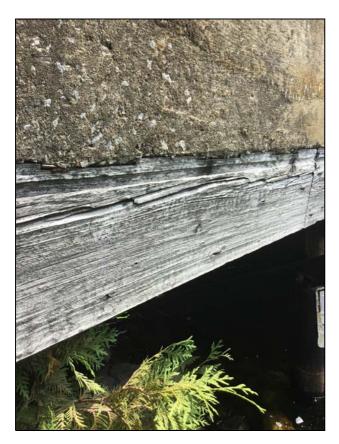
Decks / Soffit - Thin Slab (Exterior)

Description: Weathering and moderate cracks south side.

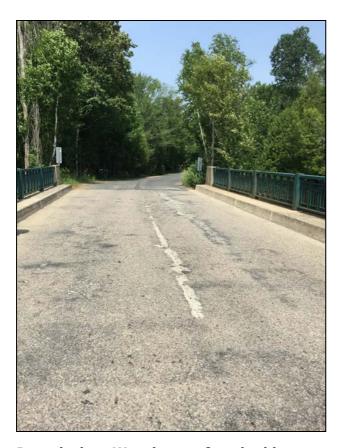
Decks / Wearing Surface (Top)

Comments:	Longitud	Longitudinal spalls, and potholes into the deck. Heavy ravelling throughout.											
Repave wearing surface 1 year, 2 years, Urgent	Recommended work:						Maintenance Ne	eds:						
Type	Comments													
Timing G Rehab, G Repair, G Peplace 21 - 5 years, G Now < 1 year, G - 10 years, G Peplace 6 - 1	Repave wearing surface							ars,						
Replace	The state of the s													
Element Name: Embankmerts Width: (m)														
Element Name: Embankmerts Width: (m)							T							
All quandris Height: (m)	Element Group:	Embankm	ents & St	reams			Length:	(m)						
Element Description:	Element Name:	Embankm	ents				Width:	(m)						
Material: Total Quantity: 4.0 (each) Element Type: Image: I	Location:	All quandr	ants.				Height:	(m)						
Not Inspected:	Element Description:	Vegetated	sandy so	oil with arm	our stone	at base	Count:	4						
Environment: □ Benign, □ Moderate, □ Severet Limited Inspection: □ Protection System: Perform. Deficiencies Condition Data: Units Exc. Good Fair Poor* Perform. Deficiencies each 0.00 3.0 0.00 1.0 BCI TEV: 4000.0 BCI CEV: 2250.0 Recommended work: Maintenance Needs: - Comments Provide erosion control at NE quadrant. Image: Provide erosion control at NE quadrant. □ 1 year, □ 2 years, □ Urgent Type Timing □ Rehab, □ Repair, □ 1 - 5 years, □ Now < 1 year, □ 6 - 10 years, □ 1 year, □ 2 years, □ Urgent	Material:						Total Quantity:	4.0 (each)

Description: Wearing surface looking east

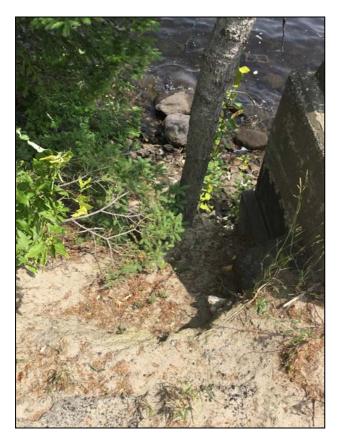
Embankments & Streams / Embankments (All quandrants.)

Comments: Runoff has deterior at least the embankment at northeast quadrant. Maintenance Needs:	Condition Data:	Units	Exc.	Good	Fair	Poor*								
Recommended work: Comments Provide erosion control at NE quadrant. Type Timing □ 1 year, □ 2 years, □ Urgent Urgent □ Rehab, □ Repair, □ 1 - 5 years, □ Now < 1 year, □ 6 - 10 years,		each	0.00	3.0	0.00	1.0	BCI TEV: 4000.0	BCI CEV: 2250.0						
Comments Provide erosion control at NE quadrant. □ 1 year, □ 2 years, □ Urgent Type Timing □ Rehab, □ Repair, □ 1 - 5 years, □ Now < 1 year, □ 6 - 10 years,	Comments:	Runoff has	deterior	ated the er	mbankmer	nt at northea	st quadrant.							
Provide erosion control at NE quadrant. □ 1 year, □ 2 years, □ Urgent Type ▼ Rehab, □ Repair, □ 1 - 5 years, □ Now < 1 year, □ 6 - 10 years,	Recommended work:						Maintenance Nee	eds: -						
Type Timing □ Urgent ☑ Rehab, □ Repair, □ 1 - 5 years, □ Now < 1 year, □ 6 - 10 years,	Comments

Description: Northeast erosion

Type Timing ☑ Rehab, □ Repair, □ 1 - 5 years, □ Now < 1 year, □ 6 - 10 years,	Provide erosion control at NE qu			rs,										
	Туре	Timing					u orgeni

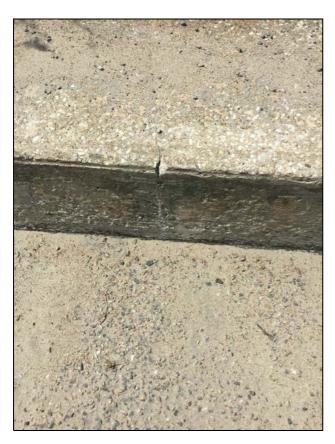
Sidewalks/curbs / Curbs (North and South)

Description: Narrow crack nw corner

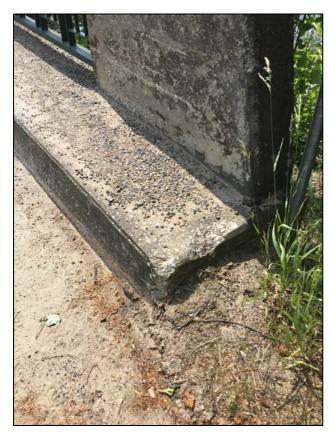
Sidewalks/curbs / Curbs (North and South)

Description: Scraping / impact damage northeast corner.

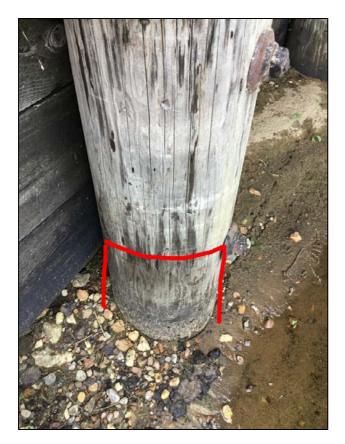
Piers / Shafts/columns/Pile Bents (East and west and mid span x 2)

Description: Typical area of minor rot, south side.

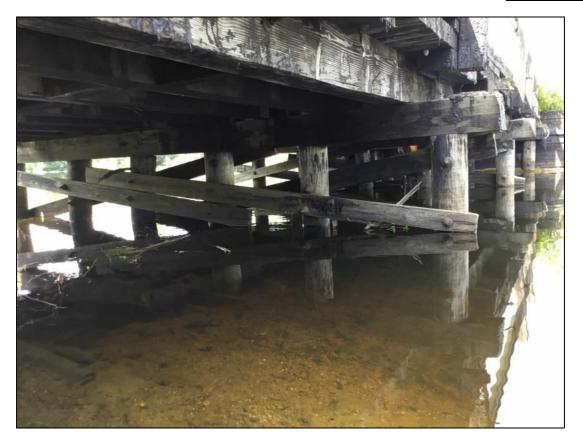
Description: General conditions.

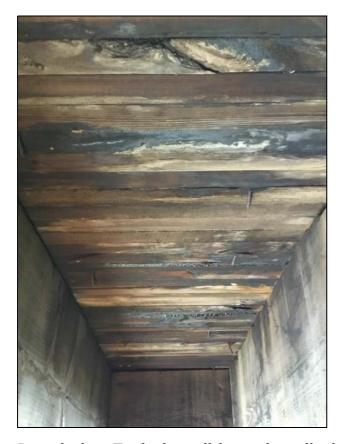
Description: Typical condition, minor displacement. No sign of rot or seepage.

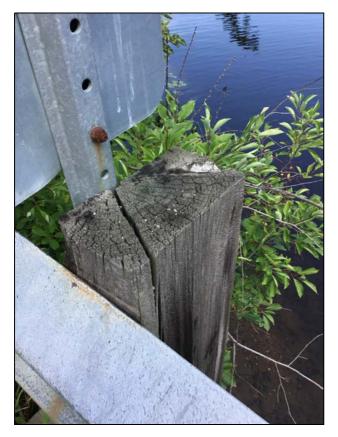
Description: Northwest railing post split.

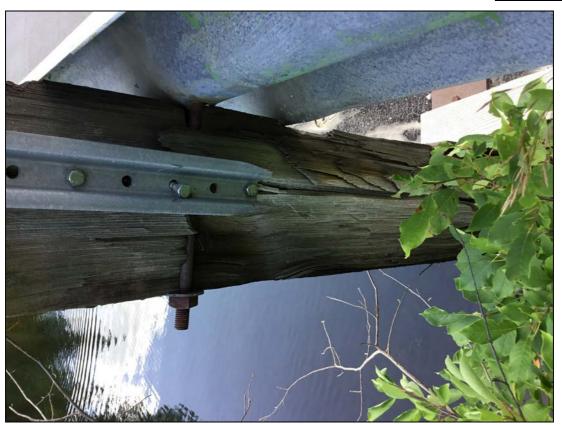
Description: Post checked and bolt exposed.

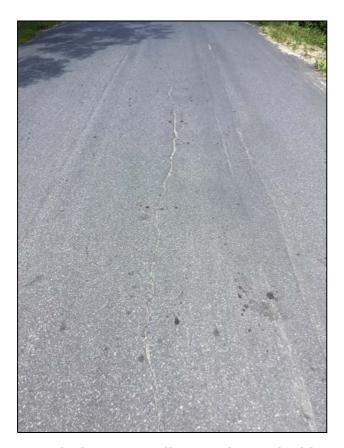
Description: Centerline crack, north side.

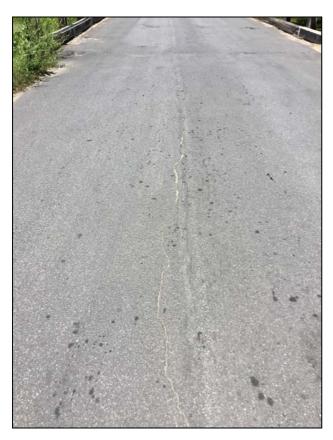
Description: Centerline crack, south side.

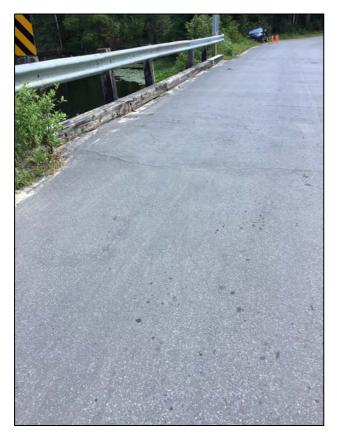
Description: Settling and bump at transition north side.

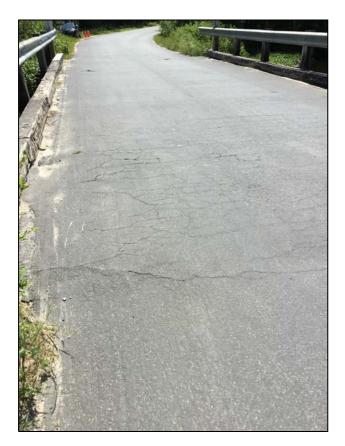
Description: Northwest, map cracks and rippling.

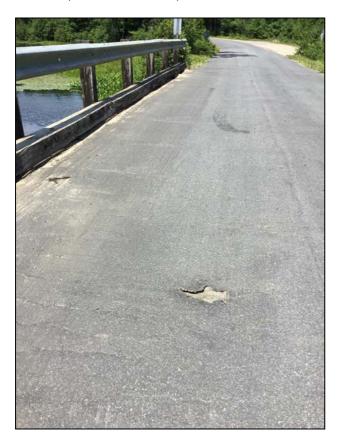
Description: Sink hole on east side.

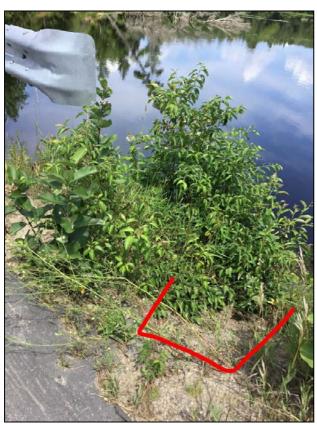
Description: Northeast quadrant erosion.

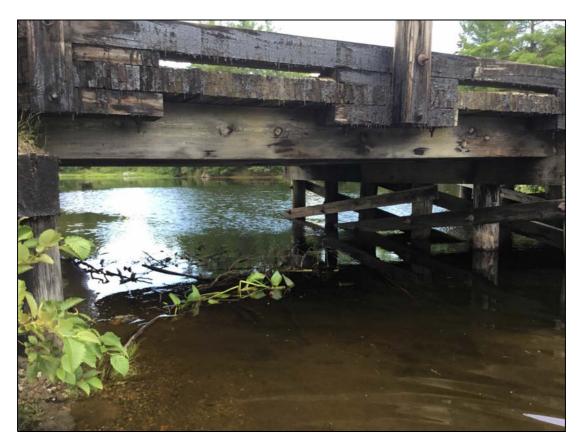
Description: Obstructed flow in north section, similar obstruction of south section. Middle is clear.

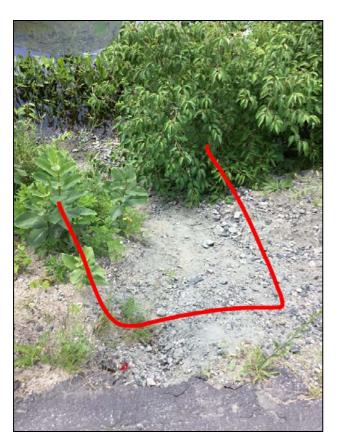
Description: Southwest quadrant erosion.

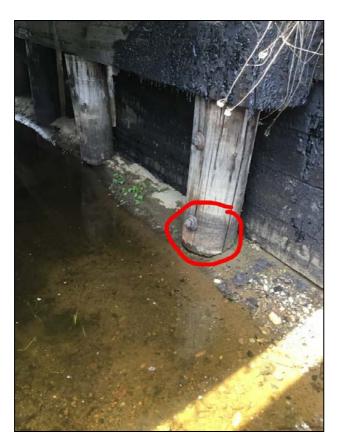
Description: Occurrence of minor rot at all abutment piles lower segment of abutment pile.

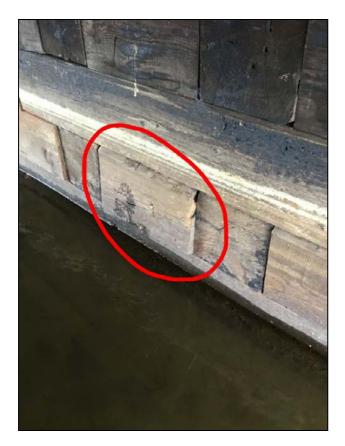
Description: West abutment midspan, shaked, split and loose Abutments / Abutment Walls

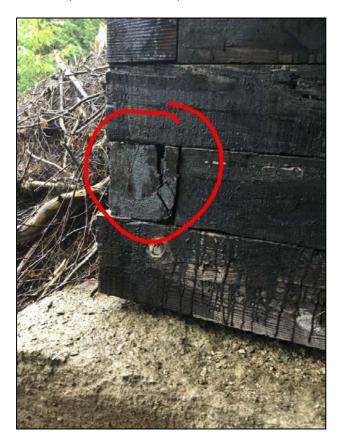
Description: Split on north side of east abutment
Abutments / Abutment Walls

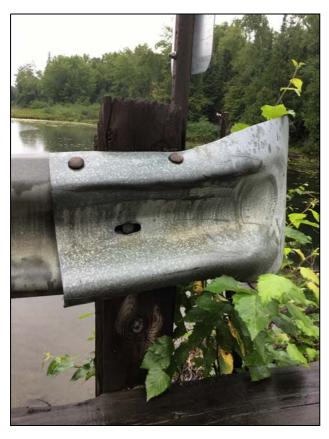
Description: NE fishtail needs to be fastened.

Ontario Structu	ıre Inspectio	on Manua	l — Inspe	ction For	m				Bridge ID:		DY-10	
Element Group:	Barriers						Len	gth:		8.0 (m)		
Element Name:	Railing Sys	stems					Wid	th:		(m)		
Location:	E/W						Hei	ght:		(m)		
Element Description:							Cou	nt:		2		
Material:	Steel						Tota	al Quantity	':	16.0 (m)		
Element Type:							Not	Inspected	:			
Environment:	☐ Benign,	□ Modei	ate, ☑ Se	evere			Lim	ited Insped	ction:			
Protection System:	Galvanized	alvanized Creosote Perform. Defic						form. Defic	iencies			
Condition	Units	Exc.	Good	d Fai	r Poo	r*						
Data:	m	0.00	16.0	0.0	0.0	0	всі	TEV: 3200.	0	BCI CEV: 2	400.0	
Comments:	Guiderail in good condition with minor corrosion and minor deflection. Posts have minor cracking, splits and checks N/E quadrant end connection bolt requires refastening.										its and checks.	
Recommended work: Maintenance								ntenance l	Needs: 17. Other			
Type Timing Fas							☑ 1 year, □ 2 years, □ Urgent Fasten fishtail terminal end to SBGR at northeast quadrant.

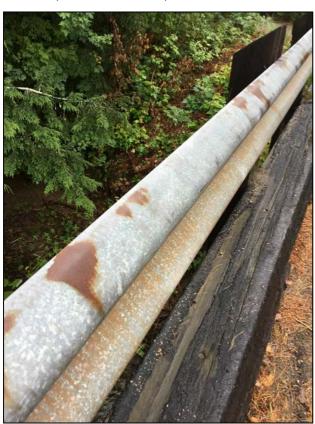
Description: Light corrosion/staining (typical condition).

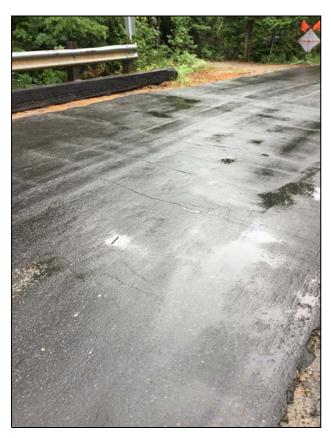
Description: Narrow cracks and rippling.

Ontario Structure Inspection Mar		Bridge ID: DY-10					
Repair and Rehabilitation Re	quired	Priority			Estimated		
Element	Repair and Rehabilitation Required	> 10 years	6 - 10 years	1 - 5 years	Now < 1 year	Urgent	Cost
Deck, Wearing Surface	Repave deck wearing surface.			✓			\$10,000.00

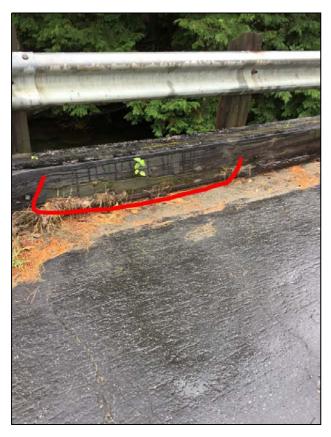
Description: Minor rot segment located at the southeast quadrant.

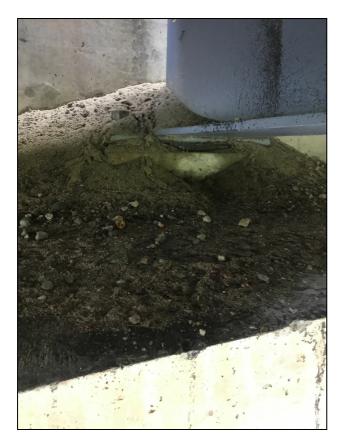
Description: South wall, sediment is washing down from above and accumulating around the bearing on the bearing seat from a defective joint fill above.

Repair and Rehabilitation Re		Estimated					
Element	Repair and Rehabilitation Required	> 10 years	Urgent		Urgent	Cost	
Joint Seal	Replace joint seal.				✓		\$5,000.00
Slope Protection	Add slope protection as needed.			✓			\$5,000.00
						Total	\$10,000.00

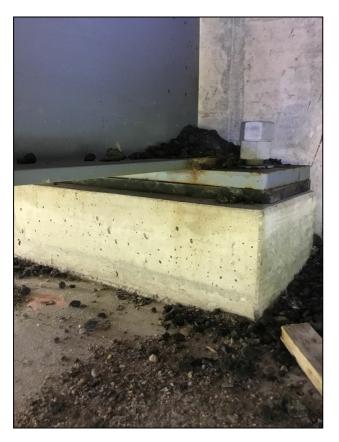
Description: Bearing seat, typical condition. Abutments / Abutment walls (Bearing Surface)

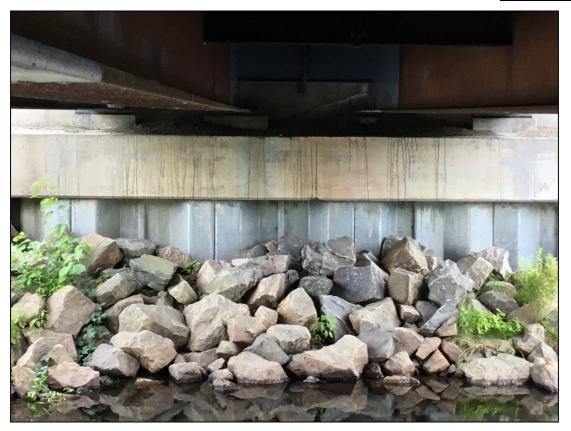
Description: South wall, general condition.

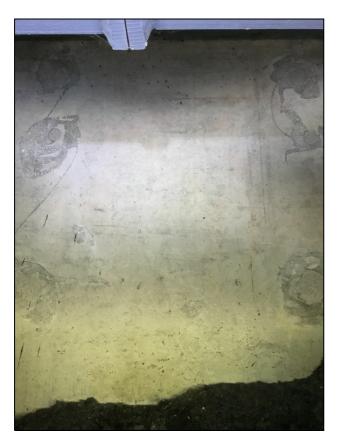
Description: North wall, typical condition.

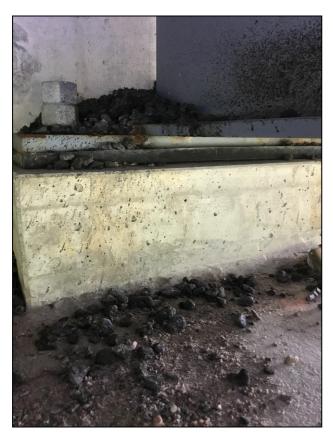
Description: Minor compression and displacement, northeast bearing #2.

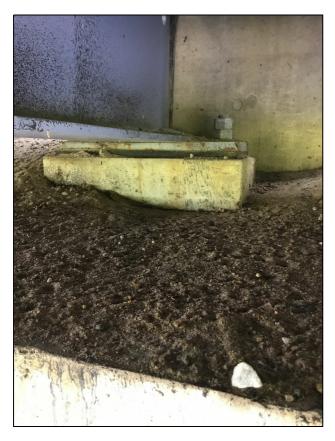
Description: South bearing, typical condition.

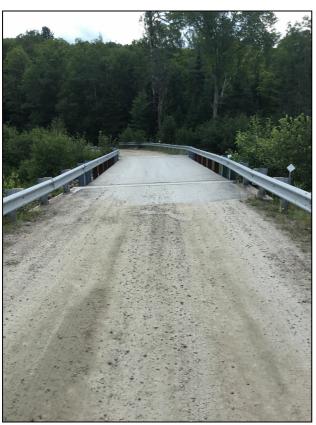
Description: North approach looking south, settling before asphalt, and potholes seen in northeast wheel track

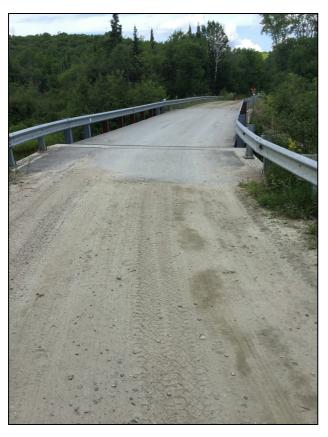
Description: South approach looking north, settling prior to asphalt, and pothole in southeast wheel track.

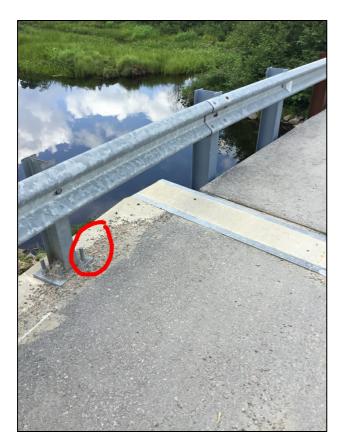
Description: One (1) missing nut from steel post of southwest quadrant prior to bridge deck

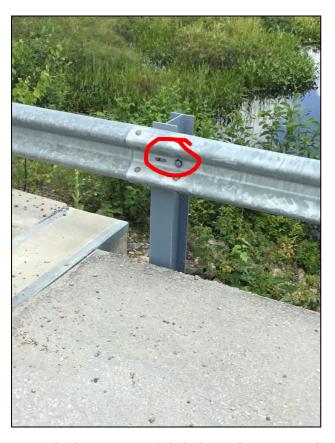
Description: Loose (right), and not attached(left) bolts at farthest northeast post on bridge deck.

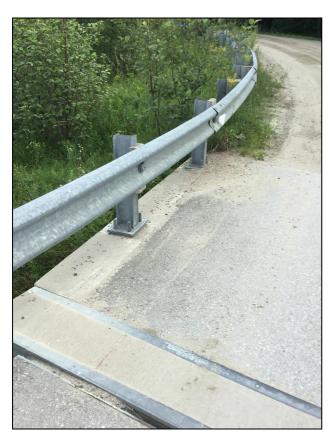
Description: Three (3) nuts missing from southeast post prior to bridge deck. Barriers / Railing Systems (E / W) $\,$

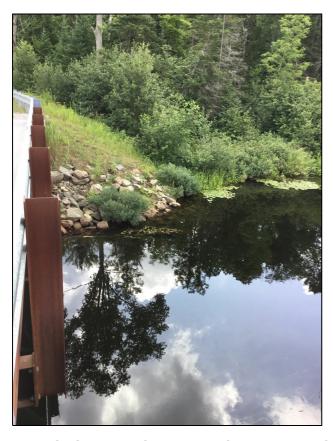
Description: Southwest quadrant, general conditions.

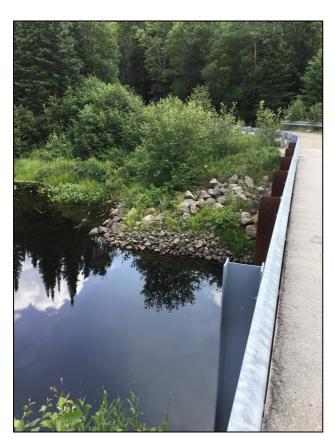
Description: Southeast quadrant, general conditions.

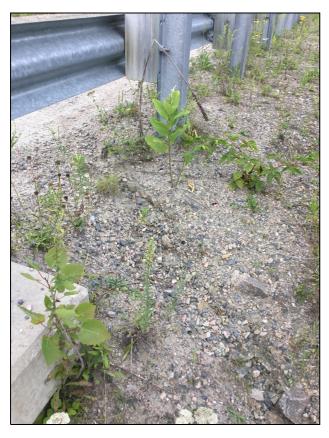
Description: Start of washout at northeast quadrant, add slope protection.

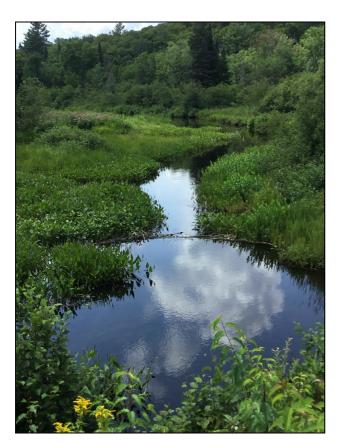
Description: Two beaver dams downstream.

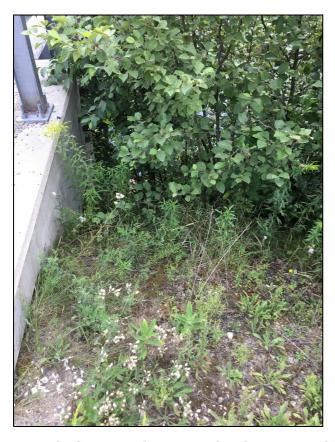
Description: Northwest embankment, stable.

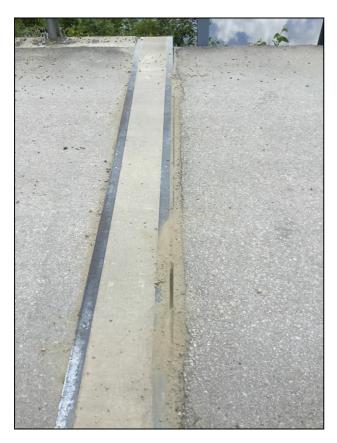
Description: North joint full of sediment, no sign of seepage on bearing seat.

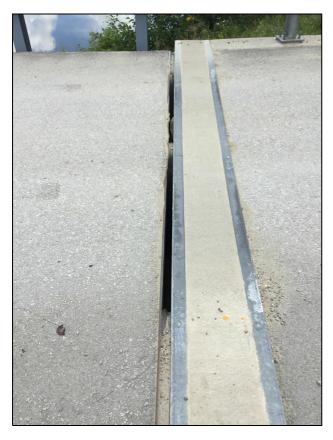
Description: South joint freely draining to bearing seat, sediment accumulating.

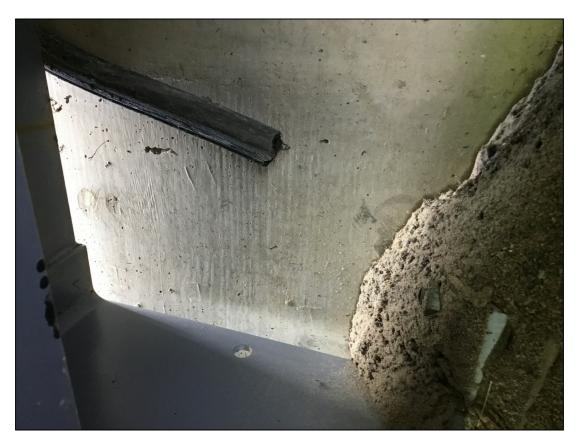
Description: South expansion joint seal has fallen out of joint gap.

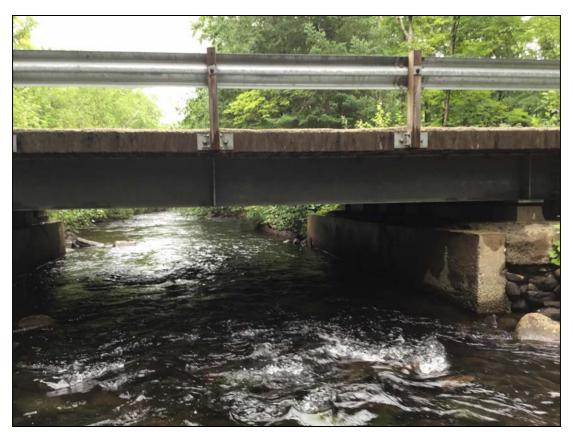
Description: West exterior soffit, slight deflection and movement of deck boards visible.

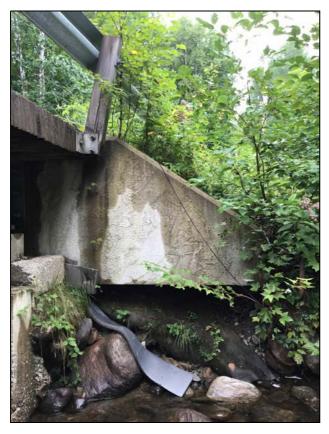
Description: Severe undermining of northeast wingwall.

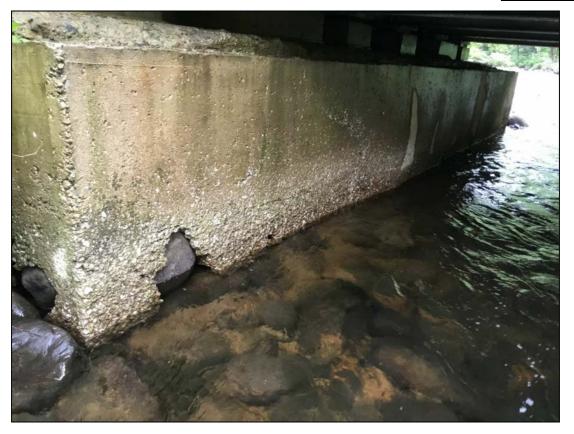
Description: South abutment showing cold joint at footing and mild to severe scaling to 0.4m from water level.

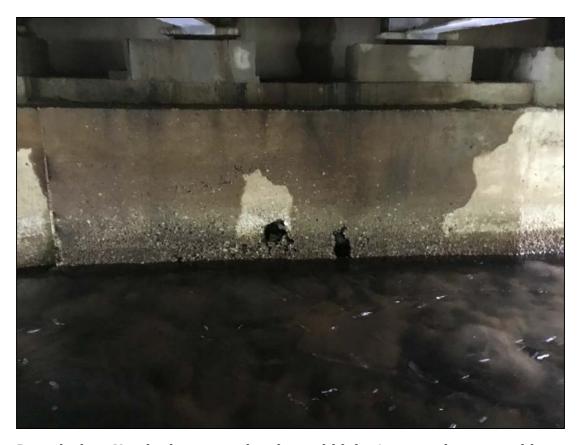
Description: North abutment showing cold joint \setminus severe honeycombing, and general scaling 0.4m up abutment wall from water level.

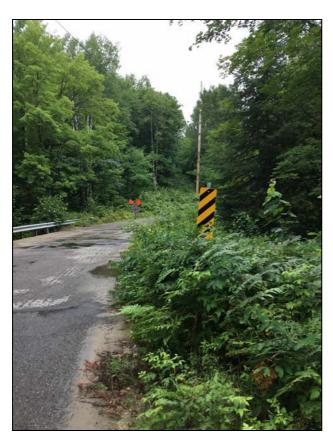
Description: Warning sign obscured by overgrown vegetation at time of inspection.

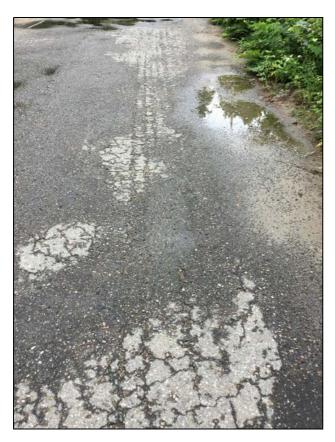
Description: Southeast quadrant, alligator cracking.

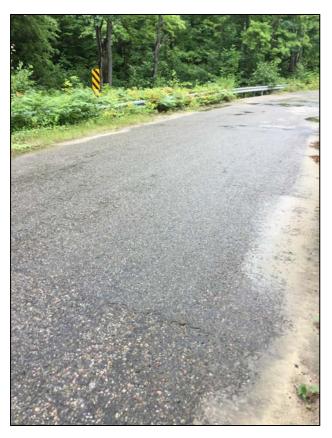
$\label{lem:potholes} \textbf{Description: South approach, settling} \setminus \textbf{pot holes starting at bridge joint.} \\ \textbf{Approaches} \ / \ \textbf{Wearing surface}$

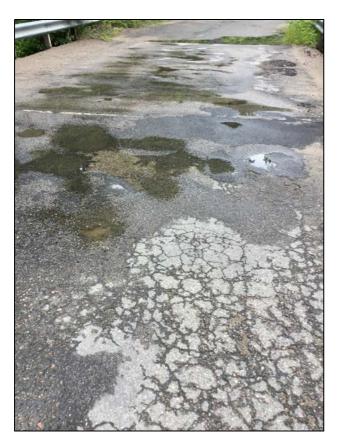
Description: Patching and settling detail.

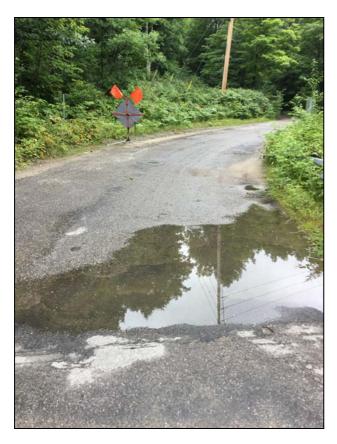
Description: North approach showing large area of ponding.

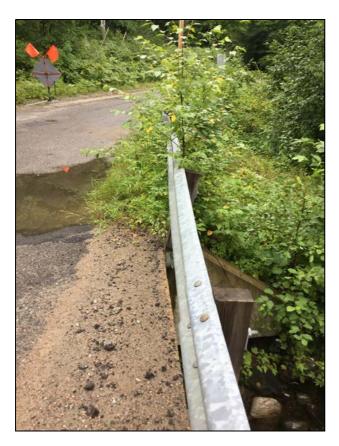
Description: Impact damage northeast edge of deck.

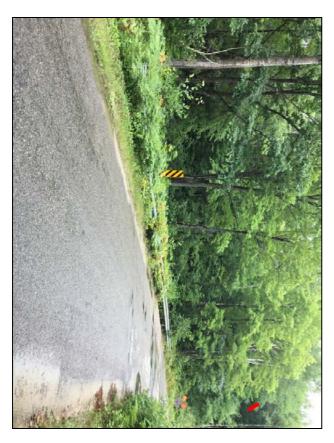
Description: West railing system, obstructed by overgrown vegetation.

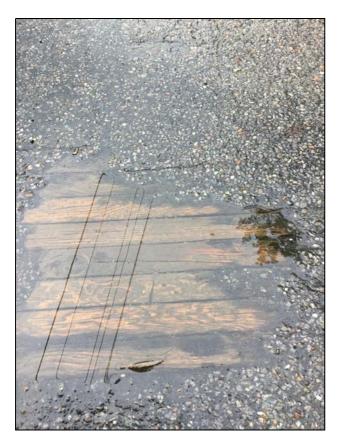
Description: Wearing surface worn away to exposed deck top. Limited inspection based on worn away areas.

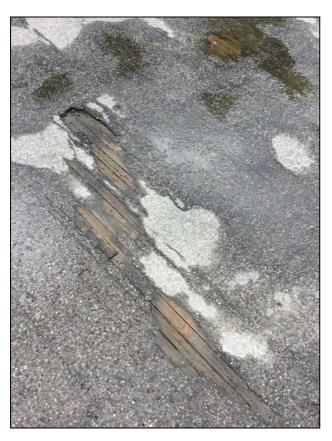
Description: Wear to visible deck top, requires padding.

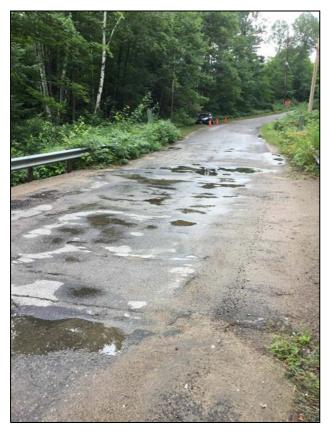
Description: General condition of deck wearing surface poor.

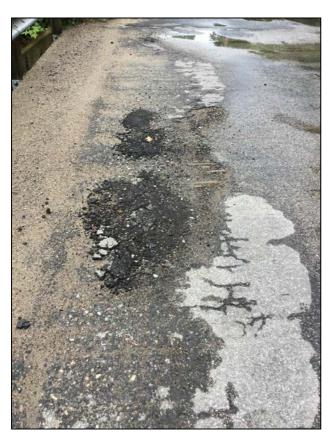
Description: Patch mounding and overall rough riding surface.

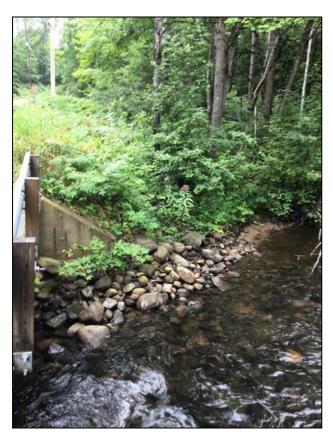
Embankments & Streams / Slope Protection (NE/NW/SE/SW)

Description: Southwest quadrant, general conditions.

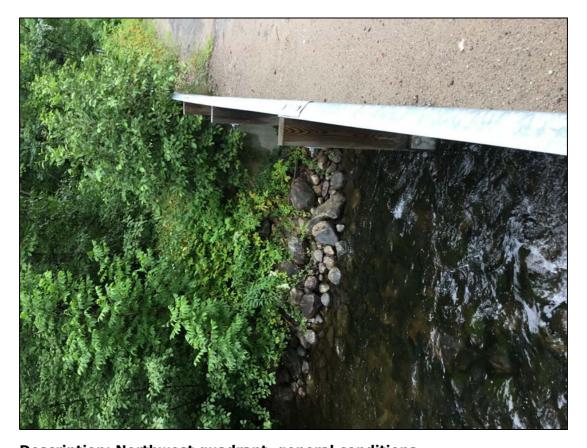
Embankments & Streams / Slope Protection (NE/NW/SE/SW)

Description: Northwest quadrant, general conditions.

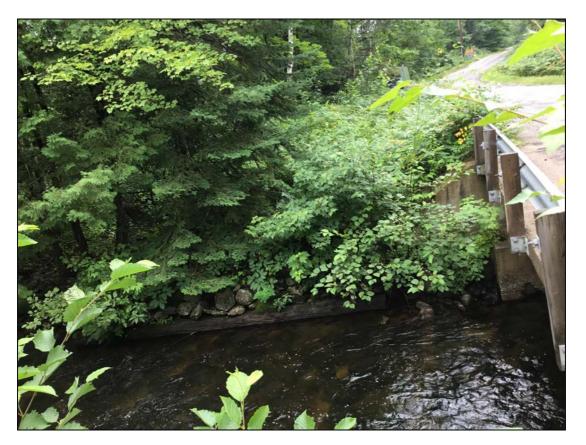
Embankments & Streams / Slope Protection (NE/NW/SE/SW)

Description: Southeast quadrant, general conditions.

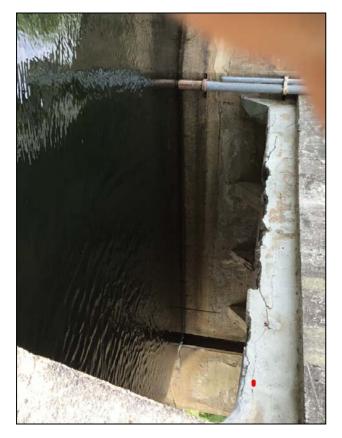
Abutments / Abutment Walls (East and west)

Description: East abutment, medium transverse crack at high waterline midway up abutment wall.

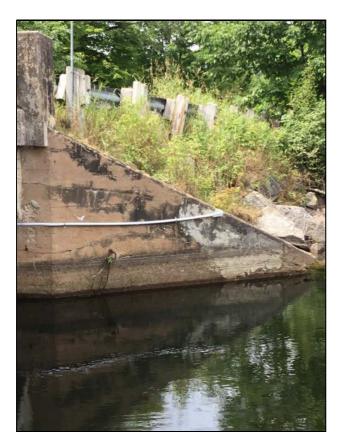
Abutments / Wingwalls (SE/SW only)

Description: NW wingwall with utility conduit attached, general conditions.

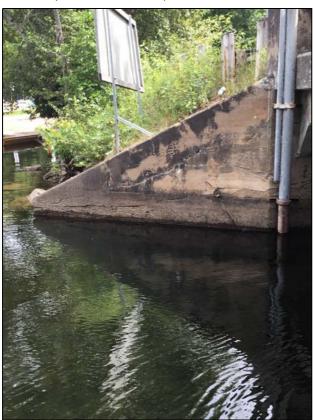
Abutments / Wingwalls (SE/SW only)

$\label{eq:Description: NE wingwall, scaling throughout waterline.} \\$

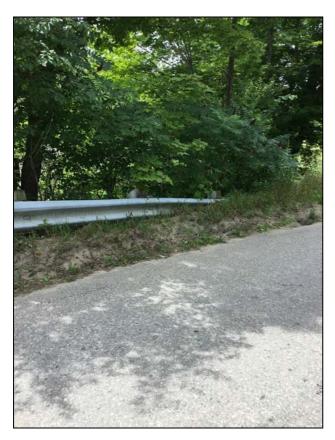
Barriers / Railing Systems (Double guiderail across structure and approach)

Description: Build up of winter sand.

Туре	٦	Γiming				Remove vegetation and winter sand.		
☑ Rehab, ☐ Re ☐ Replace		☑ 1 - 5 yea ⁄ears, □ U	ars, 🗆 Now rgent	< 1 year,	□ 6 - 10	333.

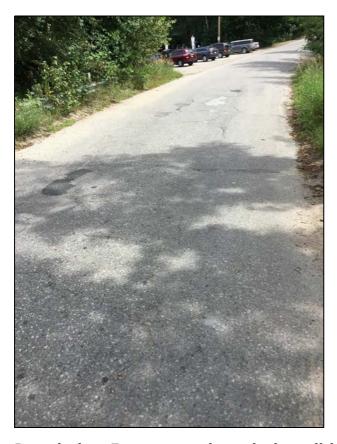
Approaches / Wearing Surface

Description: East approach, typical conditions. Transverse cracks, pothole patching and narrow to medium cracking.
