BIENNIAL BRIDGE INSPECTIONS

FINAL INSPECTION REPORT Municipality of Dysart et al

December 2018

File No. 18-4011

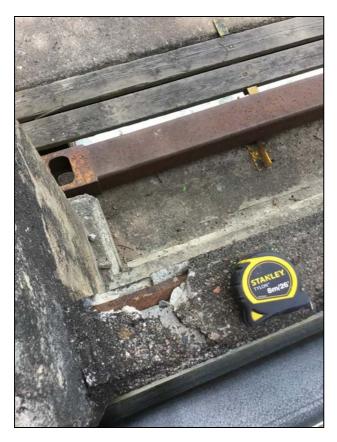
Barriers / Barrier/Parapet Walls

Description: Localized spalling exposing reinforcement bar.

Element Name: Location: Element Description: Material: Element Type: Environment: Protection System: Condition Data: Comments: Recommended work: Comments Patch spall at south east corner	Timing	Cast-In-Concret Units sq.m Concret	Parapet Place Conte Balustingn, Modes Executed 0.00	ncrete rade derate, 🗹 :	0 lition	Fair 14.0 with mo	0.00	*	Width: Height: Count: Total Quantity: Not Inspected: Limited Inspection: Perform. Deficiencie BCI TEV: 1400.0 ere spalling in localized Maintenance Needs:	(m) 1.0 (m) 2 14.0 (sq.m) □ s BCI CEV: 560.0 areas.

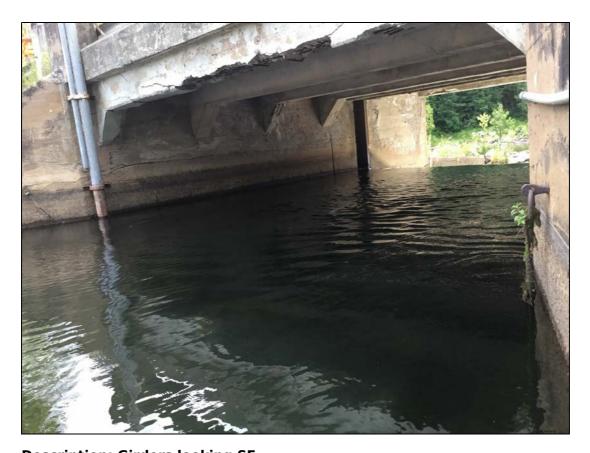
Beams/Main Longitudinal Elements / Girders (E/W Direction)

Description: Girders looking SE.

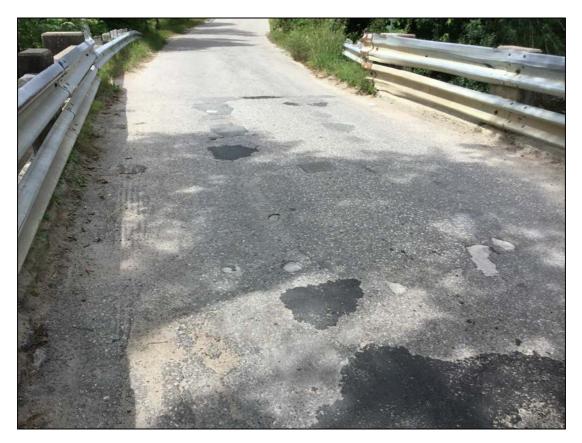
Decks / Wearing Surface

Description: General conditions, facing west.

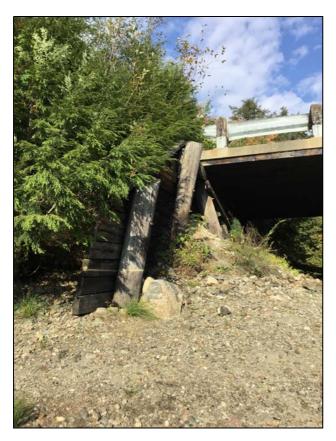
Abutments / Ballast walls

Description: Inward rotation, northwest.

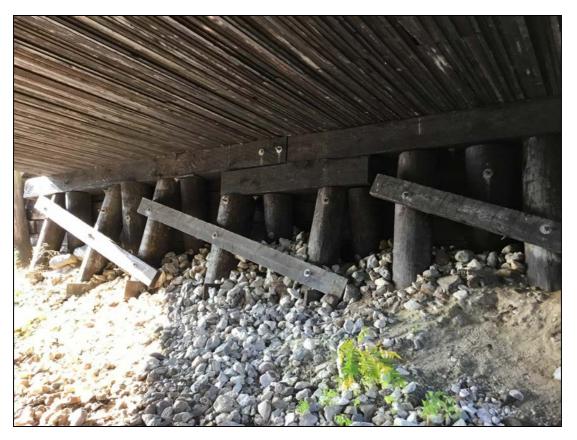
Abutments / Ballast walls

Description: North, general condition.

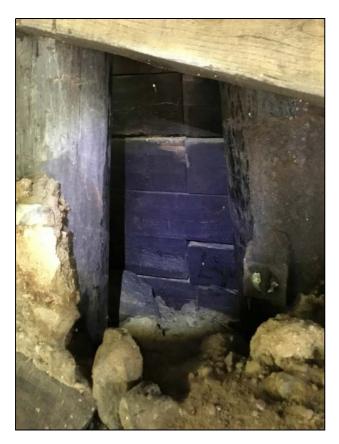
Abutments / Ballast walls

Description: Typical condition detail from south wall.

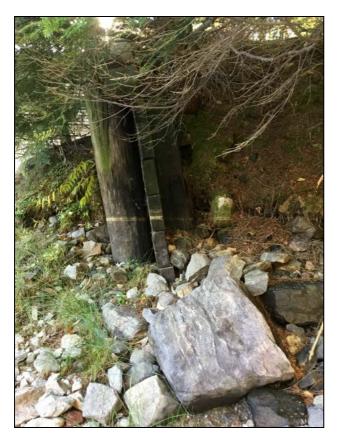
Abutments / Ballast walls

Description: Inward rotation, northeast.

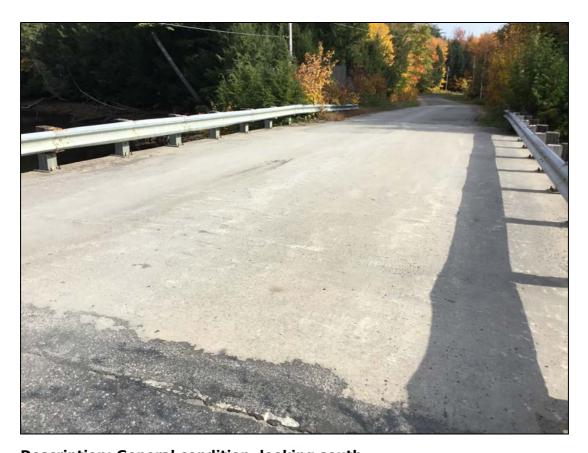
Decks / Deck Top

Description: General condition, looking south.

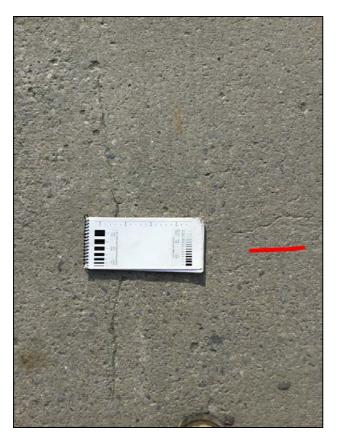
Decks / Deck Top

Description: Typical narrow cracks.

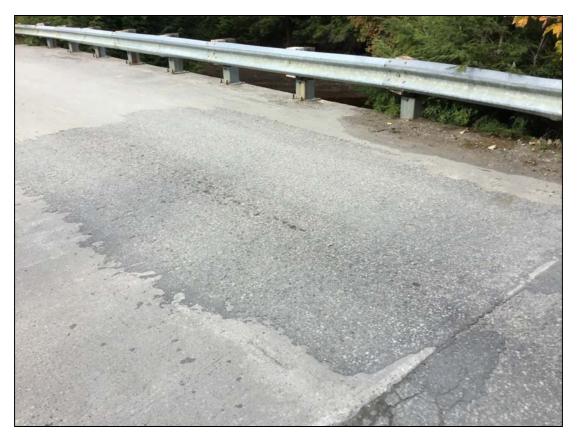
Decks / Wearing Surface

Description: Asphalt wearing surface southeast corner.

Repair and Rehabilitation Re							
Element	Element Repair and Rehabilitation Required			1 - 5 years	Now < 1 year	Urgent	Estimated Cost
Approaches	Repave.		✓				\$20,000.00
Guiderail / Railing	Replace end treatments and damaged posts.					✓	\$25,000.00
Total

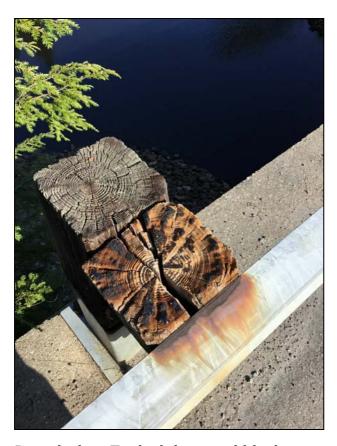
Barriers / Railing Systems (Approach and deck.)

Description: Typical damaged block.

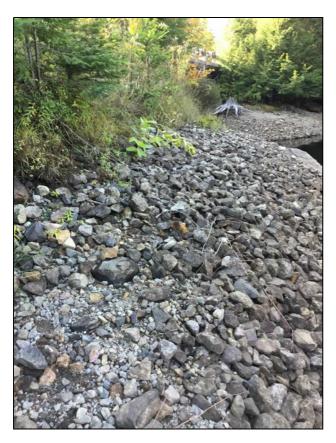
Embankments & Streams / Embankments

Description: Southeast, typical embankment protection.

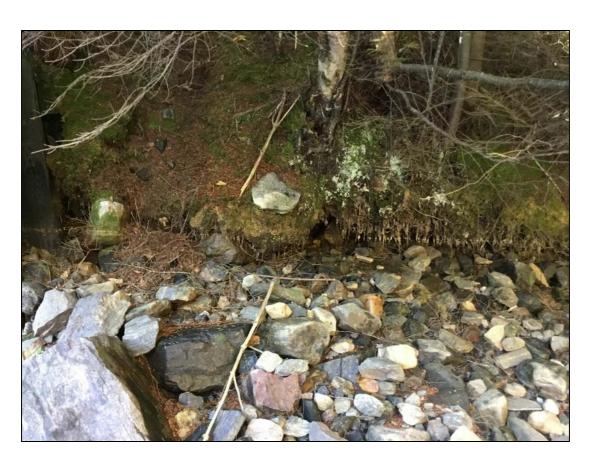
Embankments & Streams / Embankments

Description: Undermining at northeast

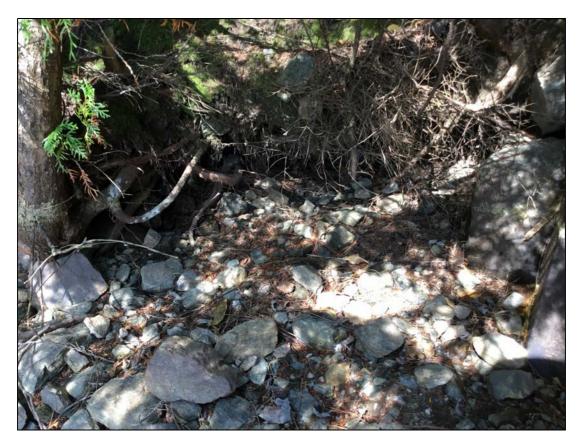
Embankments & Streams / Embankments

Description: Undermining at high water mark with overlaying root mat at northwest quadrant.

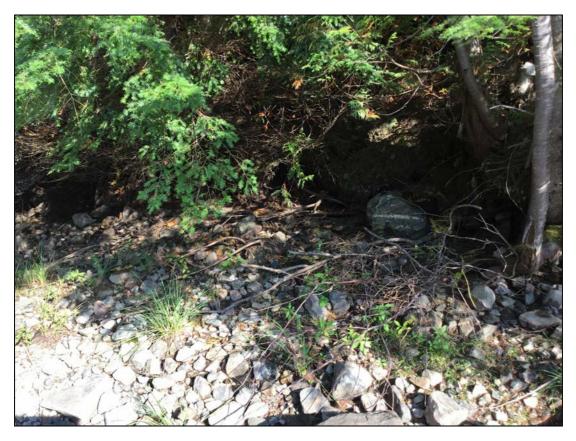
Embankments & Streams / Embankments

Description: Minor undermined root mat at southwest quadrant.

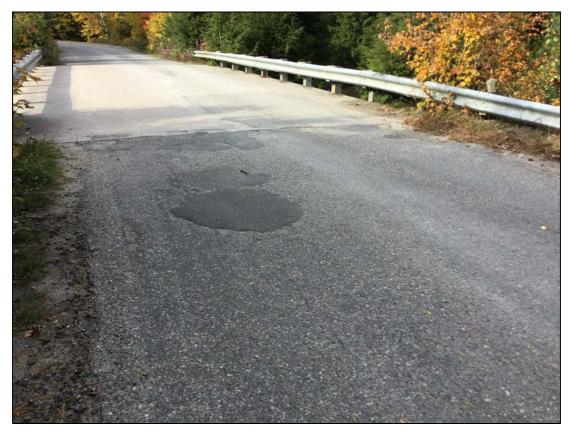
Approaches / Wearing surface

Description: South approach, general condition.

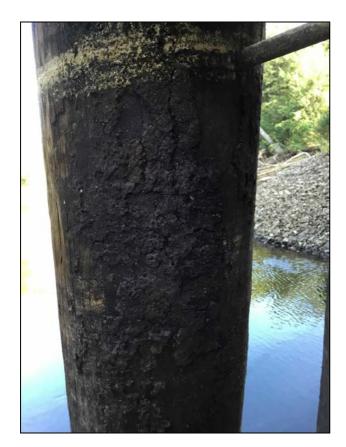
Piers / Shafts/columns/Pile Bents

Description: Area of rot at northeast armour pile.

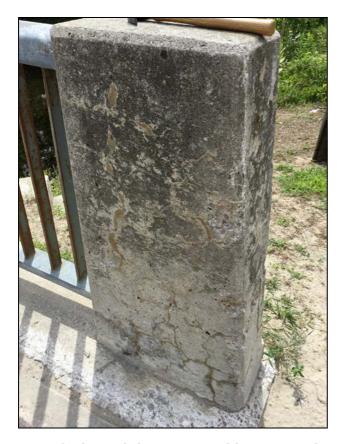
Barriers / Barrier/Parapet Walls (Interior.)

Description: Light map cracking at northwest parapet.

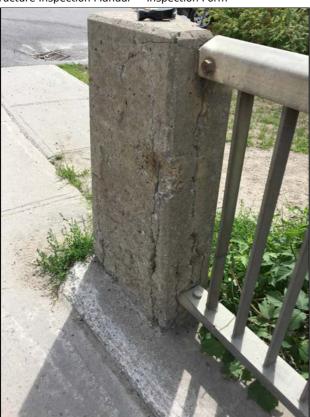
Barriers / Barrier/Parapet Walls (Interior.)

Description: Narrow to wide cracks at southwest parapet.

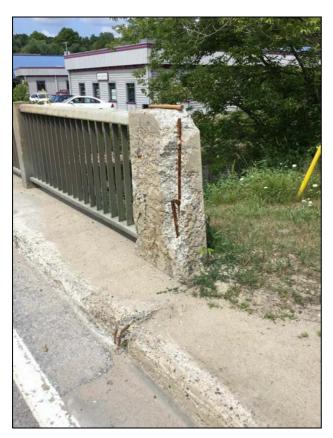
Barriers / Barrier/Parapet Walls (Interior.)

Description: Large spall at top of southeast parapet.

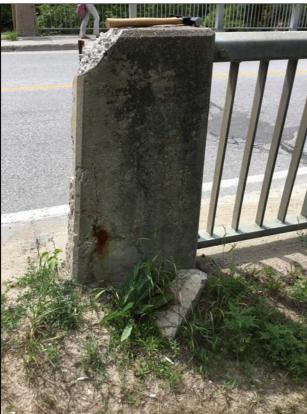
Barriers / Barrier/Parapet Walls (Interior.)

Description: Northeast parapet showing severe spall and exposed reinforcement bar.

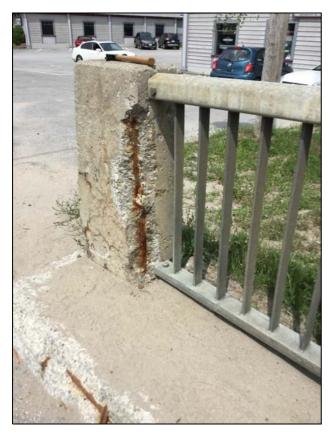
Barriers / Barrier/Parapet Walls (Interior.)

Description: Northeast exterior parapet, map cracking.

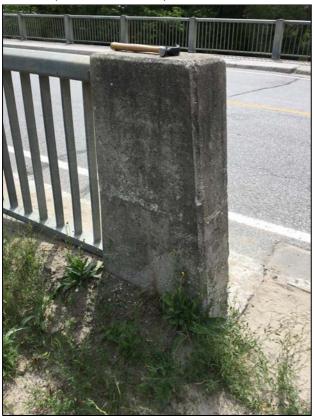
Barriers / Barrier/Parapet Walls (Exterior)

Description: Exterior of northwest parapet.

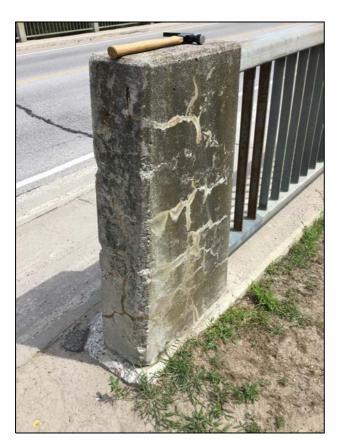
Barriers / Barrier/Parapet Walls (Exterior)

Description: Exterior of southwest parapet, narrow crack at base.

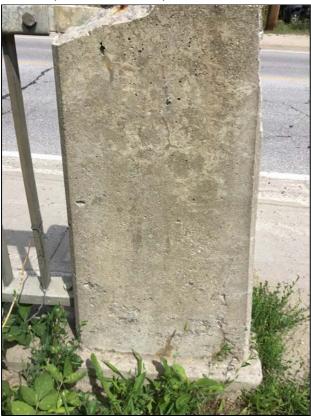
Barriers / Barrier/Parapet Walls (Exterior)

Description: Large spall at the northeast side.

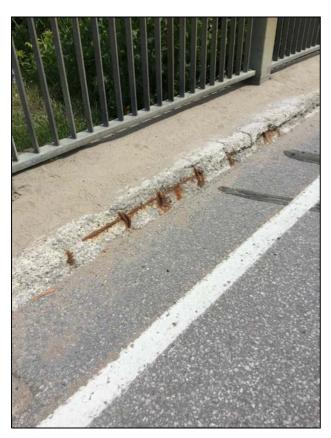
Sidewalks/curbs / Curbs (East and west)

Description: Typical abrasion, east side.

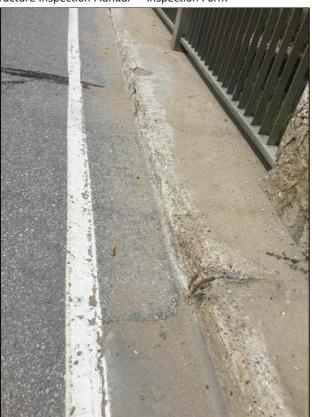
Sidewalks/curbs / Curbs (East and west)

Description: West curb, typical condition.

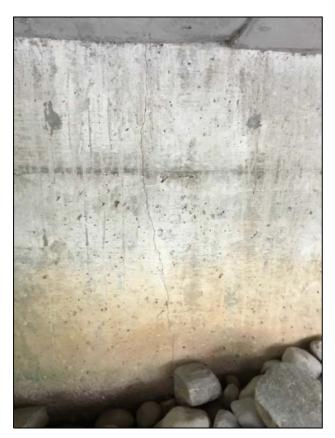
Abutments / Abutment walls (North and south)

Description: South abutment, typical scaling.

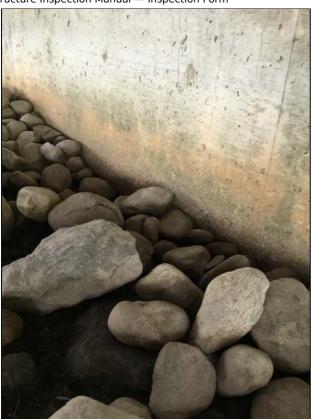
Abutments / Abutment walls (North and south)

Description: South approach at joint.

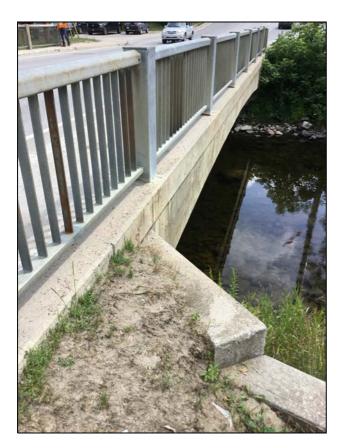
Barriers / Railing Systems (East and west)

Description: Light corrosion/staining.

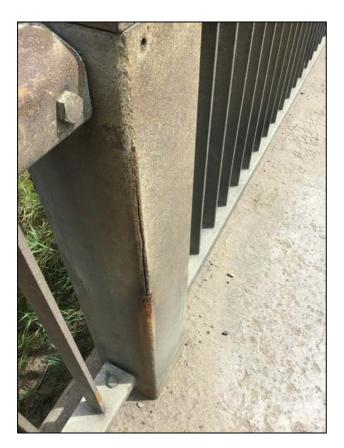
Barriers / Railing Systems (East and west)

Description: Grout wear and corrosion at joint to deck.

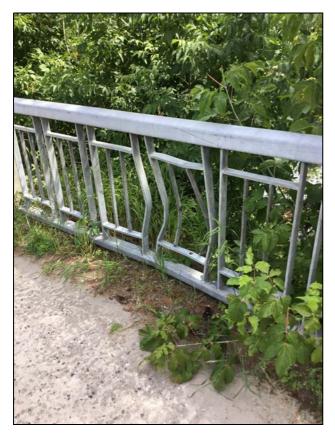
Barriers / Hand Railings (South)

Description: Missing caps on railing system. **Barriers / Hand Railings (South)**

Element Name:	Hand R	ailings					Wid	th:	(m	n)
Location:	South						Heig	ght:	1.2	(m)
Element Description:	South s	ide only.					Cou	nt:	1	
Material:	Steel						Tota	al Quantity:	27.	7 (m)
Element Type:							Not	Inspected:		
Environment:	□ Beni	ʒn, □ Mo	derate, 🗵	Severe			Limi	ited Inspection:		
Protection System:							Perf	form. Deficiencies		
Condition Data:	Unit	s Exc	c. Go	ood Fa	air	Poor*				
Condition Bata.	m	0.0	0 2	3.8 3	.1	0.8	ВСІ	TEV: 2770.0	ВСІ	I CEV: 1909.0
Comments:	Caps m	issing on	seven p	osts. Impad	t dama	age on so	utheas	st side.		
Recommended wo	rk:						Mai	ntenance Needs: 03. Bridg	ge Ha	andrail Maintenance
Comments Replace								year, □ 2 years, Irgent		
Туре	т	iming					Clea	an debris and vegetation are	ound	handrail to promote
□ Rehab, □ Repair,☑ Replace		l 1 - 5 yea ears, □ U		w < 1 year	r, □ 6 -	10	prop	per surface water drainage.	Insta	all top caps.

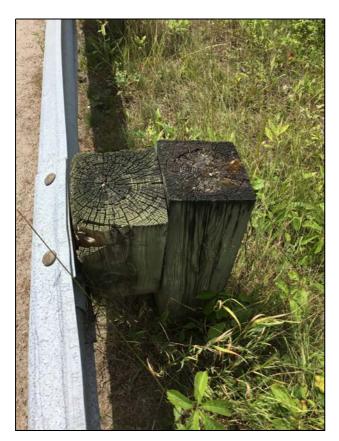
Description: Rotten post.

Ontario Structure Inspection Manual -	– Inspectior	n Form				Bridge ID:	DY-16				
Element Group:	Barriers					Length:	(m)				
Element Name:	Posts					Width:	(m)				
Location:	North side	e only.				Height:	(m)				
Element Description:						Count:	30				
Material:	Wood					Total Quantity:	30.0 (each)				
Element Type:						Not Inspected:					
Environment:	□ Benign,	. 🗆 Moder	ate, ☑ Seve	ere		Limited Inspection:					
Protection System:						Perform. Deficienci	es				
Condition Pales	Units	Exc.	Good	Fair	Poor*						
Condition Data:	each	0.00	14.0	8.0	8.0	BCI TEV: 6000.0	BCI CEV: 2740.0				
Comments:	Several po	osts rotte	n, checking	, and spli	t. Light to m	edium splits throughout					
Recommended work:	•					Maintenance Needs	5:				
Comments											
Replace rotten wood posts						\square 1 year, \square 2 years,					
						□ Urgent					
Type Timing											
I Renan Renair √ Reniace	- 5 years, □ gent	Now < 1	year, □ 6 -	10 years	5,

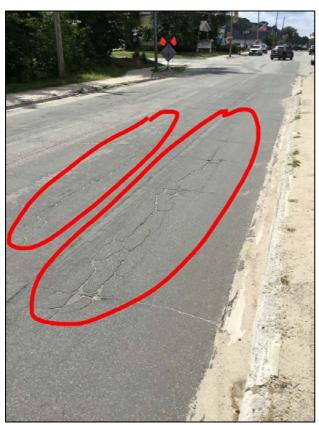
Decks / Wearing Surface (Top)

Description: Patched potholes and surrounding in south lane are cracking and and ravelling severely.

Repair and Rehabilitation Re	quired			Priority			Fatimatad
Element	Repair and Rehabilitation Required	> 10 years	6 - 10 years	1 - 5 years	Now < 1 year	Urgent	Estimated Cost
Deck Wearing Surface	Repave deck wearing surface at next major rehabilitation.		1				\$10,000.00
Approach Wearing Surface	Repave approaches at next major rehabilitation.		1				\$10,000.00
Curb / Sidewalk (south)	Replace curb and sidewalk.			✓			\$20,000.00
Barrier Steel Beam Guide Rail	Replace.			✓			\$20,000.00
Handrail	Replace.			✓			\$20,000.00
		_		_	_	Total	\$80,000.00

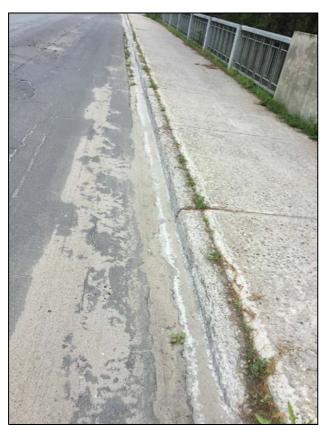
Sidewalks/curbs / Curbs (North and south)

Description: South curb, general conditions.

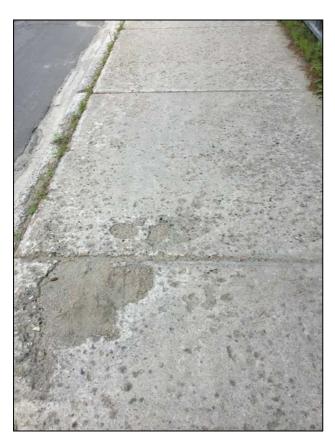
Sidewalks/curbs / Curbs (North and south)

Description: South sidewalk pot hole and general wear.

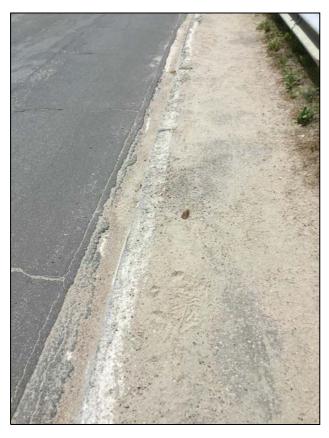
Sidewalks/curbs / Curbs (North and south)

Description: Abrasion damage to north side curb.

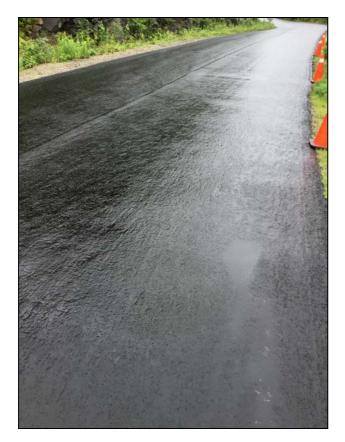
Approach / Wearing Surface (N/S)

Description: West approach wearing surface, general condition.

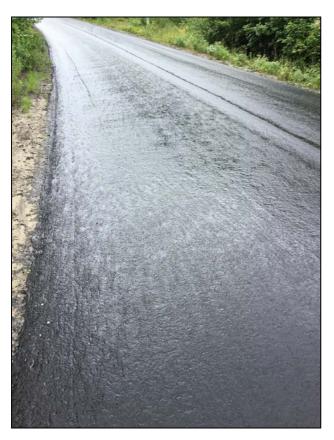
Approach / Wearing Surface (N/S)

Description: East approach wearing surface, general condition.

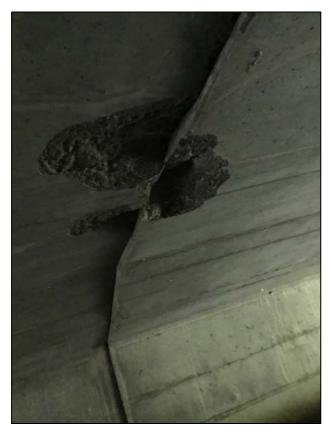
Description: Spall at third to the south section joint.
Culverts / Barrels

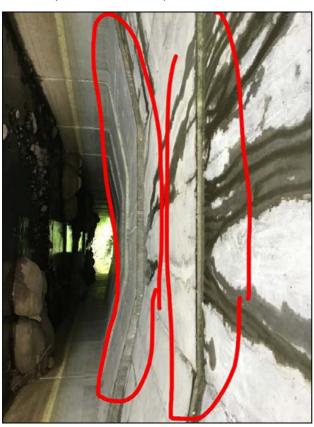
Description: Seepage, through furthest 2 section joints to the north Culverts / Barrels

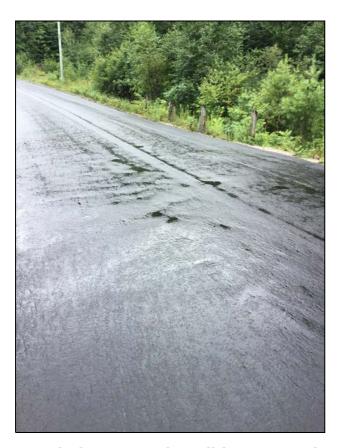
Decks / Wearing Surface (Top)

Description: General condition, some minor rippling.

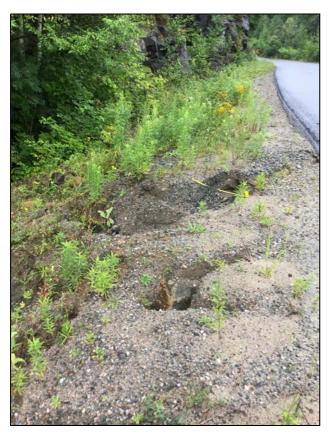
Description: Northwest erosion detail #3, tape measure pictured is extended to 1m. Embankments / Slope Protection (All quadrants.)

Repair washout at southwest quadrant and add slope

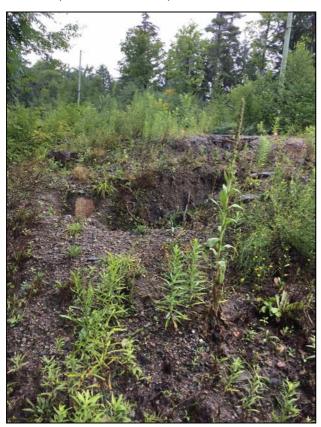
Embankments / Slope Protection (All quadrants.)

Description: Extreme erosion at the northwest embankment, recent rain event at time of inspection.

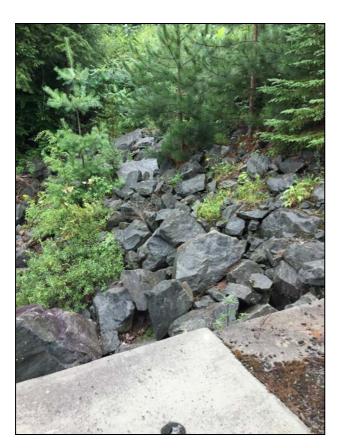
Embankments / Slope Protection (All quadrants.)

Description: Southeast embankment heavy stone armouring, typical conditions.

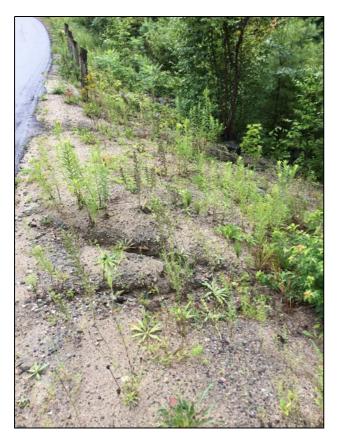
Embankments / Slope Protection (All quadrants.)

Description: Northwest erosion \ washout detail.

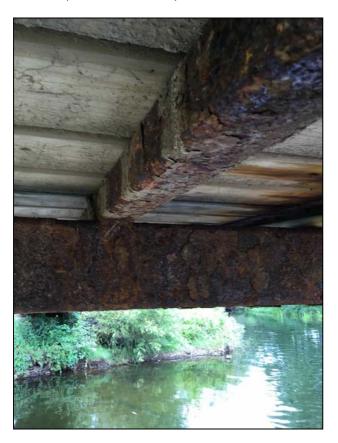
Beams/Main Longitudinal Elements / Stringers

Description: East stringer looking north.

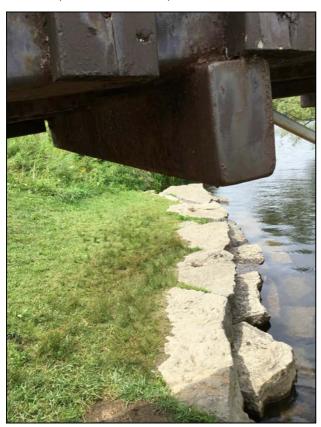
Beams/Main Longitudinal Elements / Floor beams

Description: Third floor beam to the south end looking west, severe flaking and corrosion.

Repair and Rehabilitation R			Estimated				
Element	Repair and Rehabilitation Required	> 10 years	6 - 10 years	1 - 5 years	Now < 1 year	Urgent	Cost
Bottom chords, stringers, bracing, beams	Grind and repaint.					✓	\$80,000.00
						Total	\$80,000.00

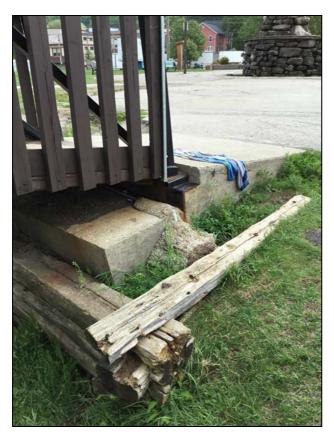
Abutments / Abutment walls (N/S)

Description: South abutment, mass concrete utility conduit pictured.

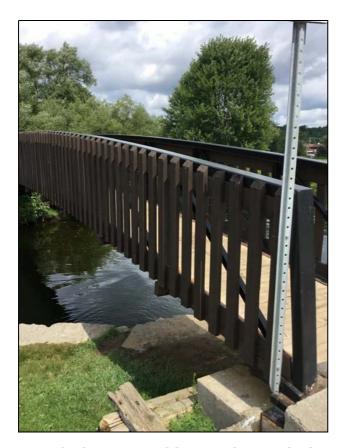
Barriers / Hand Railings (N/S)

Description: West side exterior, typical condition.

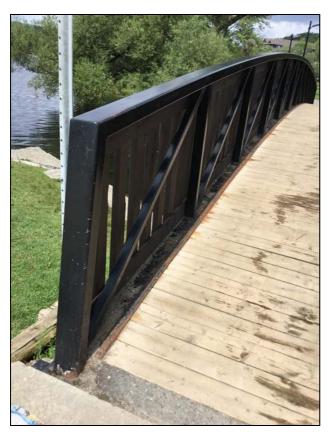
Barriers / Hand Railings (N/S)

Description: West side interior, typical condition.

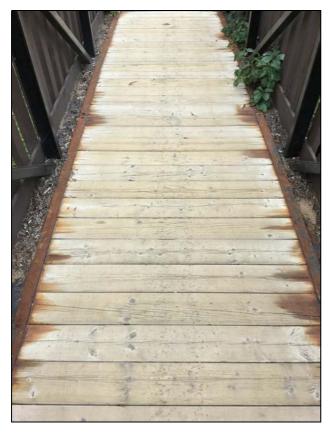
Decks / Deck Top (Top of deck)

Description: North end, typical conditions.

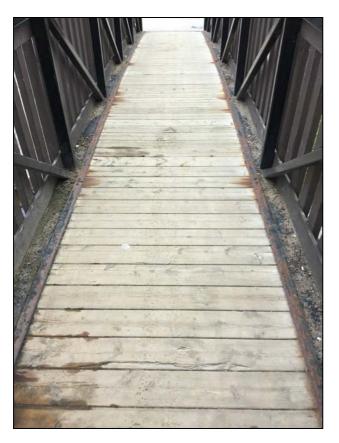
Decks / Deck Top (Top of deck)

Description: South end, typical conditions.

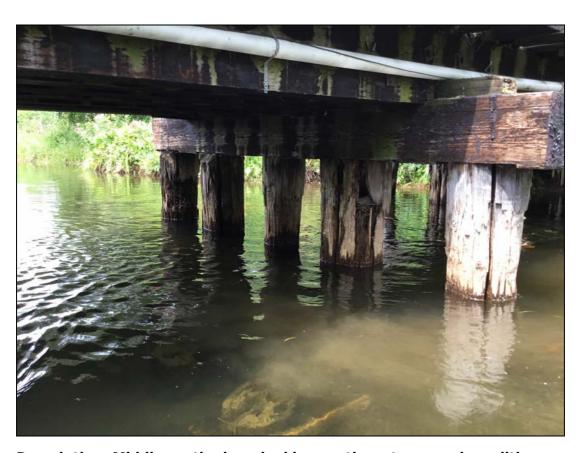
Piers / Shafts/columns/Pile Bents

Description: Middle north piers, looking northwest, general condition.

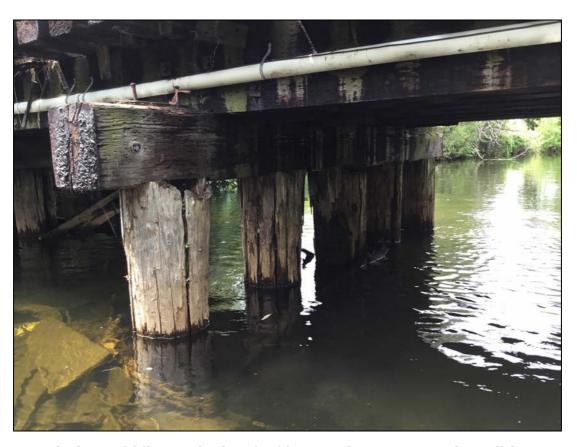
Piers / Shafts/columns/Pile Bents

Description: Middle south piers looking southwest, general condition.

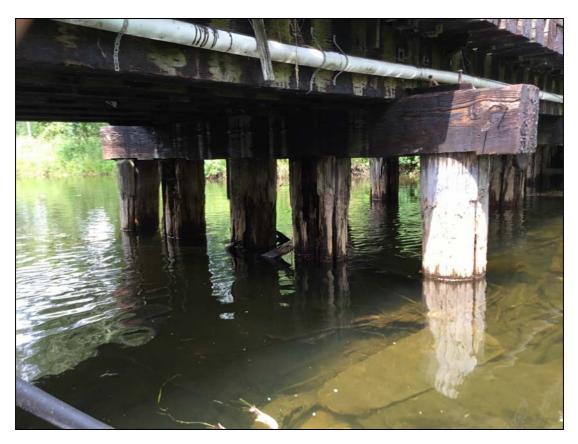
Piers / Shafts/columns/Pile Bents

Description: Middle south piers, looking northwest.

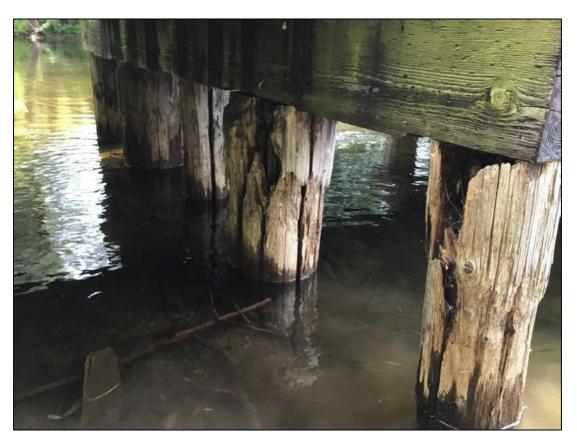
Piers / Shafts/columns/Pile Bents

Description: Second to north piers looking, looking southeast. Severe disintegration.

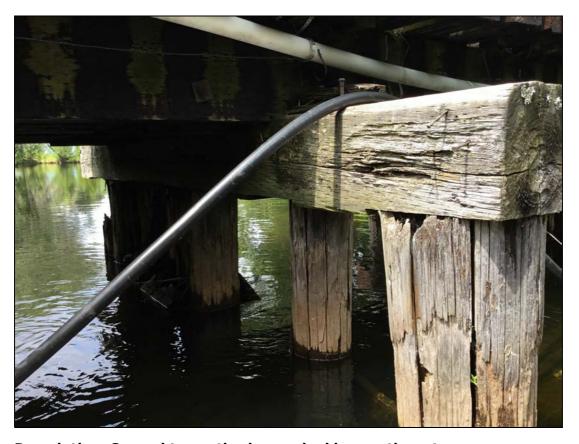
Piers / Shafts/columns/Pile Bents

Description: Second to southerly cap, looking northwest.

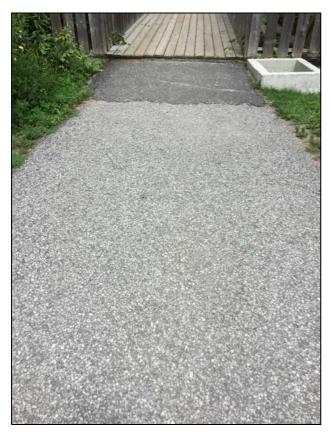
Decks / Deck Top (Top of deck.)

Description: South approach, typical condition.

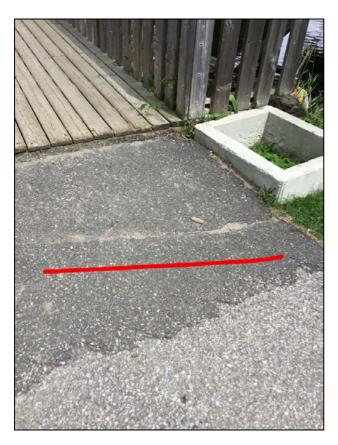
Approaches / Sidewalk/Curbs (South only.)

Description: Crack in asphalt access ramp.

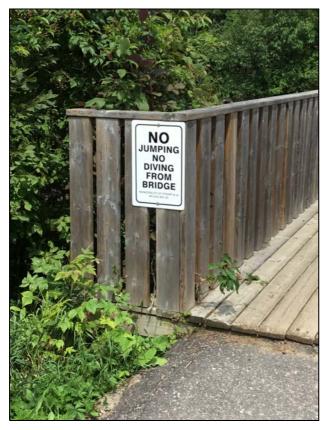
Approaches / Sidewalk/Curbs (South only.)

Description: Warning sign, south side.

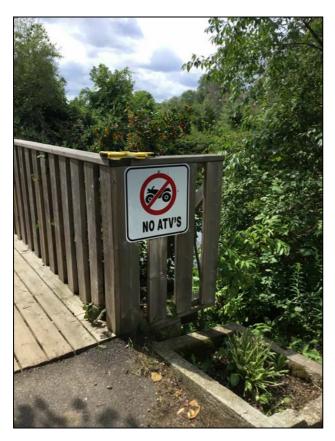
Accessories / Signs (N/S)

Description: No ATV sign, north side.

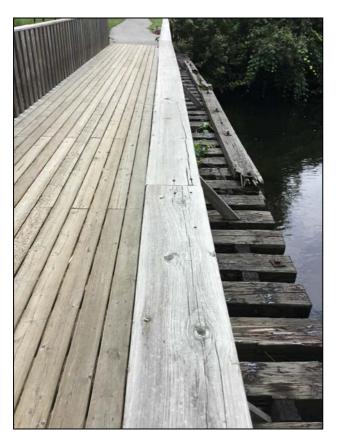
Approaches / Wearing surface (North)

Description: Handrail, typical conditions.

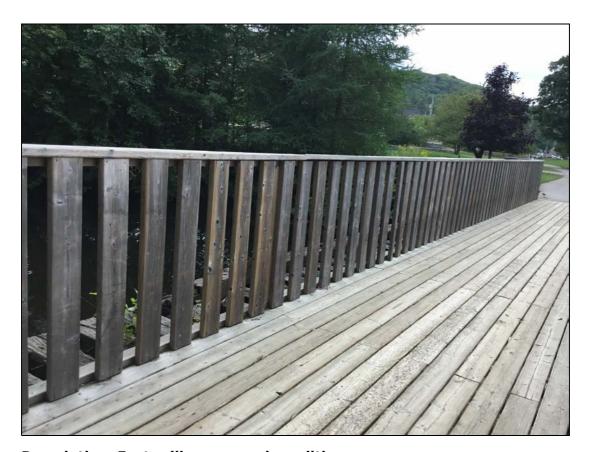
Barriers / Hand Railings (E/W)

Description: East railing, general condition.
