## BIENNIAL BRIDGE INSPECTIONS

FINAL INSPECTION REPORT  
Municipality of Dysart et al

October 2016

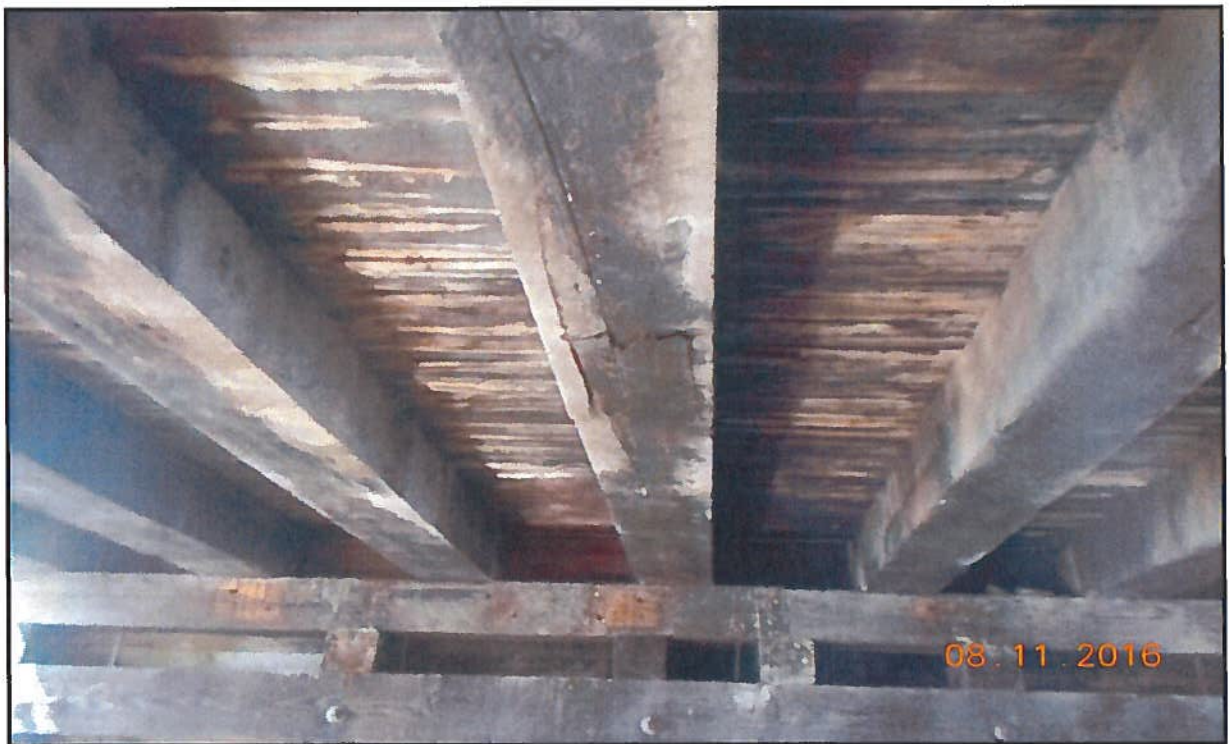
Photo 6: Splintering of Wood Beam (4<sup>th</sup> from North face) – Looking West

- A design remedy should be provided to repair or replace the damaged girder(s) and deck. Rehabilitation work as a minimum is required to repair damaged girder. Depending on the outcome of the structural evaluation it may be required to replace all girders.
- The deck and approach wearing surfaces, and the wing wall /retaining walls, are in poor to fair condition and should be replaced within 1-5 years or at time of girder replacement.

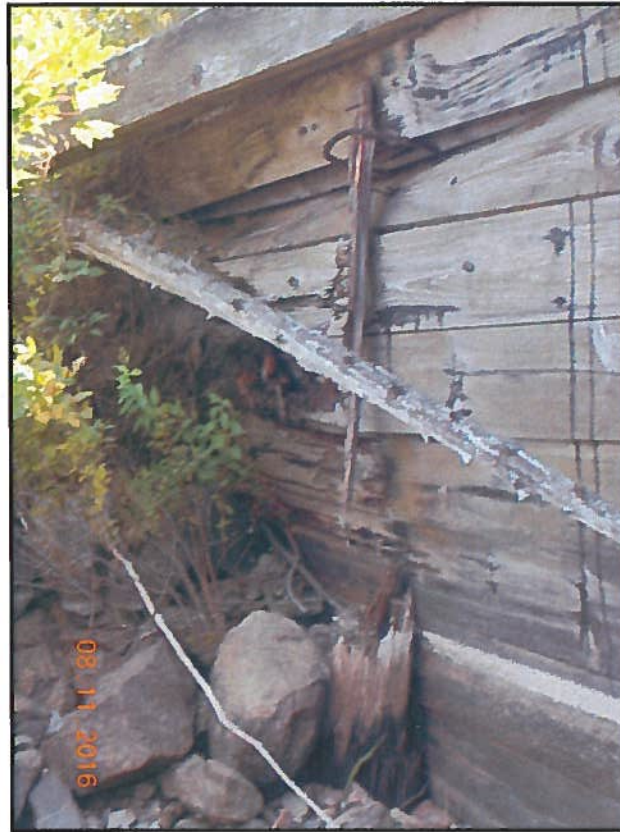
Photo 9: Northeast Abutment Wing Wall – Looking Southwest

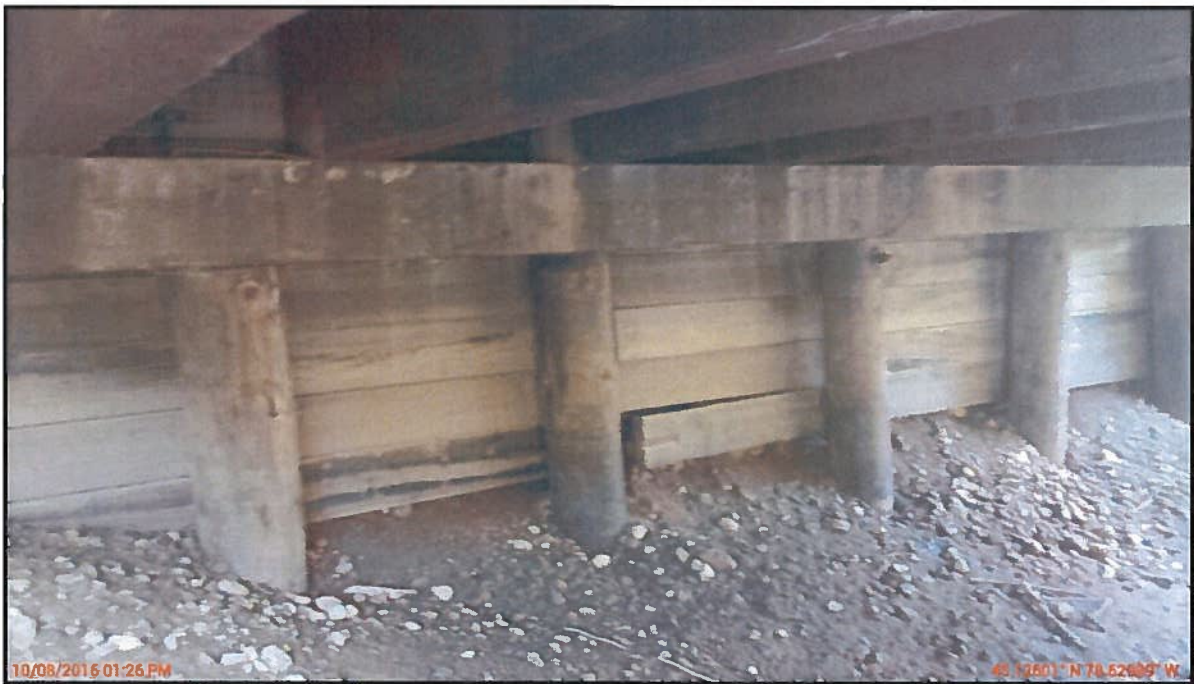
Photo 4: General Arrangement – North Ballast Wall

- Repair ballast wall timbers.
- Repair / replace damaged guiderail post.
- Clean the bridge deck and deck drains under the curb.
- Debris should be cleaned from stream in northwest quadrant.

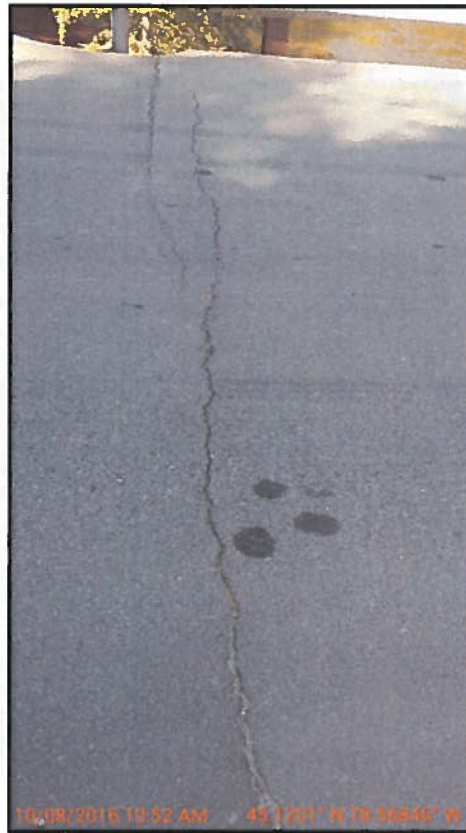
Photo 3 : South Approach Wearing Surface

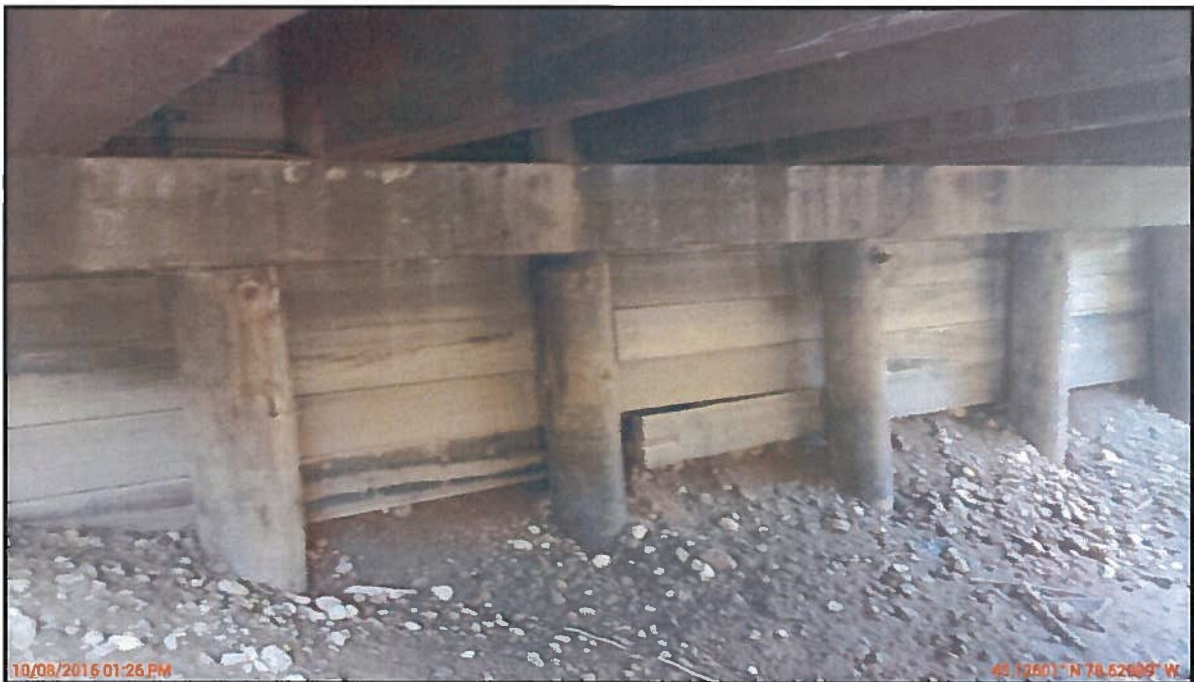
Photo 4: General Arrangement – North Ballast Wall

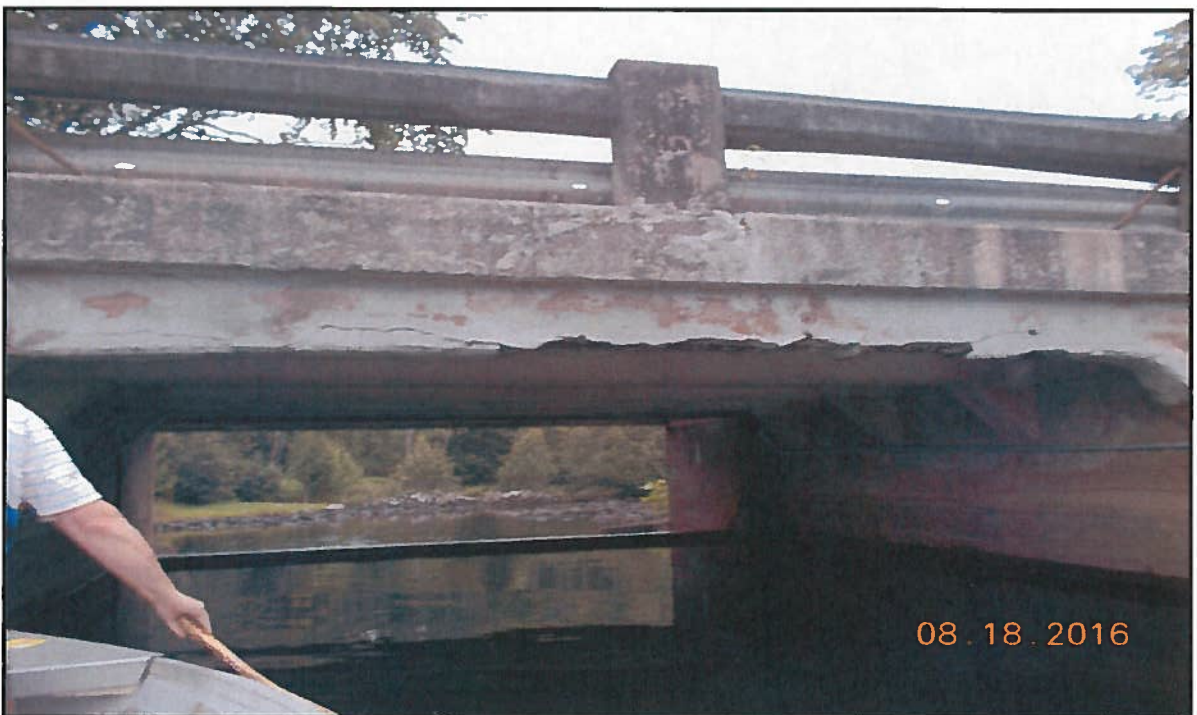
Photo 4 : General View – North Elevation Exterior Girder
